Dutch presence in Cuban waters

A first year of archaeological surveys

**L.F. Derksen, R.W. de Hoop,
M.R. Manders and M. Cacéres Suárez**

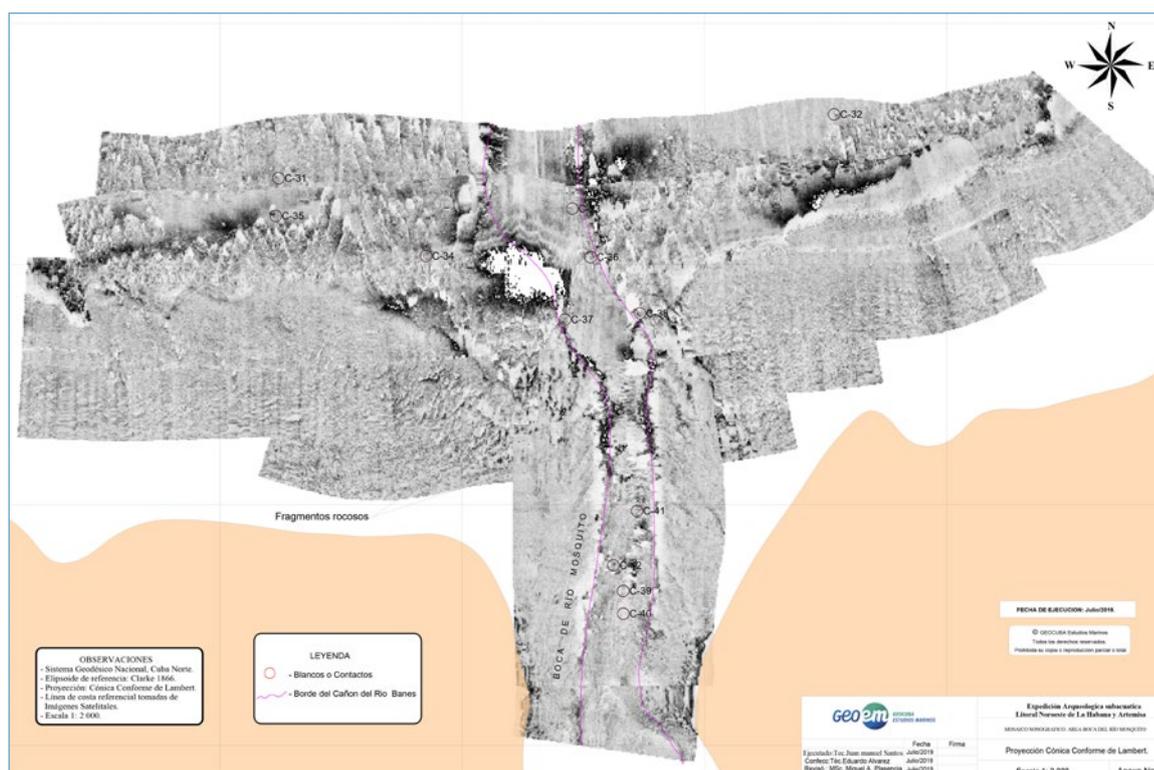
Figure 7 - Side-scan sonar image of the seabed at Boca de Río Mosquito. A total of 11 contact points are circled. Diver's points of entry were chosen to correspond with the two magnetometer anomalies. Scale 1:2000 (Courtesy of GEOEM).

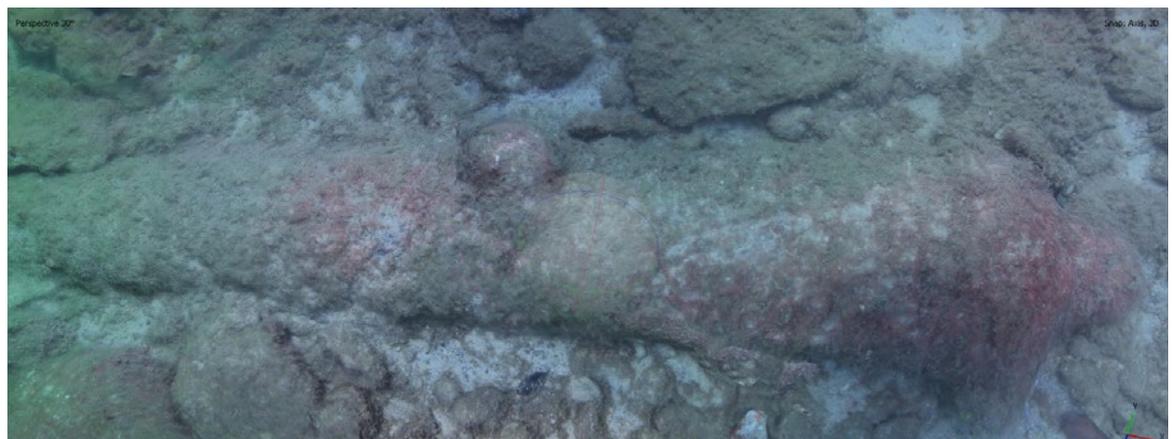
Three iron cannons were found within close distance of each other, at depths ranging from 18 metres farther out to sea to 15 metres closer to the coast. The first cannon was found at the bottom of the entry point, lying next to a modern long metal pipe (Fig. 9; Appendix IV).¹⁶ A total length of 270 cm was recorded, its muzzle pointing north. The cannon was heavily concreted, meaning that otherwise diagnostic features, mostly at the breech end, were no longer visible. Leaving not much more than the outlines of a cannon, the only roughly discernible features were its button and a trunnion on the eastern lateral side. At first glance, the cannon appeared to be a heavily corroded cast-iron 12 pounder.

Figure 9 - 3D photogrammetry depiction of the middle cannon, corresponding to the drawing in Appendix IV.

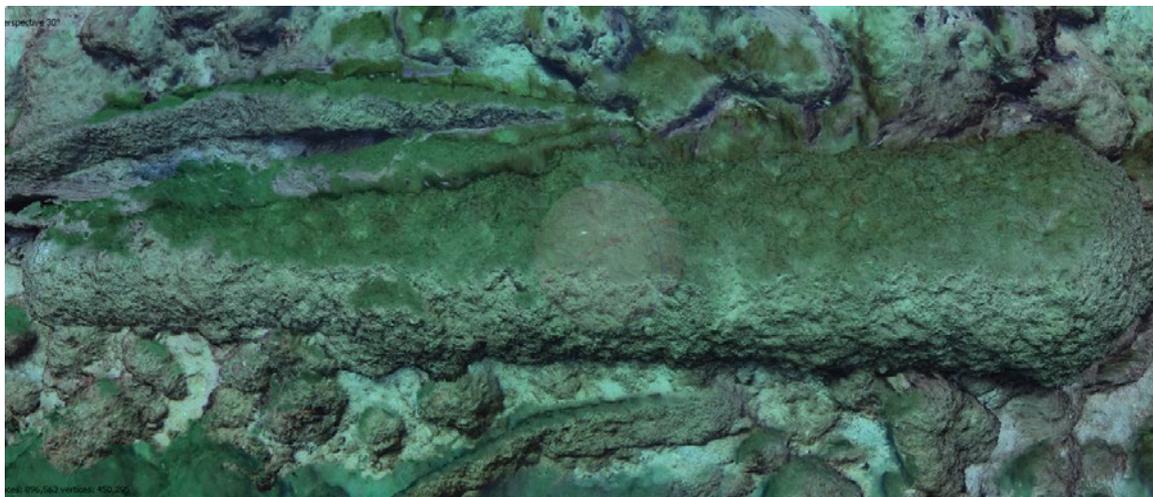
Figure 10- 3D photogrammetry depiction of the southern-most cannon, corresponding to the drawing in Appendix VI.

Approximately 10 metres south of the cannon, another cannon was found (Fig. 10; Appendix VI).¹⁷ The muzzle and button were the only recognizable features of this equally heavily concreted cast-iron specimen. It had a length of 294 cm, with its muzzle pointing north. It was initially assessed to be a 24 pounder.

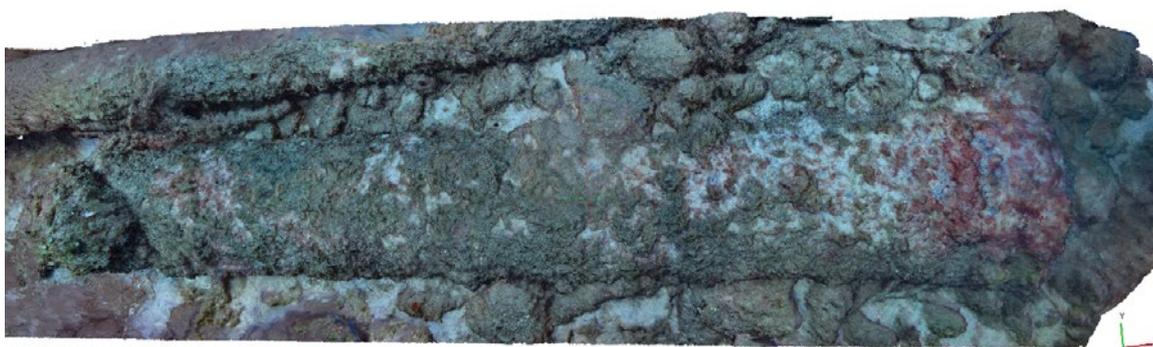
Figure 11 - 3D photogrammetry depiction of the northern-most cannon, corresponding to the drawing in Appendix V.

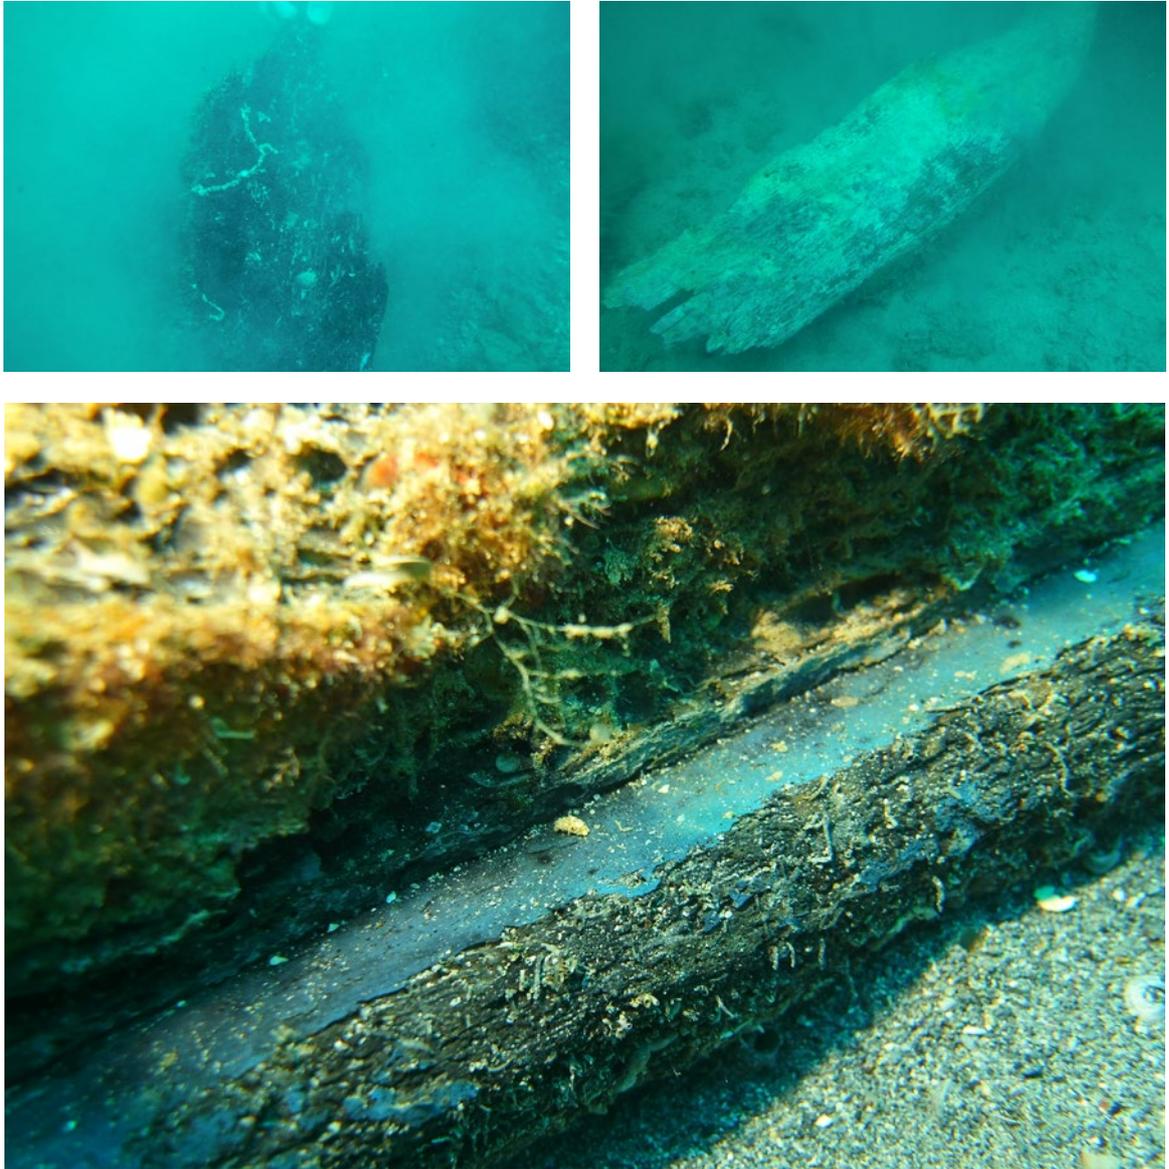
Further inspection of the immediate surroundings of the cannons yielded a few loose pieces of wood, probably oak. Some of them were definitely younger in age, but others could be old. Upon inspection, some of the wood showed blue paint (Fig. 12). These could not have been above the seabed for long, otherwise the wood would have been eaten away by shipworm (*Teredo navalis*), which is present in the warm Cuban waters.²¹

Figure 12 - Wooden shipwreck material as found at Boca de Río de Mosquito, including one specimen with remains of blue paint.

a shipwreck unrelated to Jol's fleet. Other finds, such as the yellow brick, if found to be an *IJsselsteen*, could be an indicator of a Dutch shipwreck at this location. Wooden shipwreck parts found at the site appear to be modern, due to the presence of a coat of blue paint on some of them.

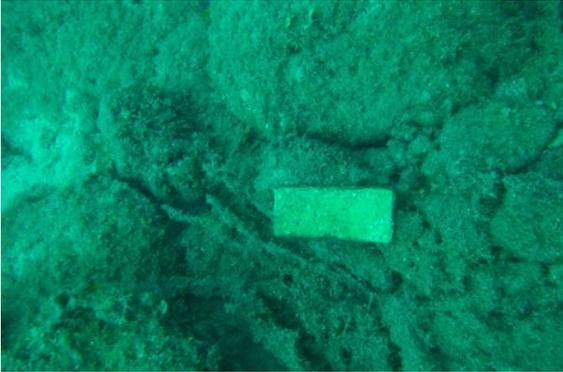
After recording all the cannons, the four divers split into groups of two to further scan the surroundings for additional archaeological finds. In this particular survey, a brick of yellow clay (Fig. 14) measuring 20 cm x 8 cm x 5 cm

Figure 14 - A yellow brick lying on the seabed

was found lying on top of the seabed. Since it was found outside any clear context, its relevance to the site remains unknown at this point. There is, however, a possibility that the brick could be associated with a Dutch ship, as it bears resemblance to an *IJsselsteen* brick. Similar bricks were used as ballast or in the construction of the galleys of Dutch ships.²² The brick was recorded on video and recovered by the second team of divers for future analysis. Future chemical analysis of the clay may point out its origins.

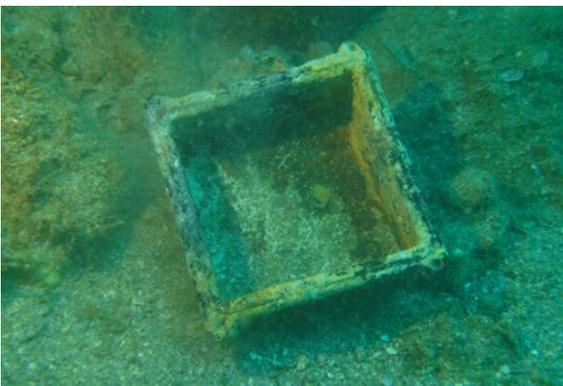
Another find included a pewter box, which was also recovered (Fig. 15). However, close inspection revealed that it was relatively modern. Furthermore, on the west side of the mouth of the Río Mosquito inlet, two iron-stock anchors were found (Fig. 16). Iron-stock anchors and chain were introduced around the second half of the 19th century and continued to be in use into the first half of the 20th century.²³ A stockless anchor dating from the period of WWII was located near the site as well. These anchors support the idea that this was an

Figure 15 - Pewter box found lying on the seabed at Boca de Río Mosquito.

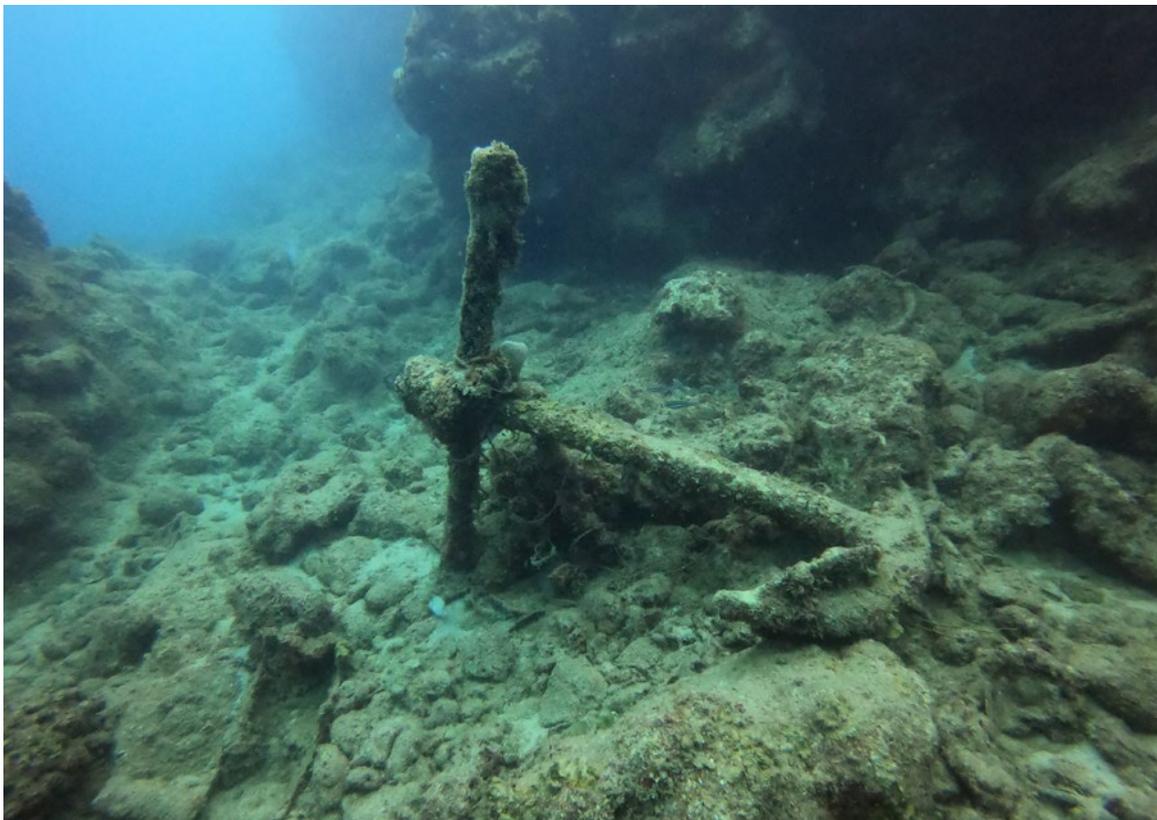
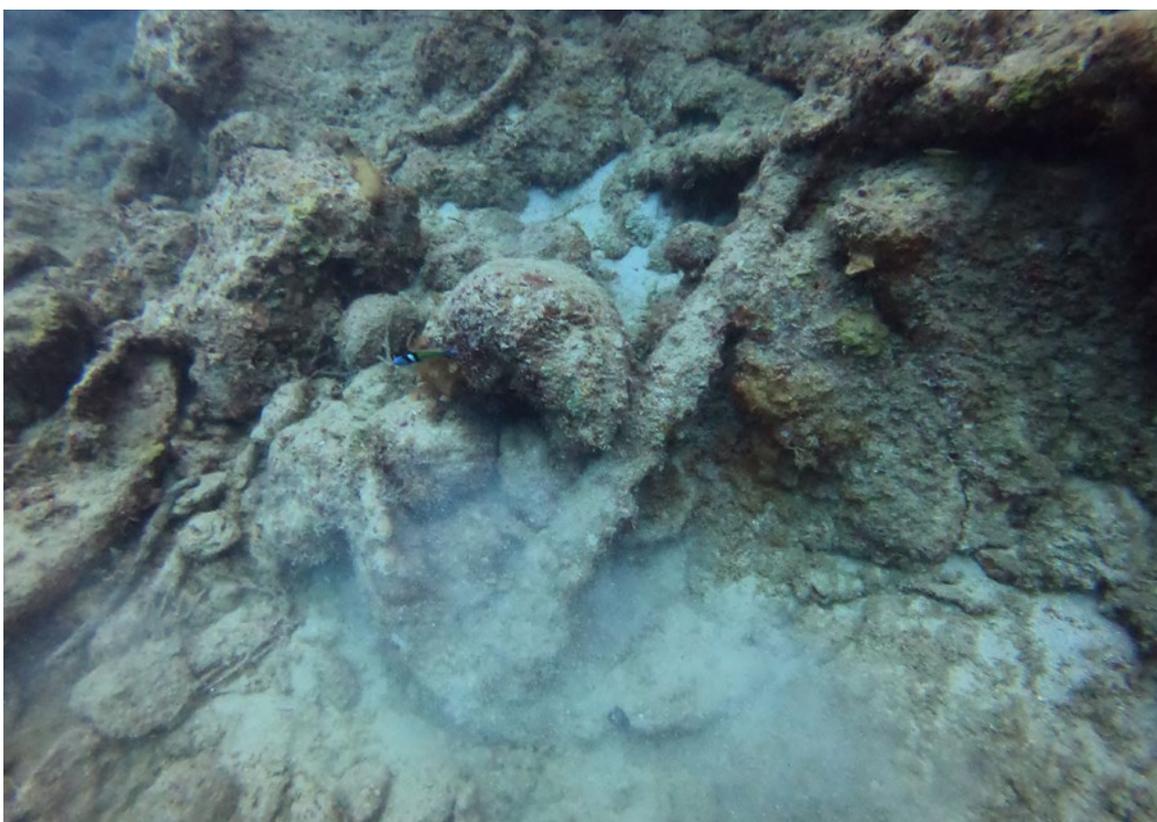
Figure 16 - Two iron-stock anchors at Boca de Río Mosquito.

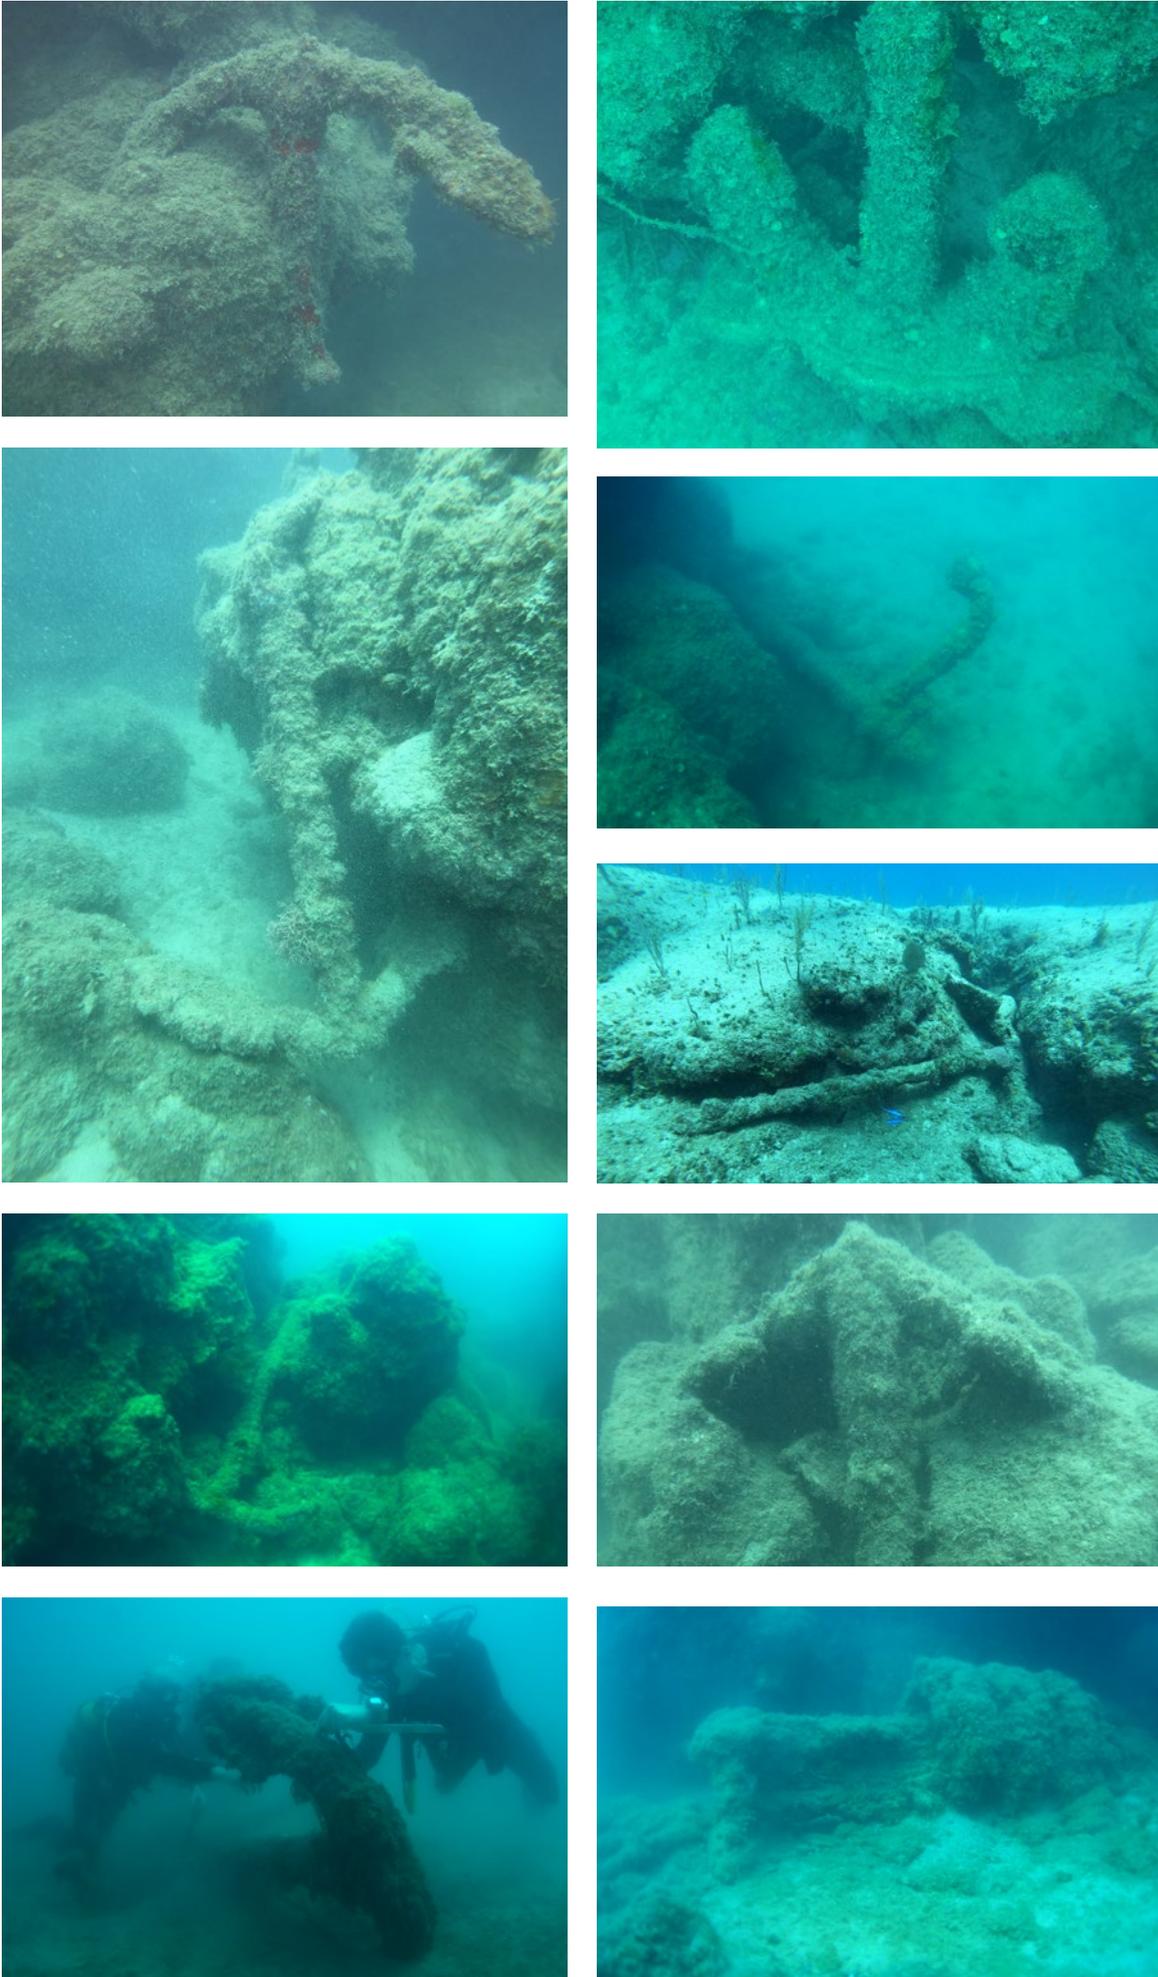
Multiple anchors were discovered at Boca del Río Banes (Fig. 19). Most of these were found stuck in the rocky features jutting out of the seabed, which were located in the centre of the natural channel leading into Boca del Río Banes.

Among them was a large iron-stock anchor and chain. It was found resting on its shank, with one arm sticking up from the seabed and the other end buried in the sediment. Iron-stock and chain anchors of the Admiralty

Figure 19 - A collage of the anchors found at Boca del Río Banes.

pattern date, at the earliest, to around the middle of the 19th century, although this classic style is still in use even today.²⁵ This anchor was sketched, measured and photographed (see cover photo). From crown to top end, the shank measured 220 cm. The iron stock measured 189 cm in length. The fluke that was visible was measured over the palm, recording a length of 56 cm, while the broad end of the fluke measured 30 cm in width.

Four small wooden-stock anchors were also found. These included the three small wooden-stock anchors as depicted in Figure 19. Those depicted have typical straight arms. Some were found upside down, suggesting that they probably got stuck when they were dropped. While wooden-stock anchors generally remained in use far into the 19th century, anchors with straight arms are typical of 18th-century designs that were predominantly used by the British Admiralty.²⁶ A stockless anchor from the late-19th century at the earliest was also found. Most of the anchors found were photographed.

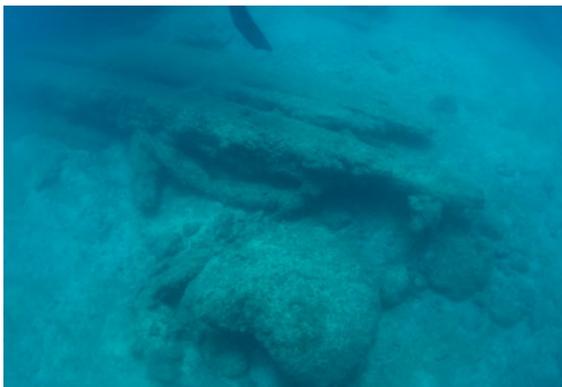
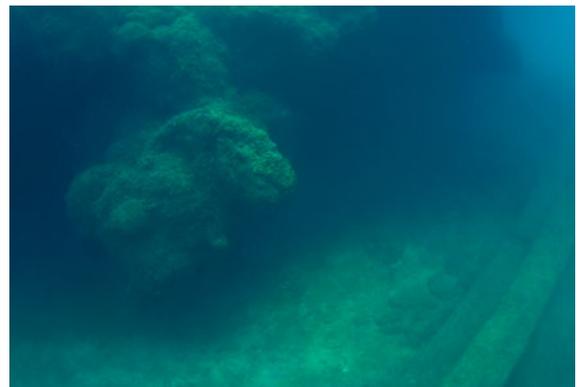
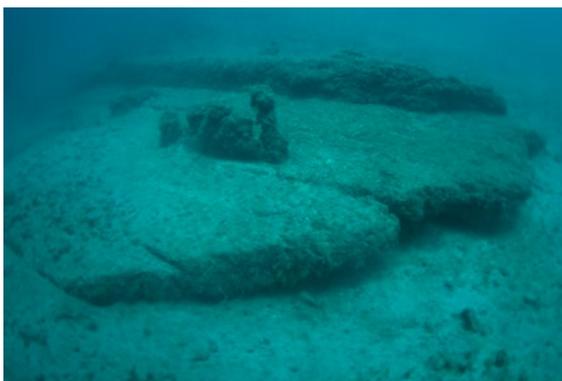
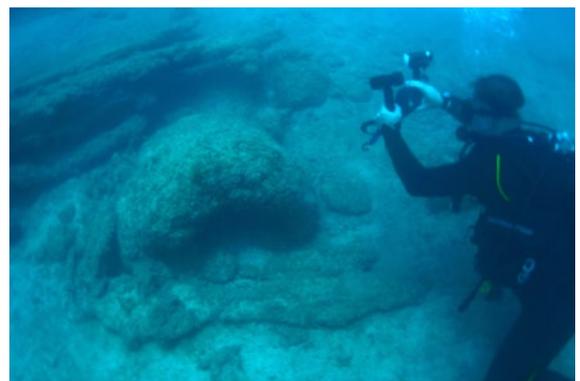
North of the rocky features set in the centre of the channel, divers found a shipwreck of pinewood. Wreckage material consisted of planks and a keel with some frames. The shipwreck material stretched over an area of an estimated length of 20 m and a width of 4 m. Although thought to be rather modern, this site was recorded with photography.

Figure 20 - Remains of a wooden shipwreck found at Boca del Río Banes.

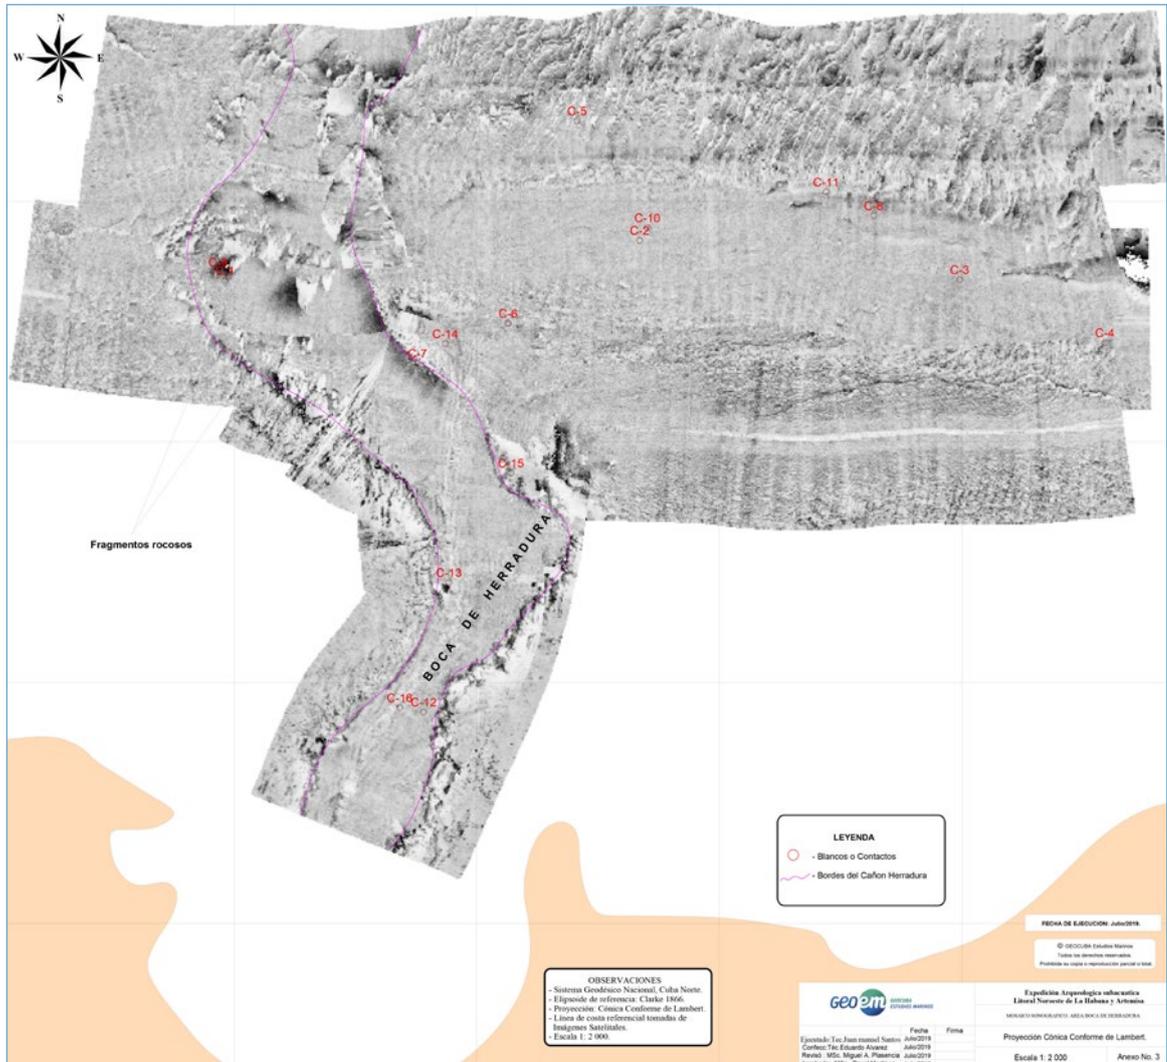
Figure 23 - Side-scan sonar rendition of the area in front of Herradura. The 15 contact points are shown in red. Scale 1:2000 (Courtesy of GEOEM).

as points of interest (Fig. 23), while two magnetic anomalies were spotted (Fig. 24).

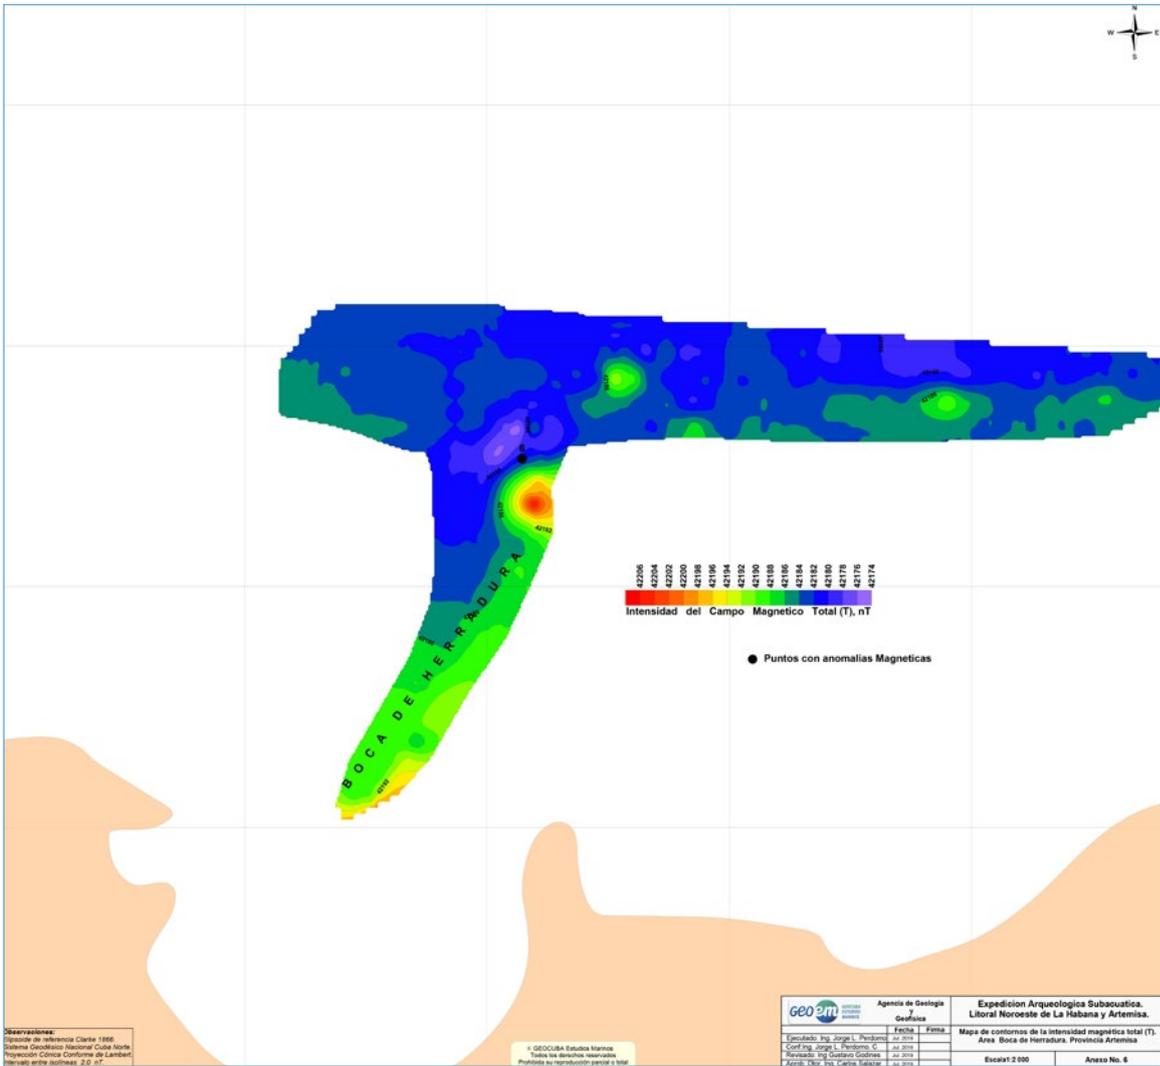
Figure 24 - Magnetometer recording of the area in front of Herradura. Scale 1:2000 (Courtesy of GEOEM).

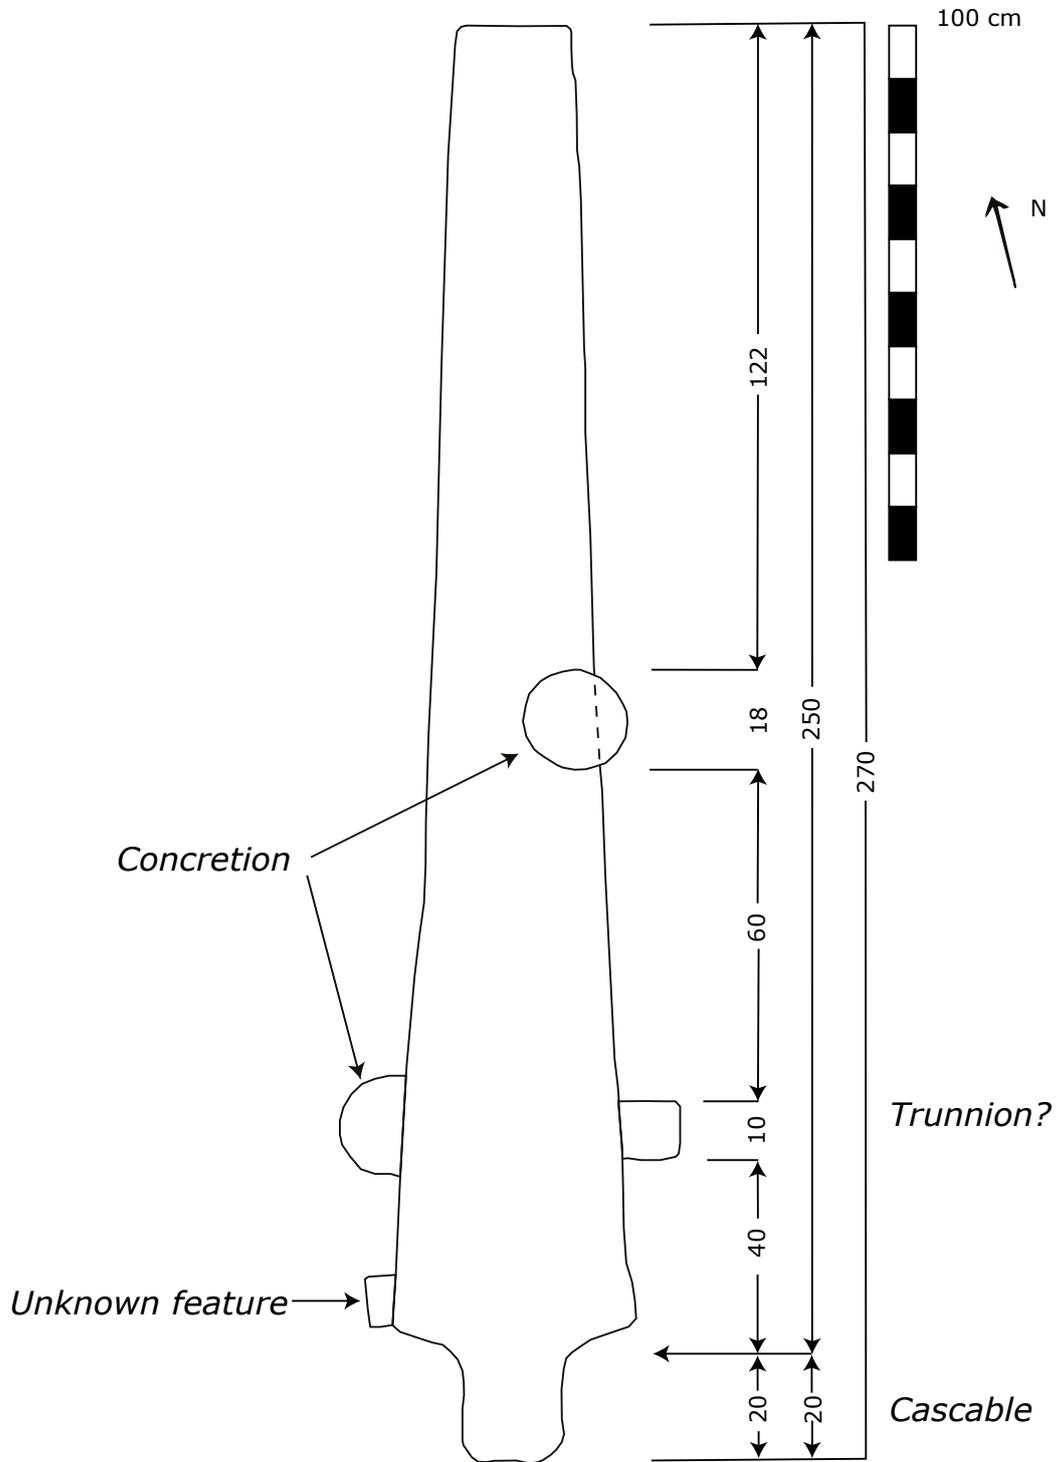
IV – Drawing of Cannon Middle

Middle Cannon
Boca de Río Mosquito, Artemisa, Cuba
Scale 1:10
Analogue drawing by Robert de Hoop (August 2019)
Digitized January 2021

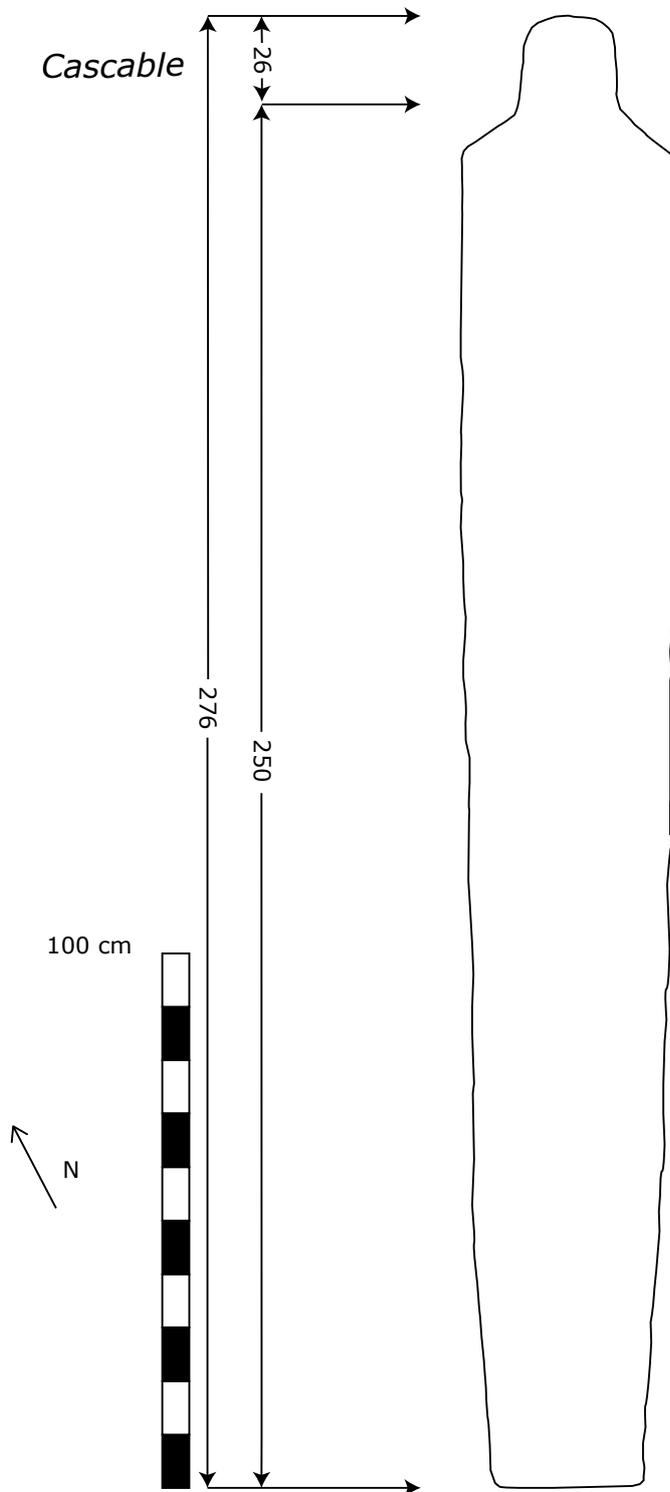
V – Drawing of Cannon North

Cannon North
Boca de Río Mosquito, Artemisa, Cuba
Scale 1:10
Analogue drawing by Robert de Hoop (August 2019)
Digitized January 2021

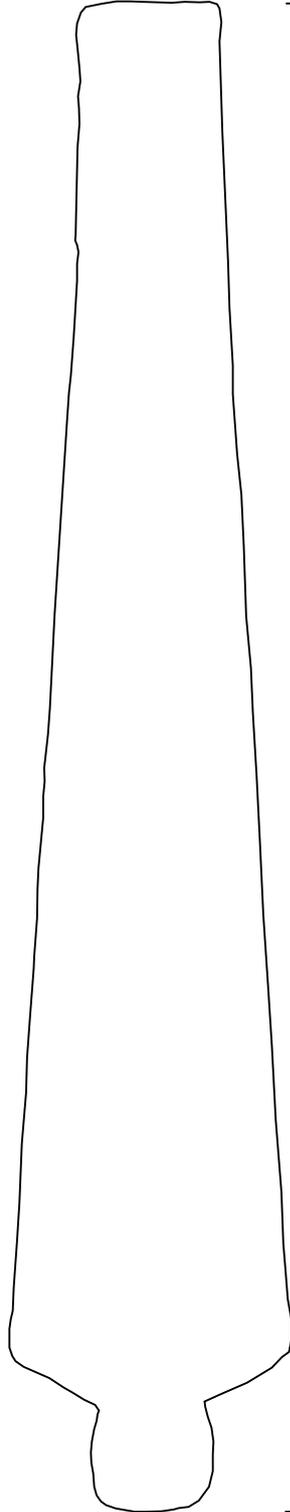
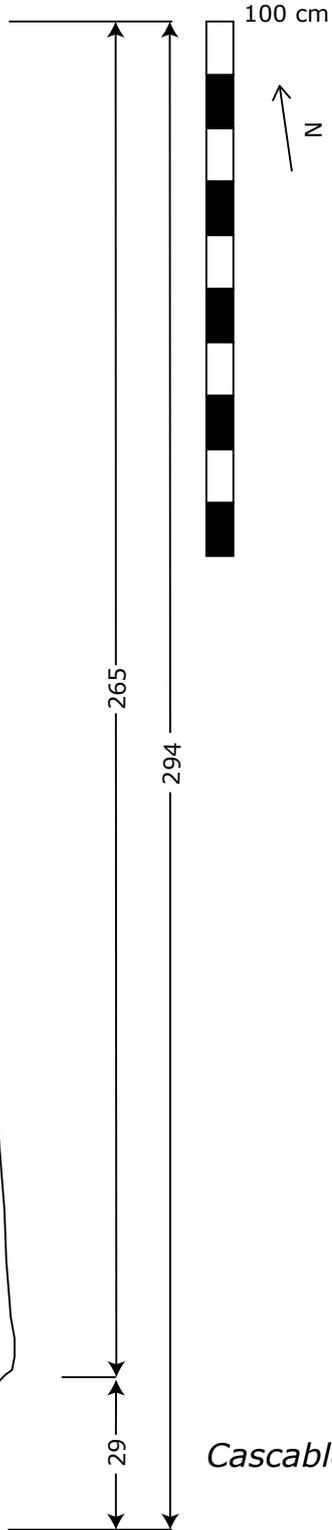
VI – Drawing of Cannon South

Cannon South
Boca de Río Mosquito, Artemisa, Cuba
Scale 1:10
Analogue drawing by Robert de Hoop (August 2019)
Digitized January 2021
