The life of the Rooswijk

What a combination of history and archaeology can tell us about the voyages of an 18th century VOC-ship.

Treasures of the Sea

Universiteit Leiden, Faculteit der Archeologie & Faculteit der Geesteswetenschappen

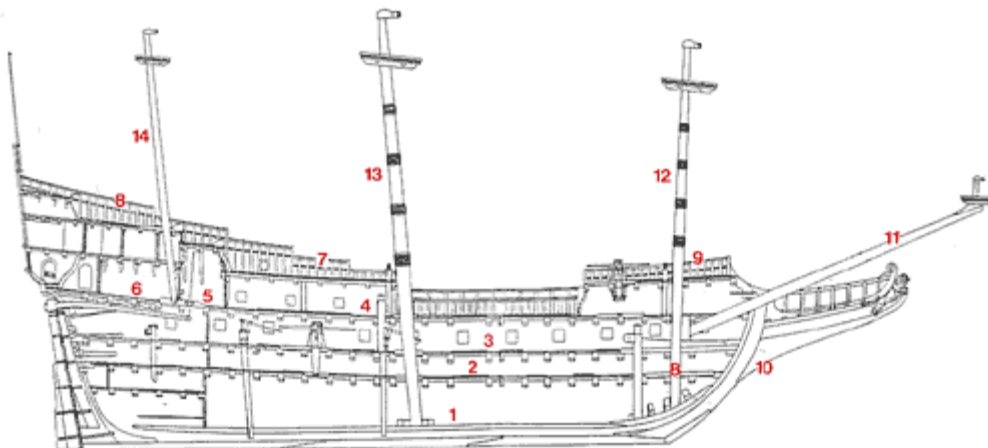
Assuming that the Rooswijk is in fact a so-called spiegelretourschip, there are a number of features by which these ships can be identified. First of all, as their English name of “square stern ships” already indicates, the hull ended in a flat square plane (Bruijn et al 1987, 38). The 145 foot ships, such as the Rooswijk, had a capacity of up to 56 cannons and a load of 140 with a tonnage of 850 (Bruijn et al 1987, 38). These ships closely resembled the warships of the Dutch republic, but with fewer guns and more capacity for cargo. These ships were great for both transporting passengers as well as transporting cargo due to having 2 or 3 continuous decks and a special deck could be added for transporting either spices or soldiers, despite the deck not being high enough for any man to stand up (img 1).

Img 1. VOC spiegelretourschip - <http://voc-kenniscentrum.nl/images/voc-schepen.gif>

The ship had three masts, with the added possibility of adding two extra sails to the bowsprit. The bow was also generally adorned with an ornament which distinguished

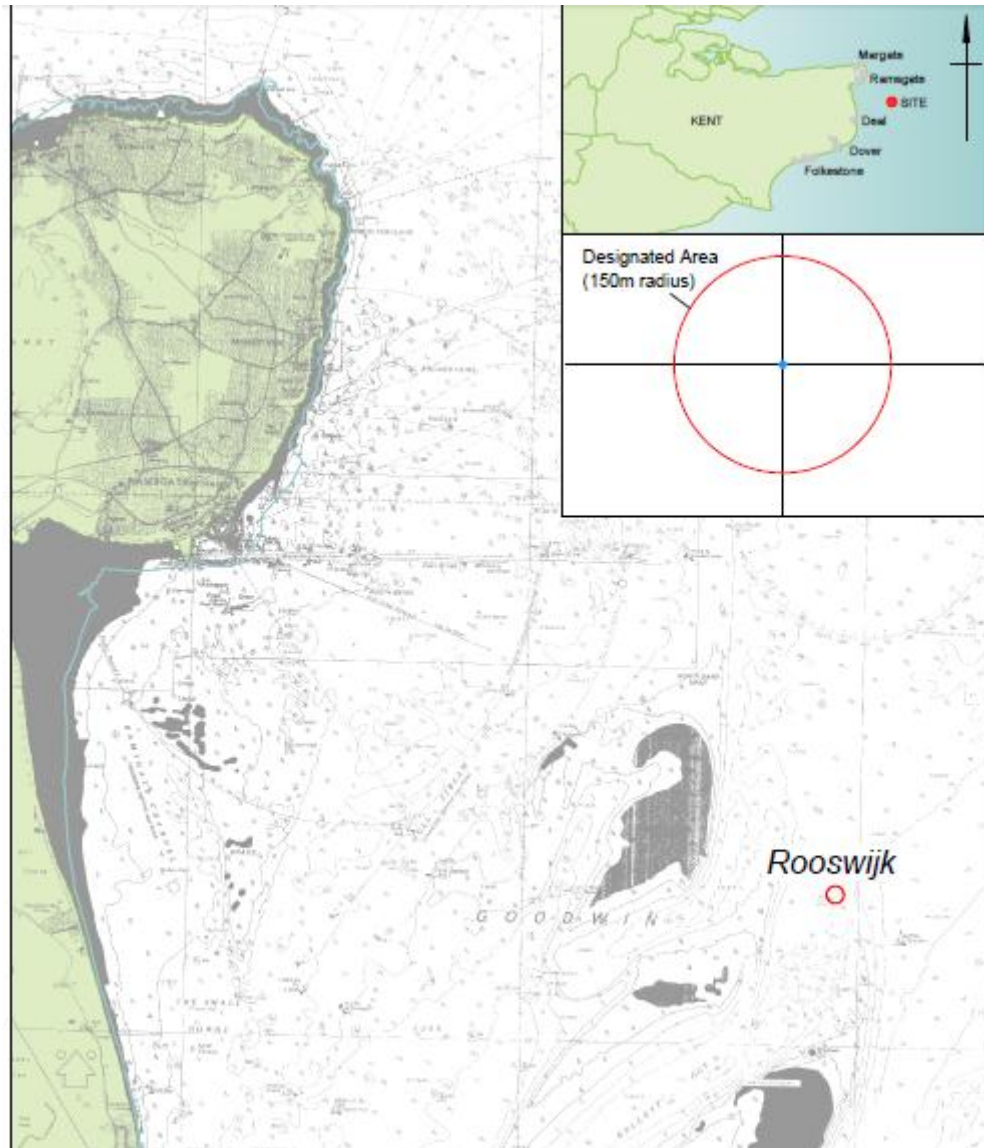
Img. 2, the last resting place of the Rooswijk. – Wessex Archaeology 2007, 18.

So on the 8th of January, 1740, the Rooswijk set off on its route through the channel and, as the night fell, decided to anchor down near the Goodwin sands, a 16 kilometre long sandbank off the coast of the English port-town/naval base of Deal (NA, VOC, inv. Nr. 123). As it was anchored down for the night, a massive January storm set in. This storm combined with the unpredictable tides at Goodwin Sands were too much for the Rooswijk its crew to deal with and it sank at the Goodwin sands (img 2). The Dutch VOC

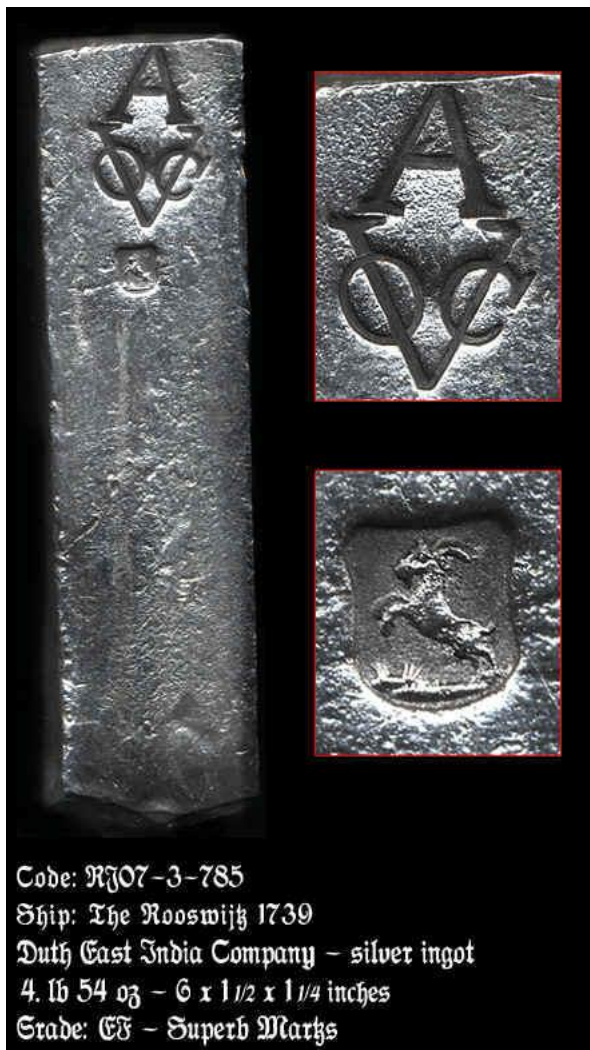
Img. 3, Silver bar aboard the Rooswijk,

On its final voyage, the Rooswijk was loaded with a rather special cargo. This cargo is also what made the ship so interesting for both archaeologists, commercial salvagers, and treasure hunters alike. When the Rooswijk left for its final voyage it was loaded with both gold and silver intended for the Asian trade. The VOC Heeren XIV allocated 300.000 guilder worth of gold and silver to be transported to Batavia aboard the Rooswijk (NA, VOC, inv. Nr. 123). These 300.000 guilder worth of precious metals were transported in the shape of mostly Silver bars and Spanish reals. There should supposedly have been approximately 1000 silver bars aboard the ship together with anywhere from 26.000-36.000 Spanish reals aboard the ship, depending on whether the cargo consisted solely out of 8 reals, or whether 4 reals were also on board (img 3) . While almost all of the silver bars have been found, only around 9000 coins have been salvaged so far. Besides carrying a large amount of silver, the archives also mention 52 tons of gold being transported to Batavia in early 1740 (NA, VOC, inv. Nr. 123). It is unlikely that any of this was transported on the Rooswijk though as no mention of this has been found so far, nor has any gold been found during preliminary archaeological research.

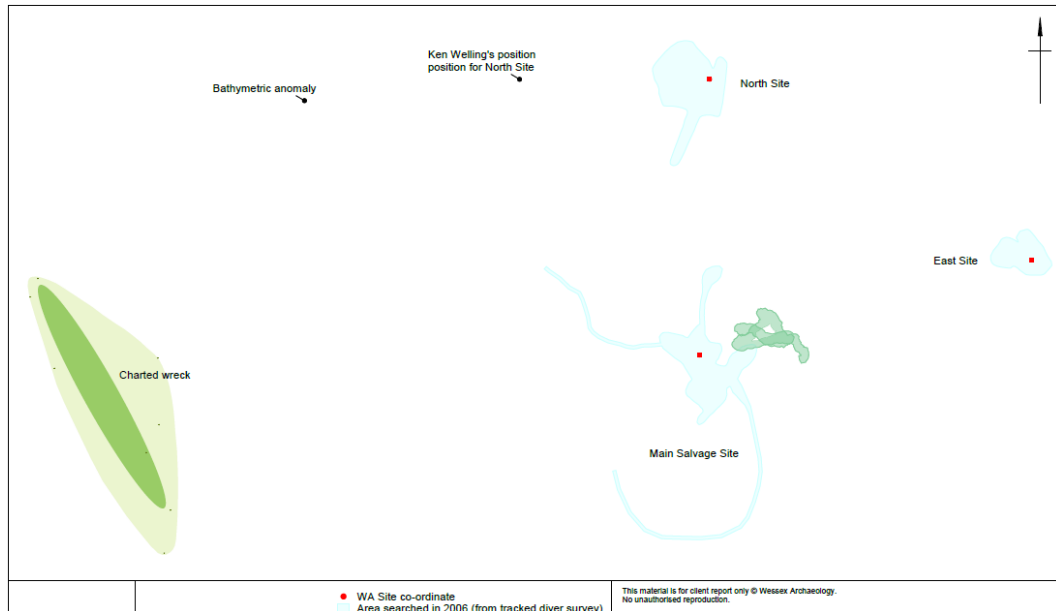
Img. 3, Rooswijk site plan. Wessex Archaeology 2007, 19.

Research on the ship is complicated though by the fact that the site is spread over a large area, and split into 3 sites in which finds linked to the Rooswijk are concentrated. These 3 sites are effectively named the North side, the East side, and the West side, with the West side likely holding the main bulk of the ship its hull but in all 3 sites finds related to the Rooswijk are present. (WA 2007) The spread of these finds is likely due to both the tidal swells and shifting sands present at the Goodwin Sands as well as the fact that the ship sank and possibly broke up during a heavy storm (Destination plan).

The west site is by far the largest site, covering an area of approximately 3966 square meter. This site holds the main bulk of the Rooswijk artefacts found so far and also seems to be where the main part of the wreck is. The east site, being only 25 meter to the east of the west site, covers an area of 487 square meter (Wessex Archaeology 2011, 2). A third concentration has also been found, just 90 meter north of the west site, this

site covers 213 square meter and is the smallest site (img 1.) (Wessex Archaeology 2011, 2).
