A shipwreck of the Dutch admiralty in the Baía de Todos os Santos, Brazil: its history from battle to archaeological assessment

M.R. Manders, W.F.G.J. Brouwers (Eds.)

The Utrecht, a shipwreck of the Dutch admiralty in the Baía de Todos os Santos, Brazil: its history from battle to archaeological assessment

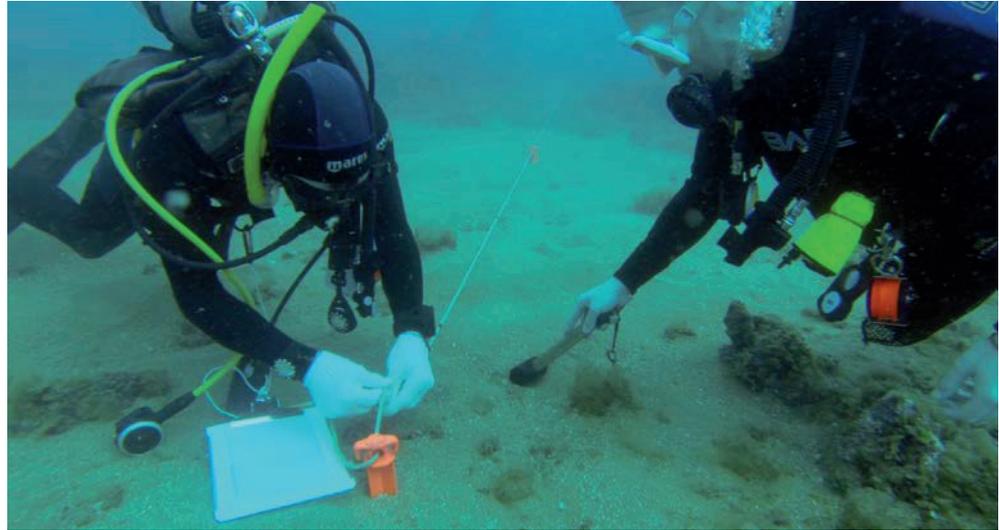
Fig. 15: Deploying the baseline

The first dives focused on getting the team acquainted with the site and comparing the actual distribution of artefacts and features with early sketches of the wreck site (1981 and 2001). A preliminary sketch of the actual situation was also made, so it could be used as a reference point for organising upcoming diving operations. The estimated position and number of objects were also recorded using this reference sketch.

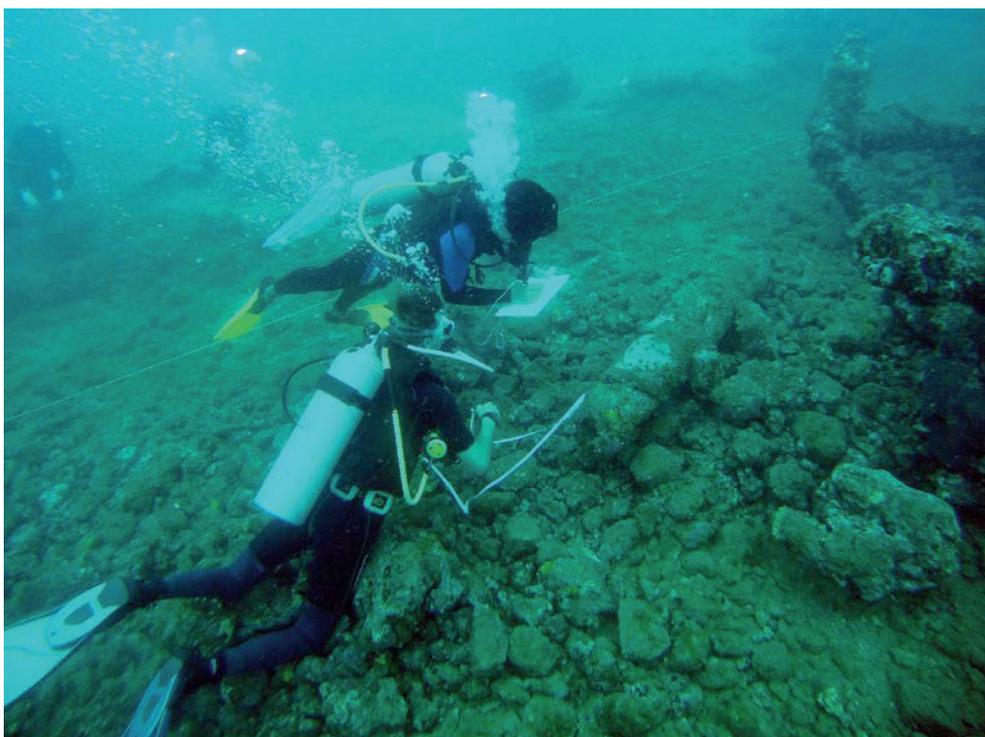
Cannons, anchors, ballast and exposed wood presented in the master plan were digitalised and recorded with supplemental information from the video overview. The result was a geographic database, where each feature is related to other information. The information provided consists of: the artefact ID; an indication of whether measurements, photos and videos were taken; general observations; and links to representative pictures of the artefact or feature (see Appendix I).

Fig. 16: Archaeologists recording individual artefacts

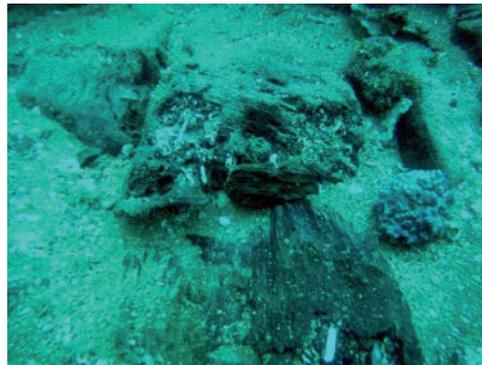
The northern most recorded evidence (H1) consisted of four closely spaced timbers (frames: T1, T2, T3 and T4) oriented NW/SE (Figure 21). The longer timber (T3) presents a discontinuity at approximately 30cm from two boulders sitting on top of it, indicating the existence of a fracture or (probably) a scarf (Figure 22). Three wooden treenails were recorded on T3, spaced circa 30cm apart, and two more were observed in close-up photographs. The frame is over 25 cm thick and also has a scarf. At least one of those treenails runs through this connection between two frame elements. Treenails were also observed in T1 and T2.

Fig. 22: Detail of discontinuity at T3

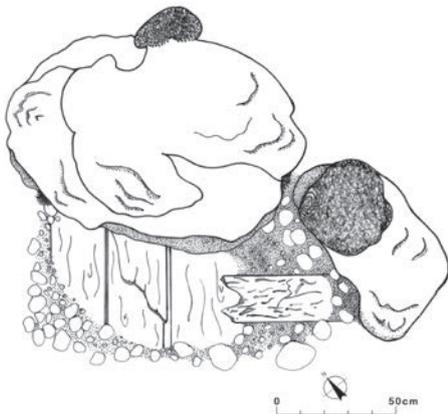
A third exposed hull fragment (H3) projects from down under a large amorphous concretion near C10 in the A5 complex of artefacts (Figure 24). It consists of four timbers (T11, T12, T13 and T14) running in a NE/SW direction, transversely overlaid by a heavily deteriorated timber (T15). T14 has been identified as the keel and is more than 50 cm wide. It was observed that shell plank T12 connected to the keel (in one observed rabbit). T13 is another plank on top of it. It is not certain, however, whether this one was also placed into a rabbit (Figure 25). The area was far too deteriorated to clarify this. It is certainly an area that needs to be investigated more closely in future fieldwork. T15 is another shell plank and is 7 cm thick.

Fig. 24: Schematic drawing of H3
