Nederlandse
Archeologische
Rapporten

Fragile monuments of the past

Physical threats and countermeasures

N.W. Willemse

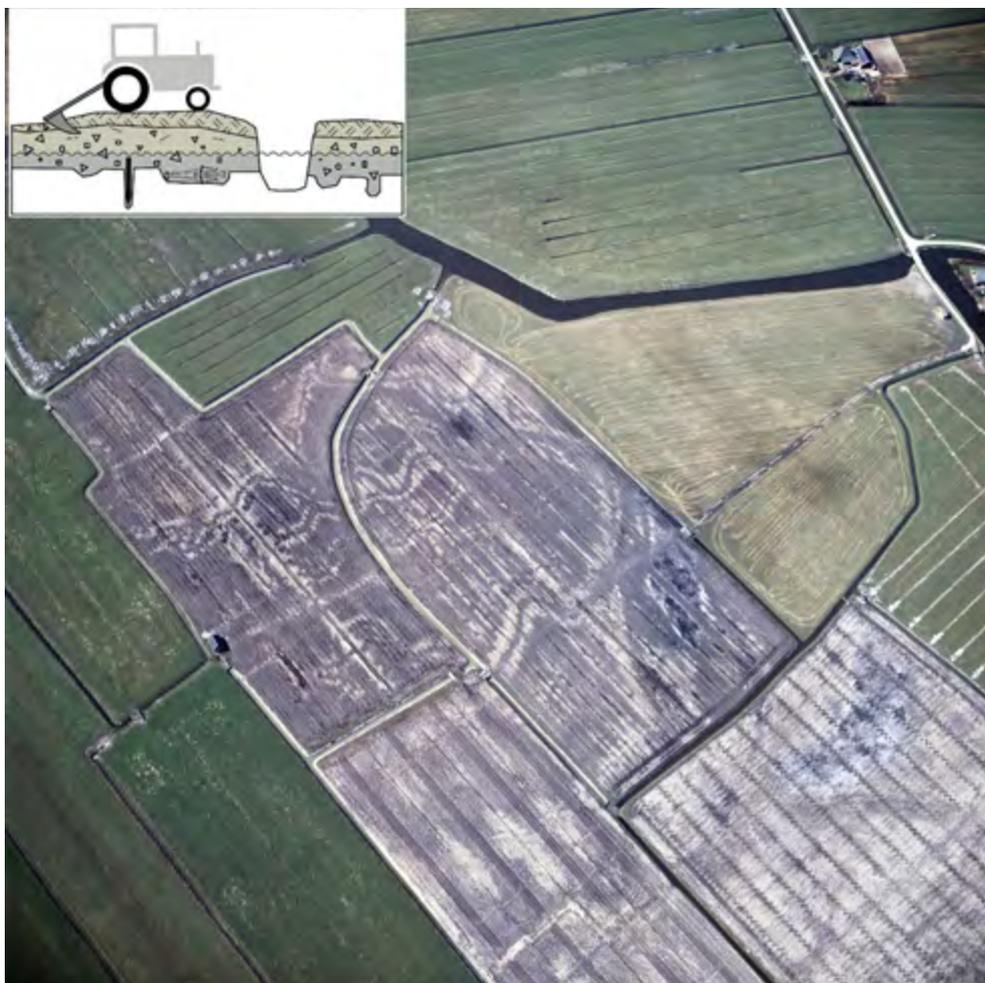
Fig. 2.11 An example of an archaeological national monument covered by Holocene deposits is the De Hooge Weere polder, Aartswoud (National Monument 531.042). Aerial photograph, 1984 (IPP – Willy de Vries-Metz). Detail: schematic cross-section of the monument (Van Heeringen & Theunissen 2006; 2007).

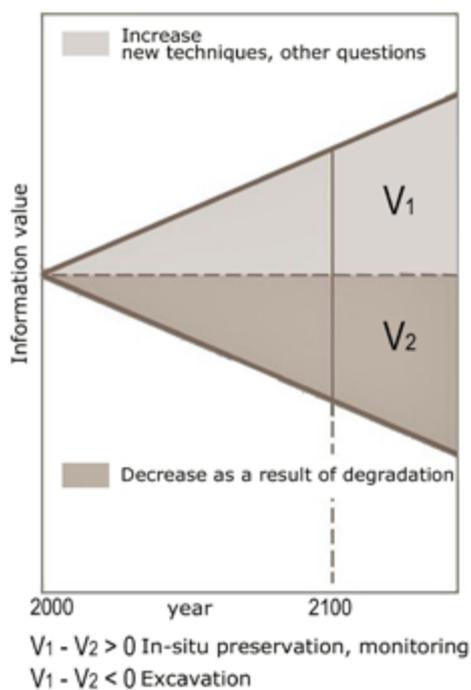
Fig. 3.1 Theoretical changes in the information value of a hypothetical archaeological site through time (after Van den Berg *et al.* 2010).

further deterioration. Archaeological excavation of (parts of) the site is another option. Figure 3.1 shows the theoretical increase and decrease in information value for a random site as lines plotted against the factor time. Here the relationship is linear, but in fact an increase in the information value of a site is more likely to proceed in leaps and bounds as a result of new techniques or new research questions.

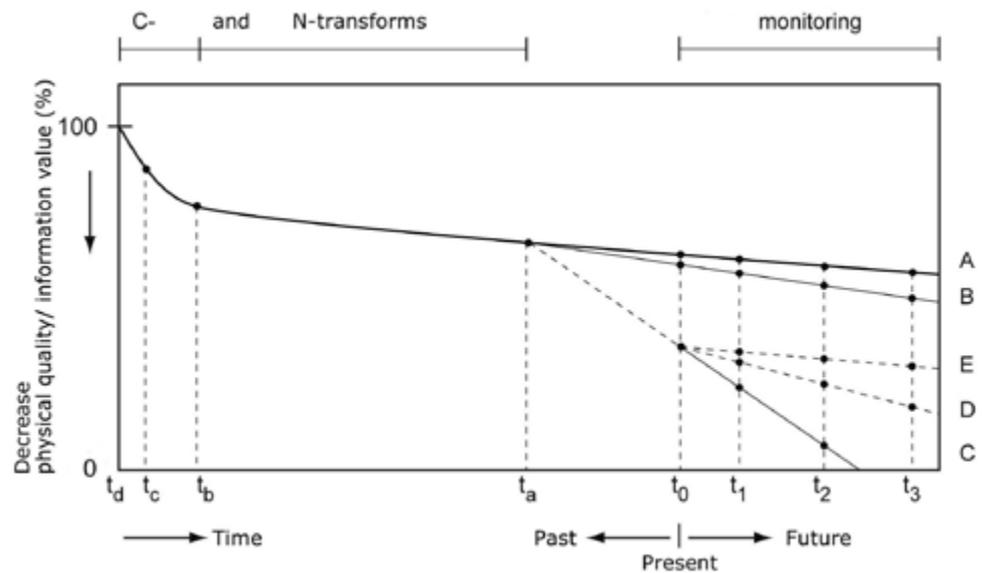
Fig. 3.2 Loss of information value of an archaeological site through time. t_d =Time of site deposition/formation; t_c =Time of intensive occupation of the site; t_b =Time of burial in the soil. C transformations = Cultural changes which affect the site; N transformations = natural changes. A = State of equilibrium during which loss of information is slow. BCDE = Outcomes of the different forms of accelerated decay starting at different times. t_a =Time when new threats start to increase. t_0 - t_3 =monitoring episodes (image courtesy of Leidraad Standaard Archeologische Monitoring ('Guideline Standard Archaeological Monitoring') version 1.0).

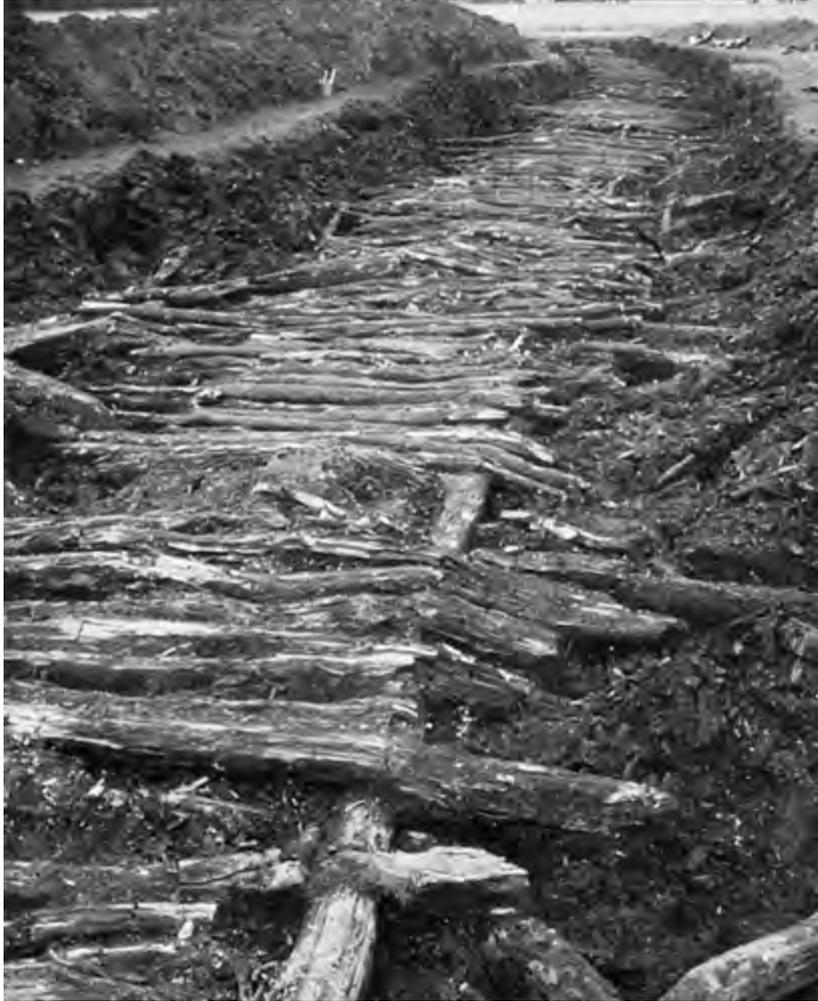
Fig. 3.5 Late Neolithic trackway through the peat, Bourtangerveen. The trackway was constructed around 2550BC by Beaker Culture farmers. The road surface consisted of c. 3m-long logs – some of them split – of alder, birch, lime, oak, and maple. The trackway has been scheduled since 1981 (National Monument 45.391). Following a lowering of the groundwater table sections the monument appeared to be at risk from desiccation, but in 2008 and 2018 fungi-related damage proved to be limited.⁵³ More or less constant waterlogging of the peat soil matrix and the wood itself have created anaerobic conditions. The oxygen content of waterlogged wood is zero due to bacterial action (Photo: Geheugen van Drenthe/Casparie *et al.* 2004).

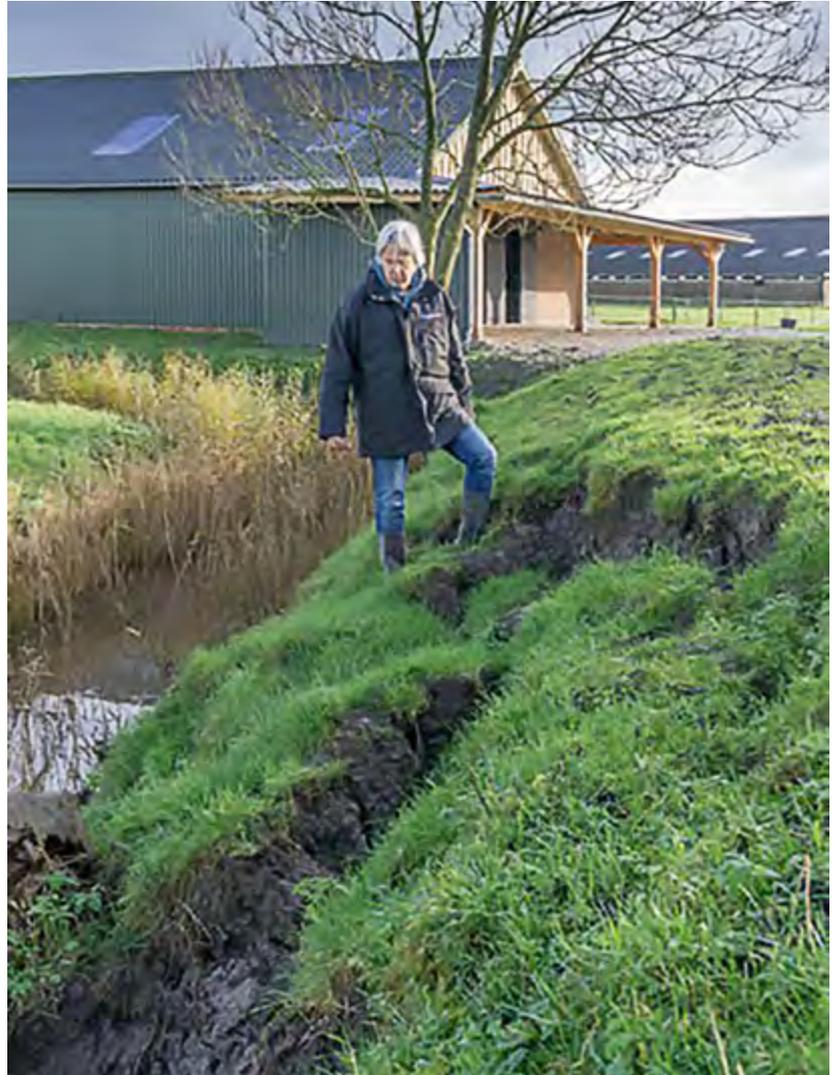
Fig. 4.4 Collapsing escarpment along the north face of the Oostrum terp (National Monument 45.391). The cause is uncertain; perhaps rotting tree roots of a few cut-down trees or flowing water in the surrounding ditch was undermining the slope (photo: Van Doesburg & Stöver 2018).

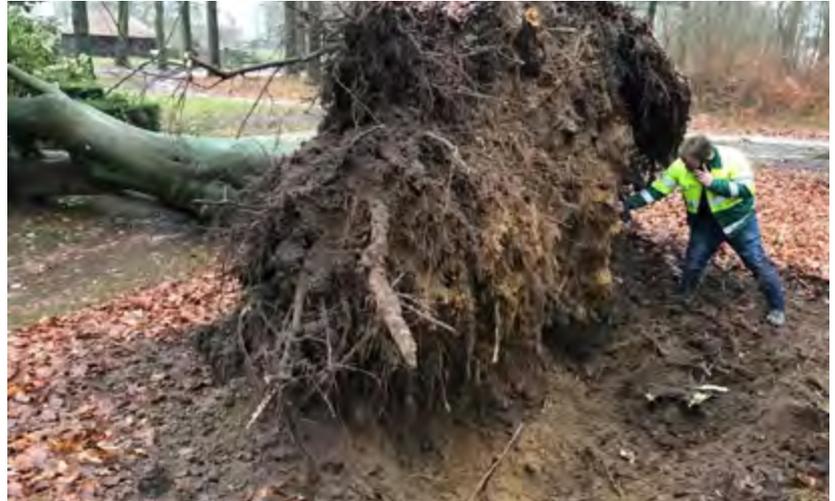
Fig. 4.6 Fallen tree; Twello (photo: Jaco van Hal 2018).

Trees can have a negative impact on archaeological remains not only by their root action. When a tree is blown over by the wind, root ball, soil and all, the damage to archaeological remains can also be extensive^{107, 108} (Fig. 4.6). Fallen trees can disturb the soil down to a depth of 120 to 150cm or more,¹⁰⁹ and leave 5 to 7m-long pits. However, the deeper a root system penetrates into the soil the less compact it becomes and the thinner the individual roots, so that the impact of windfall on archaeological remains at a greater depth will be correspondingly less.

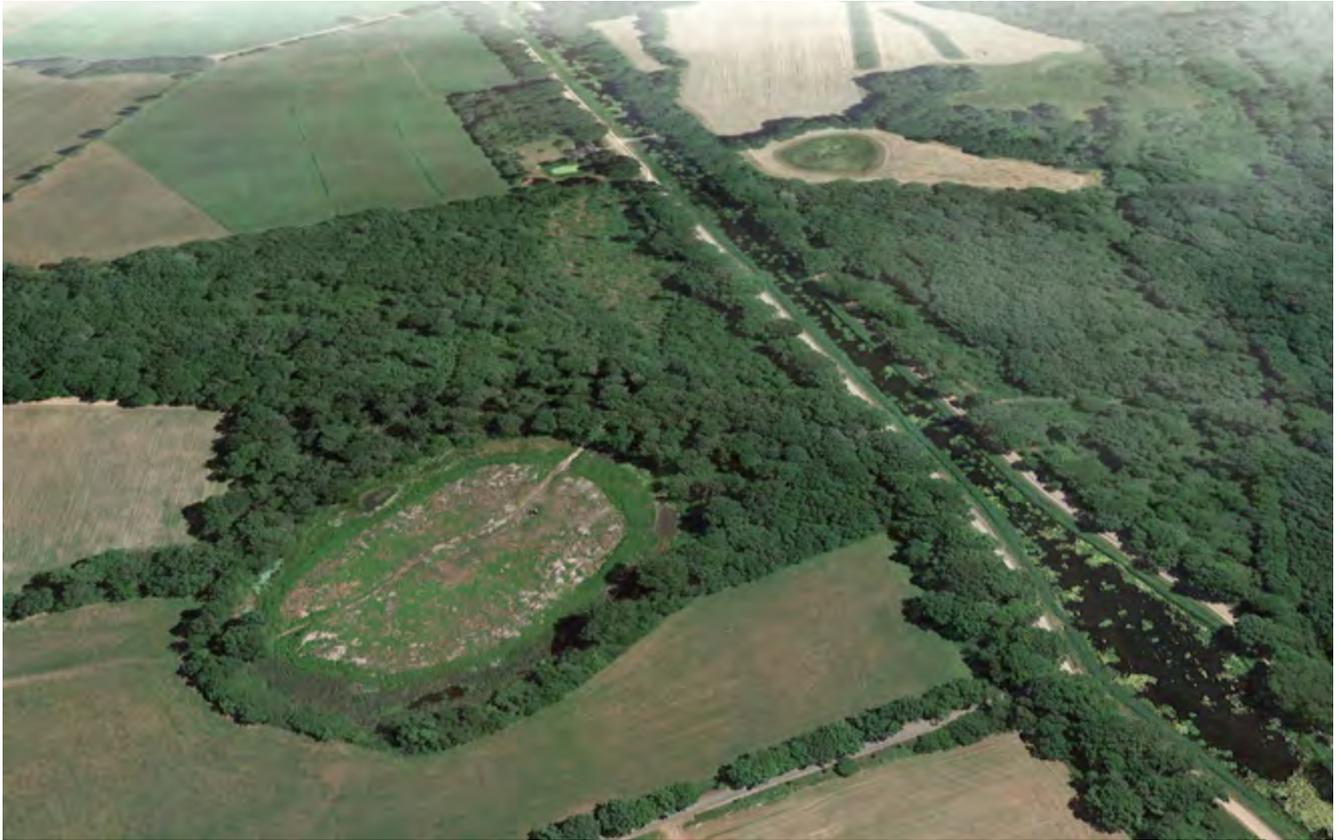
Fig. 4.7 Archaeological national monument Hunenborg, Volthe, province of Overijssel (National Monument 46.005), a probably 11th/12th-century ringfort. Around 1660 Dutch antiquarian Johan Picardt (1600-1670) described the remains of this ringfort as 'completely overgrown and destroyed'. Especially the many windfalls had a disastrous effect on the archaeological remains. The inner bailey, which over the years had become completely overgrown by trees and shrubbery due to a lack of maintenance, has now been cleared.

Windfall is a significant risk factor where leaning or less healthy trees grow on or near smaller visible or shallow archaeological sites.¹¹¹ The actual amount of windfall-related damage depends on the characteristics of the monument and the extent and degree of the disturbance (Fig. 4.7). Often the damage is limited, but even then there may be secondary effects. The created clearances, large or small, not only allow more light to reach the surface but also lead to changes in soil humidity, and both factors stimulate the growth of shrubs and ground vegetation as well as bioturbation.¹¹² Shrubs and clearances attract herbivores and burrowing animals like rabbits and wild boar, and this in turn leads to more soil disturbance.¹¹³

Fig. 6.15 In the past, access to the Hunenborg site (Volthe, province of Overijssel) was difficult, and the monument was barely visible and therefore not very attractive to visitors. The area was overgrown with trees and shrubs, and frequent windfalls had a disastrous impact on the archaeological remains. To remedy the situation, an ongoing project for the past few years has been attempting to make the Hunenborg site more accessible to the general public. Measures to ensure the monument's long-term conservation include the removal of trees and frequent mowing. Archaeological research was carried out prior to the project (National Monument 46.005, cross section through the bank; see also Fig. 4.7. Photo: RAAP).

The recommended maintenance regime for those ringforts that are national monuments (e.g. Hunneschans on Lake Uddeler, province of Gelderland, Fig. 2.8; or Huneborg, Volten, Fig. 4.7) is similar to that of burial mounds in a woodland setting. To maintain or improve the visibility of the earthen banks any undergrowth should be either controlled or removed. This should be done with care (Section 6.12). It is important to decide beforehand on the desired impression one wishes to achieve, and on possible negative consequences: root systems also keep the soil together.

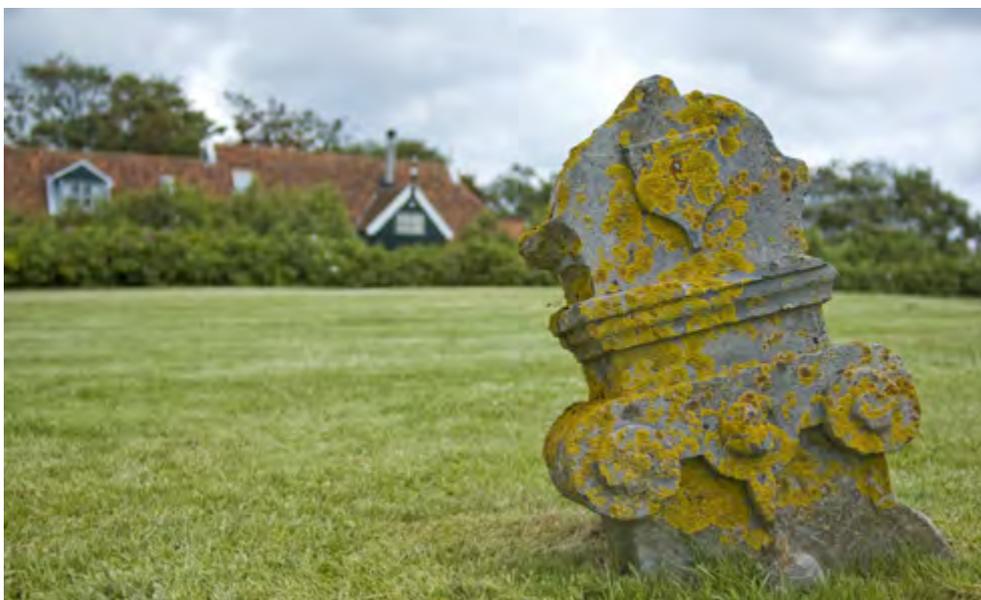
Another specific form of damage occurs when moss, lichen and algae grow on archaeological materials on the surface, such as stone or brickwork (Fig. 4.8).¹¹⁴ An overgrown surface will remain damp and may start to flake and fragment under the influence of frost or the combination of expansion and shrinkage. Lichen also secretes acids which dissolve a thin layer of the stone, but the damage usually goes no further since the lichen cover also protects the surface. On the whole, moss or lichen tend to cover a limited area and the risk of damage to national monuments is negligible,¹¹⁵ while the scientific value of the frequently rare species and other wall vegetation, as for instance *Asplenium ceterach* (Rustyback) or *Asplenium adiantum-nigrum* (Black spleenwort), is considerable.¹¹⁶

Fig. 4.8 Moss-covered pavement pole re-used as a grave marker; Stryper cemetery, Midsland (National Monument 46.015, photo: Jos Stöver/erfgoedfoto.nl).

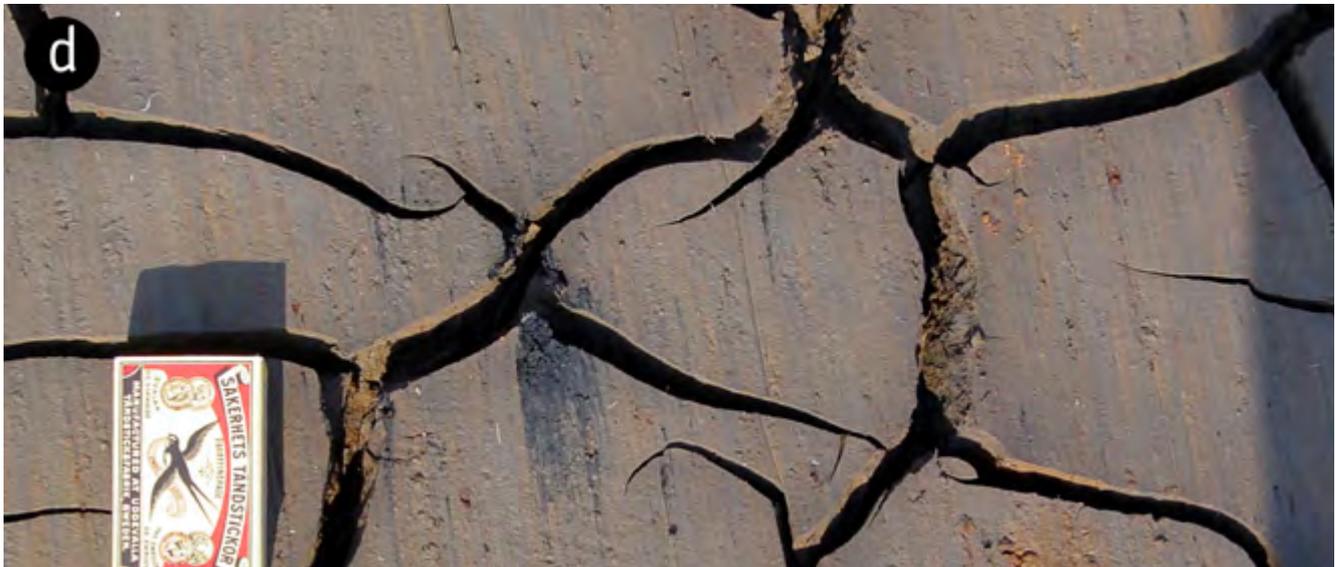
Fig. 4.9 Mud cracks in humic non-silty clay (photo author, river Berkel, Lochem).

(Fig. 4.9). Under wet conditions, when the soil expands, these cracks will (mostly) close again.¹²¹ In porous or hygroscopic soils, repeated wet and dry cycles are thus accompanied by matching cycles of expansion and shrinkage. Under such conditions artefacts can start to flake, fracture, or be completely pulverized.

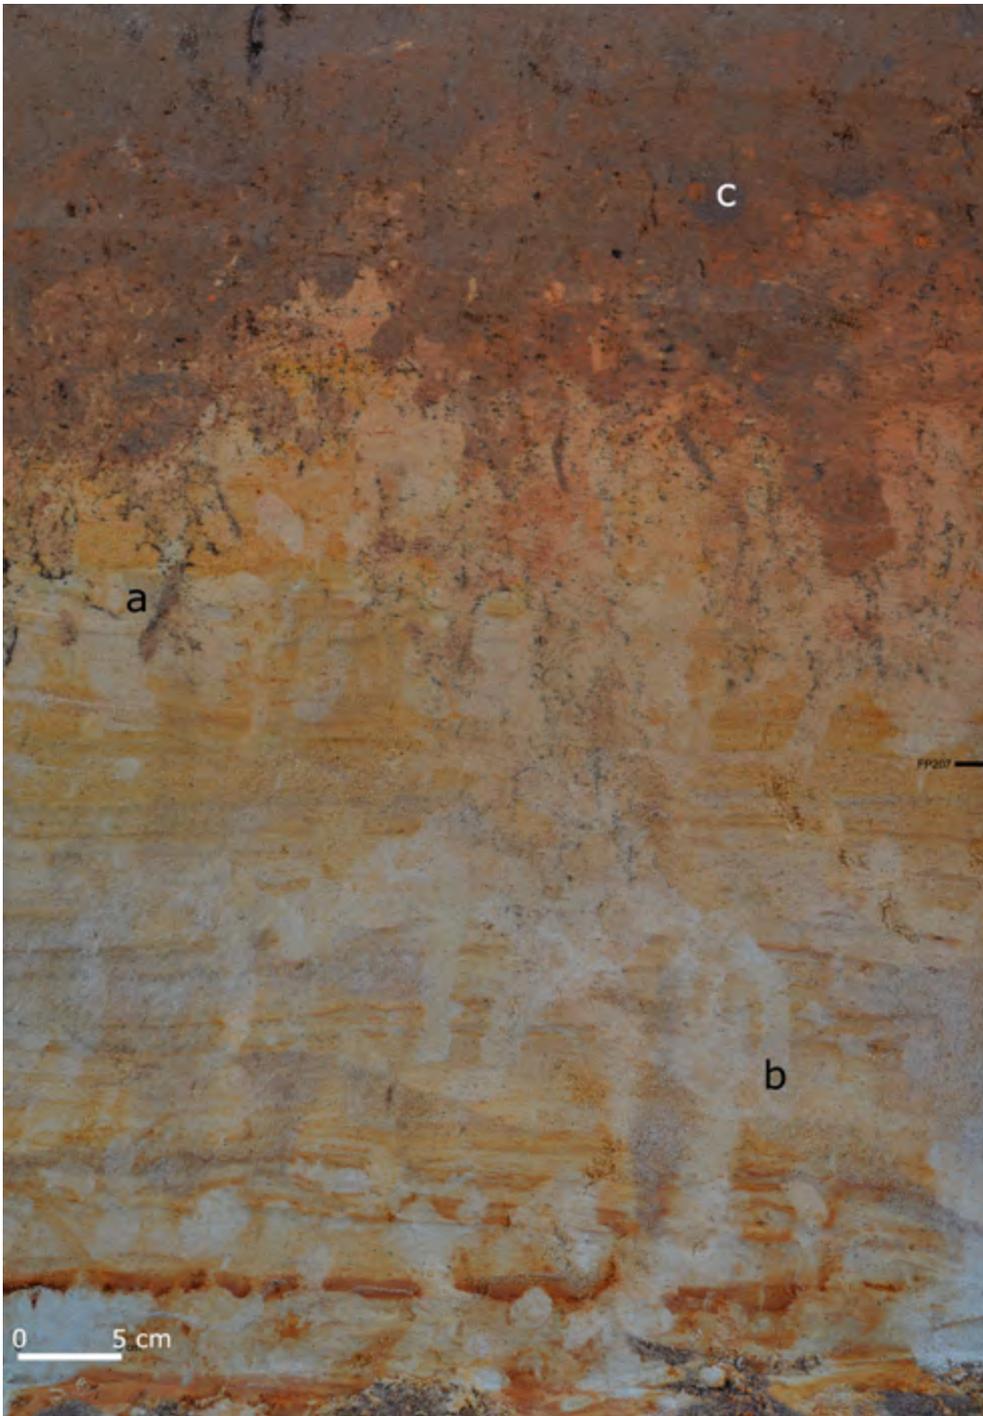
Fig. 4.10 Bioturbation due to plant root action (a), burrowing by beetles (b), and the activities of a small mammal (c) in a mineral humic layer (above a coversand profile), Borne-Oude Aalderinkskamp (photo author).

The prime factor responsible for bioturbation are the activities of larger and smaller invertebrates such as worms, but the role of insects and arthropods is also significant (Table 4.1, Section 4.4.3). Soils may contain huge numbers of especially tiny insects such as springtails, mites, beetles, or ants.¹³³ The degree to which these animals will disturb the soil largely depends on soil oxygen content and the amount of fresh organic matter. Other potential sources of bioturbation are vertebrate species which live (partly) below the surface, tunnelling or burrowing through the soil (Section 4.4.5). Underground holes and dens (badgers, foxes) and tunnels (moles, rabbits, mice, rats, badgers, foxes) leave behind 'natural' soil features.¹³⁴ Only larger animal tunnels are still easily recognizable by the naked eye in a soil profile (Fig. 4.10).¹³⁵

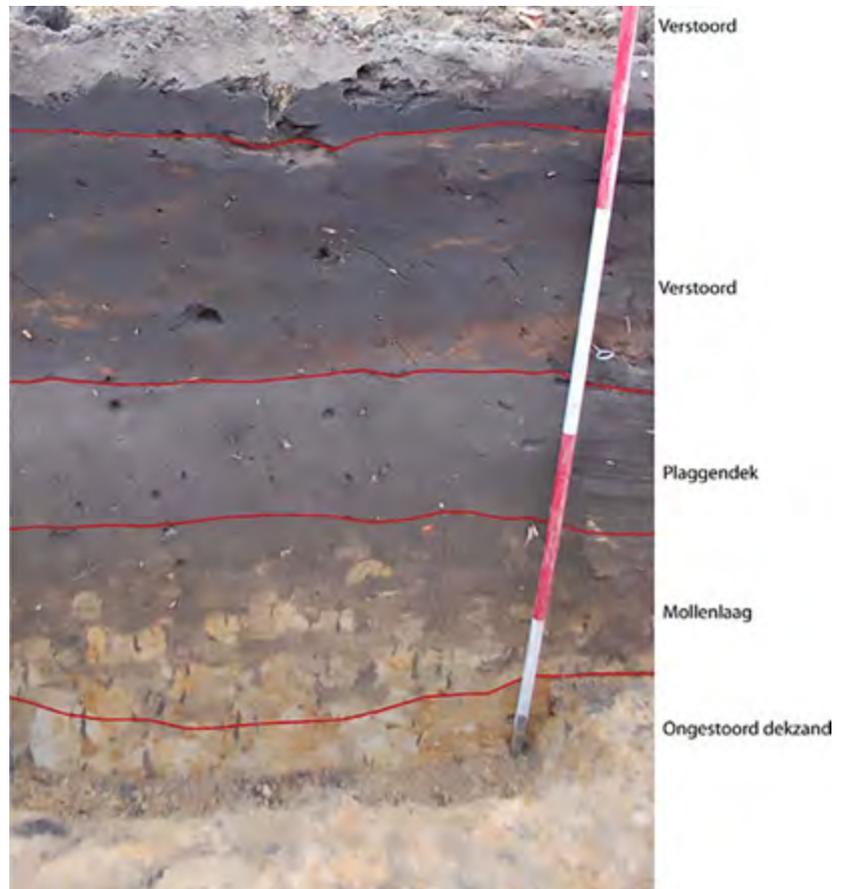
Fig. 4.14 Vertical profile, Ceintuurbaan, Deventer. A so-called ‘mole layer’ is clearly visible in the top section of a coversand substrate, below a disturbed sod layer (photo: Archeologie Deventer).

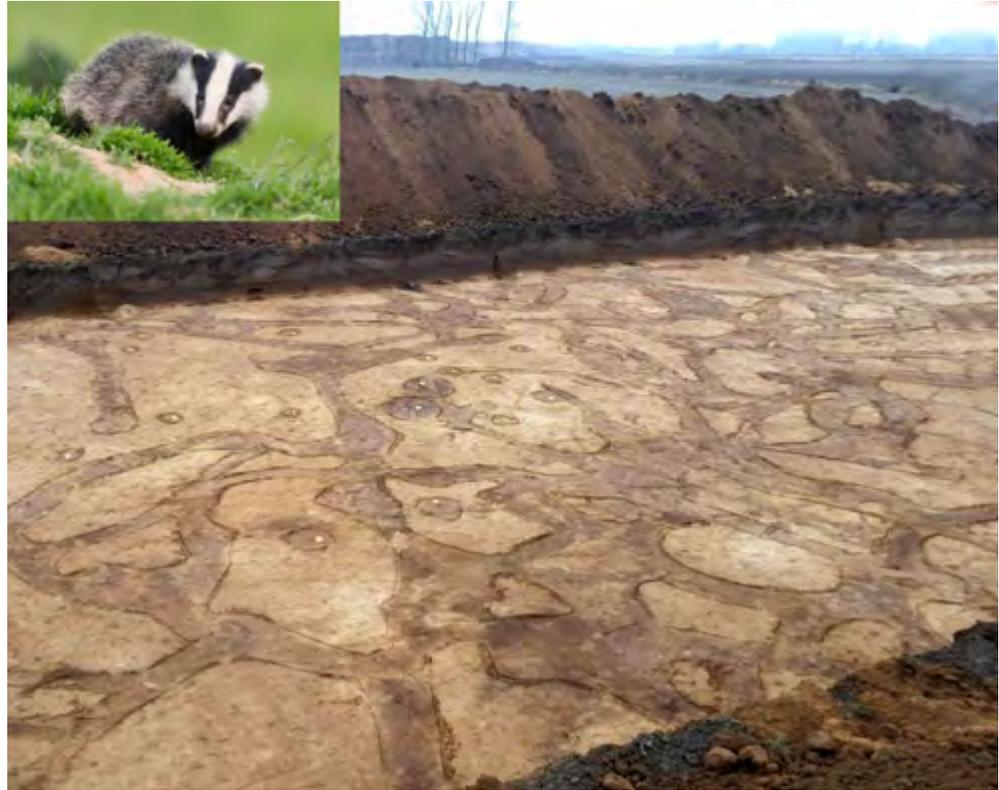
Fig. 4.15 Filled den, or 'set', of a family of badgers (photo: RAAP).

Badgers live in extensive dens (also called sets) they have dug themselves.¹⁷⁴ One set usually has three to ten entrances (although up to eighty have been reported) and consists of chambers linked by corridors that can be hundreds of metres long (Fig. 4.15). When inside their own territories badgers also dig refuges, simple holes in slopes, escarpments (e.g. Barrow 7, Oss-Paalgraven¹⁷⁵) or ditch sides where they

can hide in the event of danger. Badger tunnels are 25cm to sometimes 60cm across, and the subsurface depth of an entire badger set can be 1 to 4m.¹⁷⁶ Over the course of many generations a set often expands into a huge subterranean complex of corridors which sometimes cover a full hectare (Fig. 4.15).¹⁷⁷ Clearly badgers can inflict serious damage to archaeological remains above and below ground.¹⁷⁸ However, badgers are a protected species in the Netherlands; chasing them away to another location is therefore not an option. Foxes also dig dens comprising one or several tunnels 25 to 30cm across. Often existing (rabbit) tunnels are enlarged,¹⁷⁹ and sometimes an abandoned badger set will be used. Pre-existing damage by rabbits or badgers can thus be compounded by fox activity.

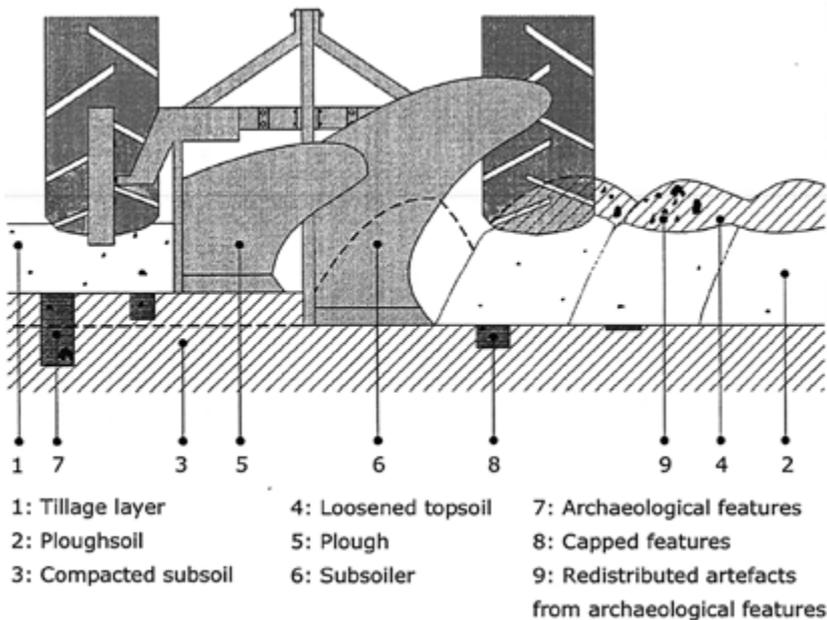
Fig. 5.2 Process, affected depths, and impact of (deep) ploughing (after Heunks 1995).

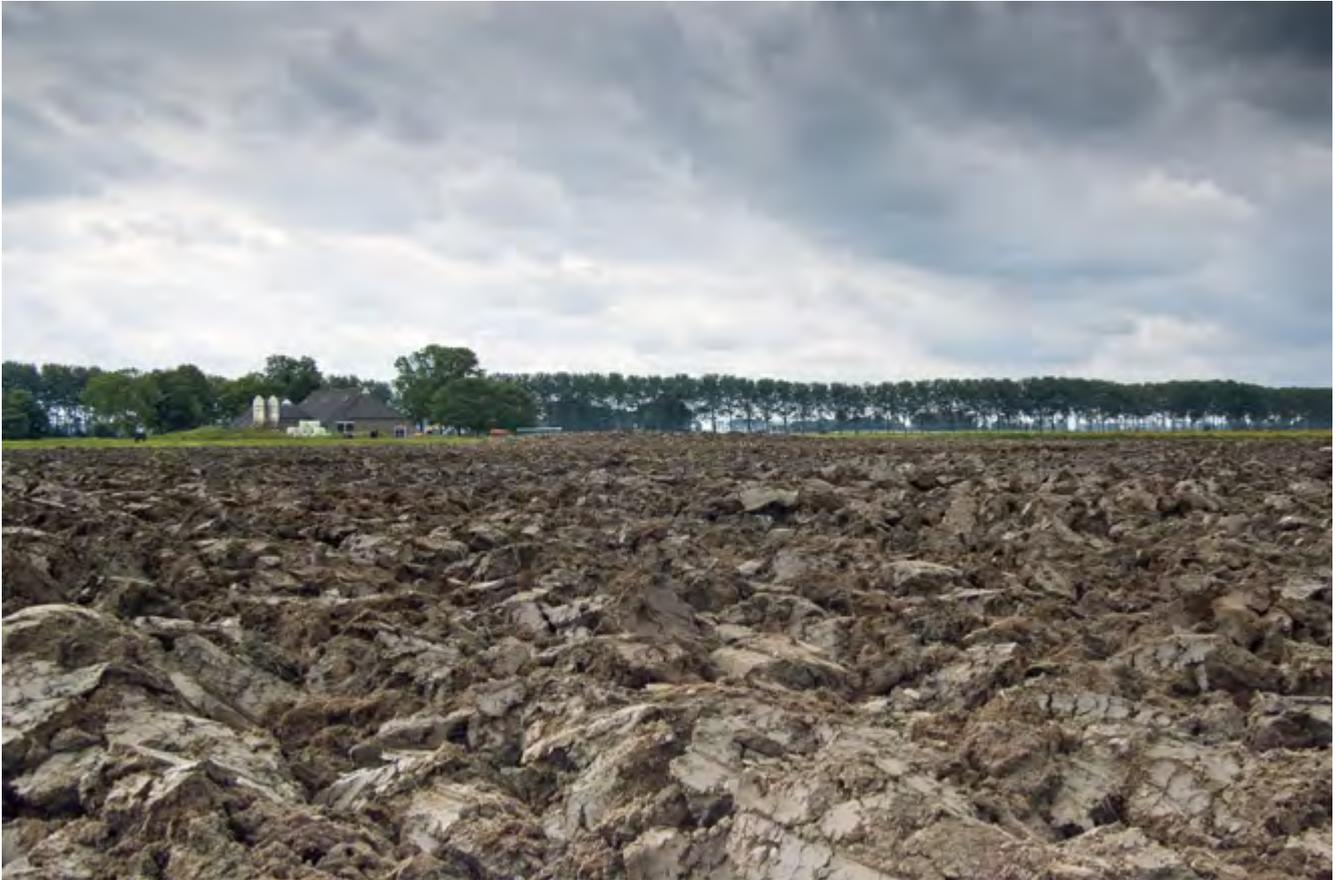
Fig. 5.3 Adorp-Munniketocht. Ploughed field; the slight elevation in the background is a small, completely ploughed-over terp (National Monument 45.062, photo: Jos Stöver/erfgoedfoto.nl).

the underlying archaeological levels vulnerable. Furthermore, levelling obviously also affects the surface sections of archaeological and cultural historical objects such as terps, mottes, dikes, raised fields, and burial mounds (Fig. 5.3).

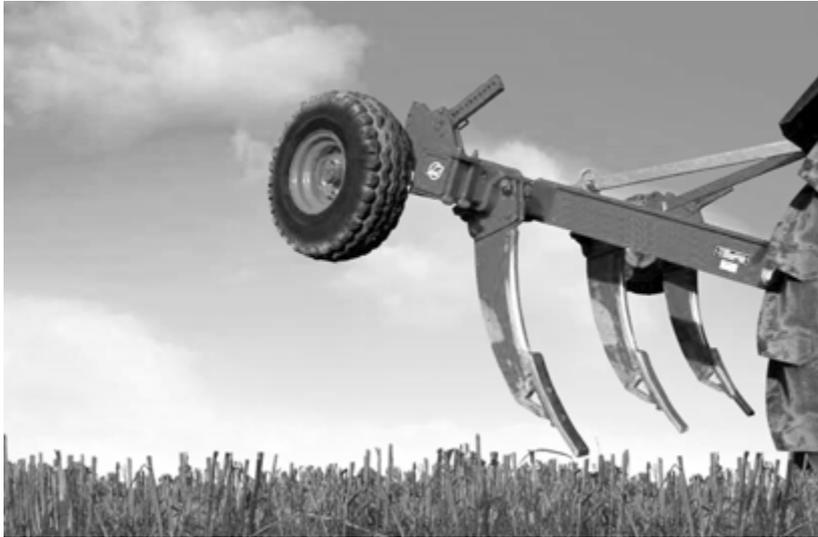
Fig. 5.4 Cultivator or 'subsoiler', reaching a depth of c. 65cm (photo: Lemken 2017).

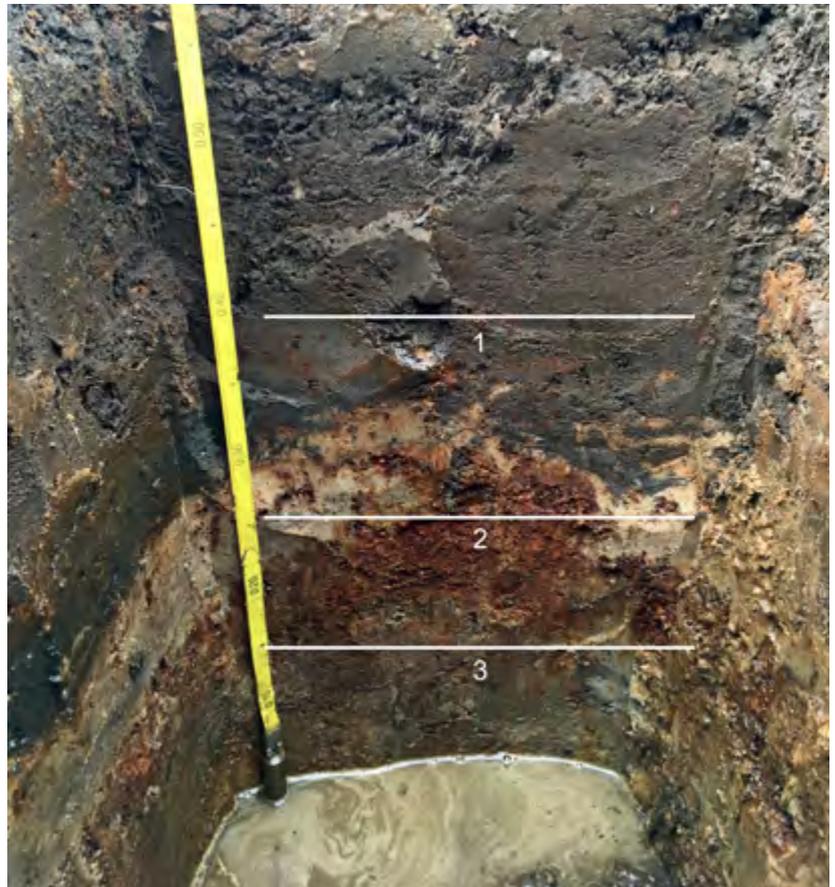
Fig. 5.5 Profile trench on an arable field near the Lonnekermeer nature preserve, showing three compacted layers: 1) dense plough pan (due to heavy traffic) with stagnating water (30-35 cm -GL); 2) hard, impermeable iron pan (45-55 cm -GL); and 3) a loam-rich layer (55-65 cm -GL) (photo: Joris Schaap, Badus Bodem & Water).

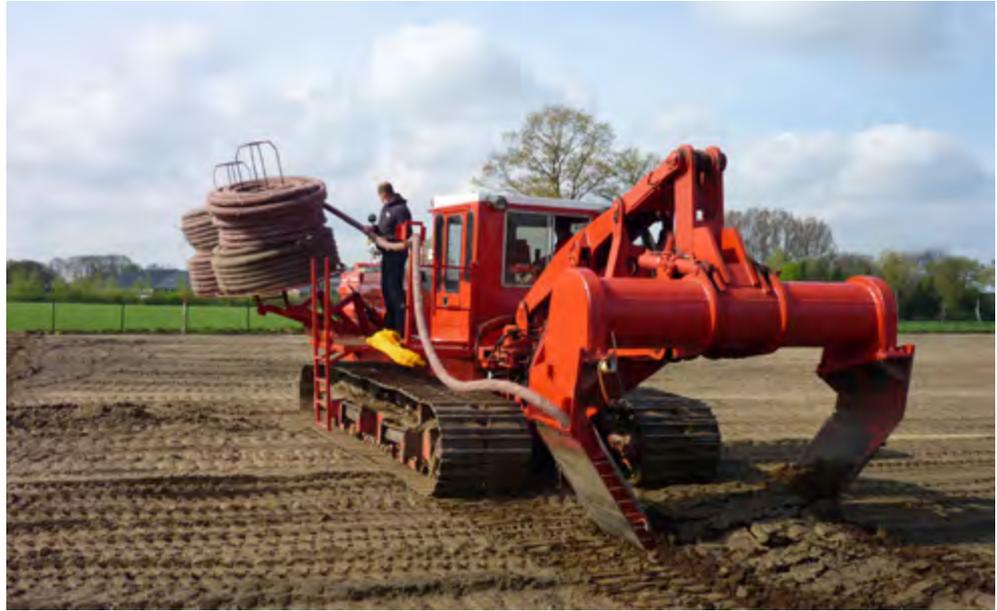
Fig. 5.6 Trench-less insertion of a drainage pipe by means of a V-shaped soil cutter (photo: Smits B.V., Veldhoven).

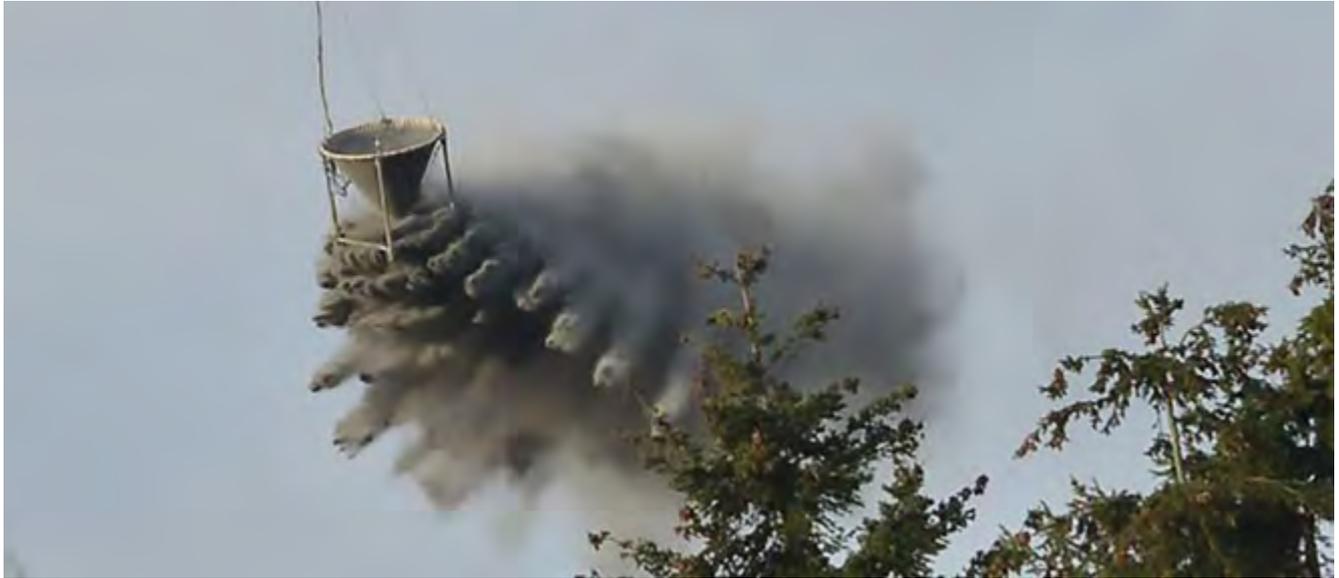
Fig. 5.7 Dispersing 250 tonnes of rock flour over 25ha heathland and forest, province of Noord-Brabant (Strabrechtse Heide and Beuven), November 2018 (photo: P. van Schalen).

poor sandy soils. The buffering agents are released after weathering, which ensures a long-term continuous supplement rather than a temporary, short-term boost such as that which calcium provides. The volume of applied rock flour ranges from 10 to 16 tonnes per hectare (Fig. 5.7). Little is known about the effects of rock flour application to the surface of archaeological sites.

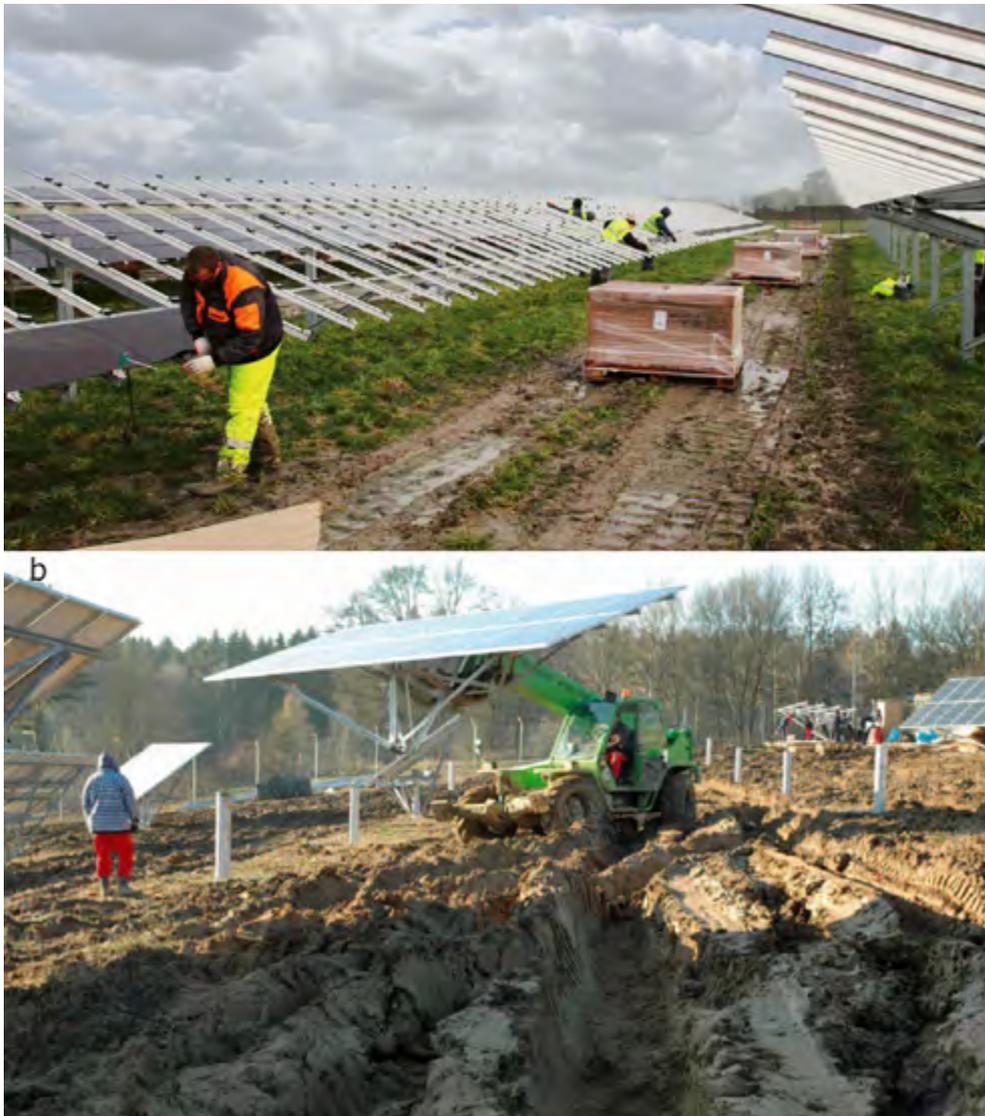
Fig. 5.8 a: Construction of a solar plant with pile foundation near Hoofddorp (photo: SolarEnergyWorks 2017); b: Soil disturbed by rutting during the construction of a solar farm, Landkreis Straubing-Bogen, Germany (photo: Büttner & Husty 2015).

Clay and loam soils are most susceptible to disturbance by vehicles when the topsoil is saturated. Under those conditions the pressure between the soil particles is low and the soil consequently ‘weakens’ so that rutting and compaction may occur rapidly. A heavy downpour or the partial thawing of the topsoil after a period of frost can be enough to bring about such conditions. These situations are most likely to occur from October to March. Rutting can be avoided as long as traffic on the site at this time is kept to a minimum (see also Fig. 5.8b). These are the same the months when natural recovery of the grass cover by regrowth is limited.

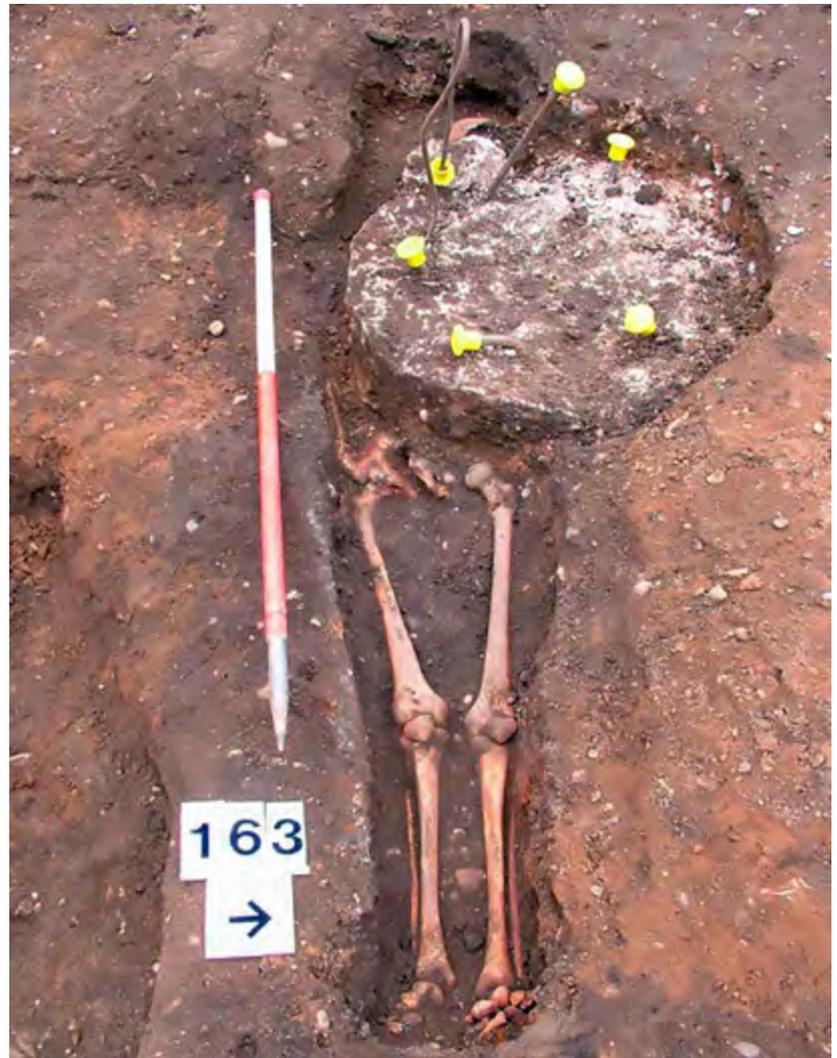
Fig. 5.11 Piercing archaeological remains (photo: Historic England 2019).

The greater a site's feature/object density the greater the potential loss of information (and by implication damage) that may result from piling (Fig. 5.11).²⁷³ Particularly at risk are small sites with object clusters, sites comprised of thick archaeological (artificial deposition) layers such as terps, or river dunes with settlement traces. Equally vulnerable are sites with extensive timber or masonry constructions such as revetments and foundations, for piling will cause fracture, displacement and distortion of those archaeological constructions and the surrounding soil.²⁷⁴ The removal of pile and sheet foundations is yet another potential source of disturbance.²⁷⁵ Even if the piles are allowed to remain in place, subsequent building activities will not only cause additional disturbance but the addition of more piles will also limit options

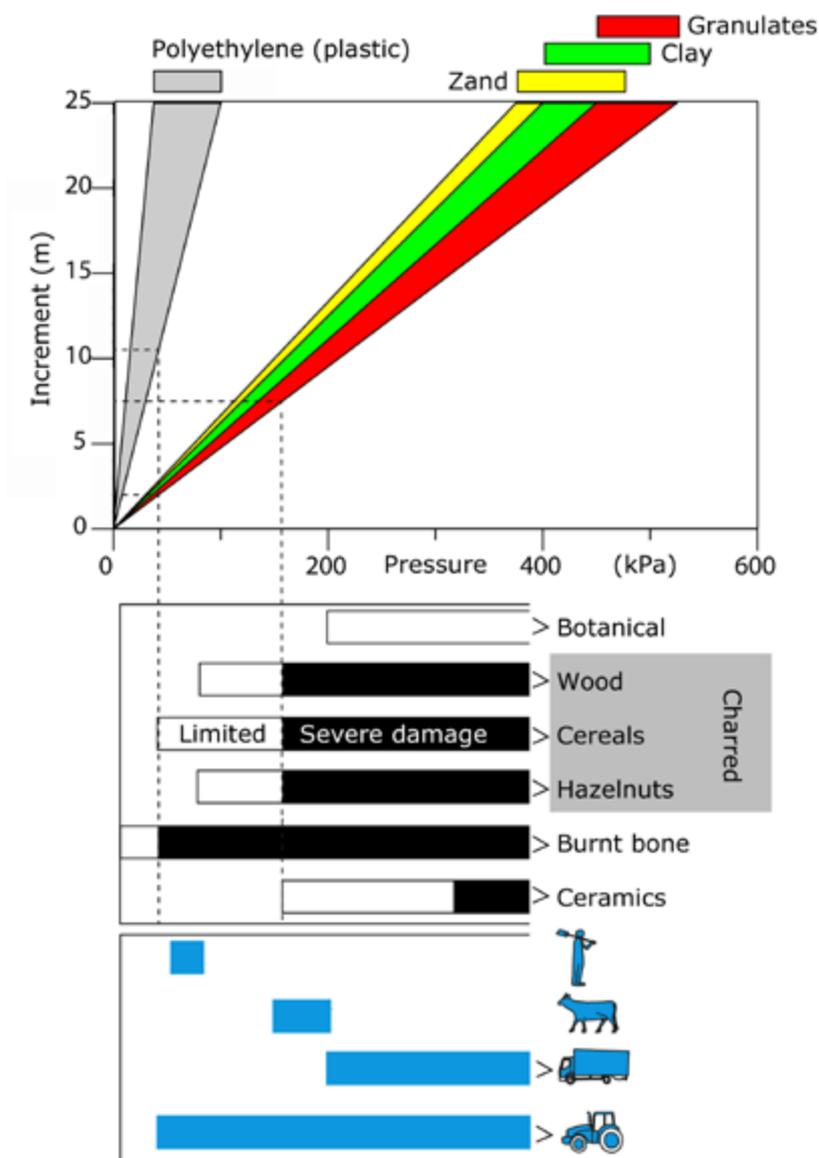
Fig. 5.13 The relation between added soil mass and potential damage to archaeological materials. Top: coloured bands indicate the relation between the volume of deposited soil (in metres) and increased strain, for different archaeological materials. Centre: volume of added soil at which limited (white) or severe (black) damage to small artefacts/ecofacts will occur. Bottom: comparison between, on the one hand, pressure exerted by pedestrians, livestock, and vehicles, and, on the other, that of an added soil mass (image courtesy of Huisman & Ngan-Tillard 2019).

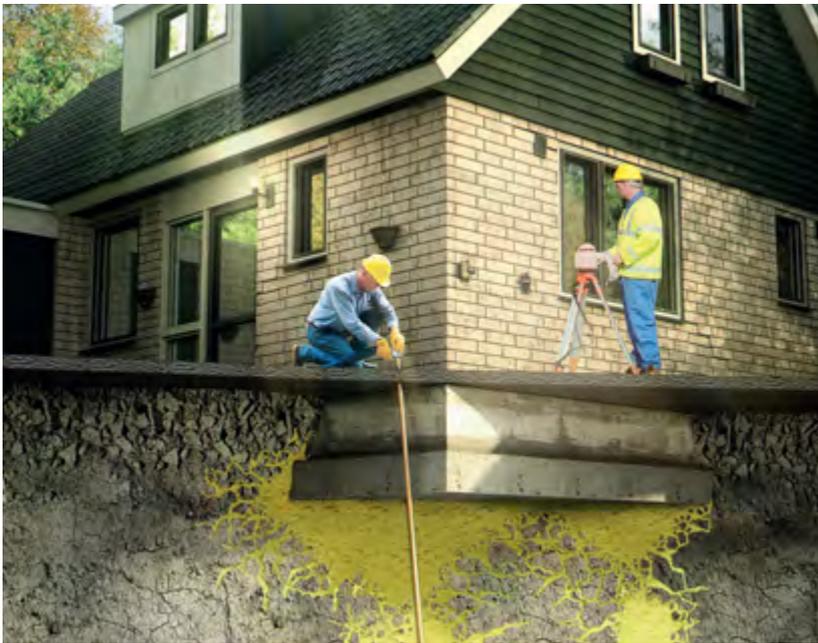
Fig. 5.15 Application of synthetic resin under foundations (image: product information brochure Uretek, 2019).

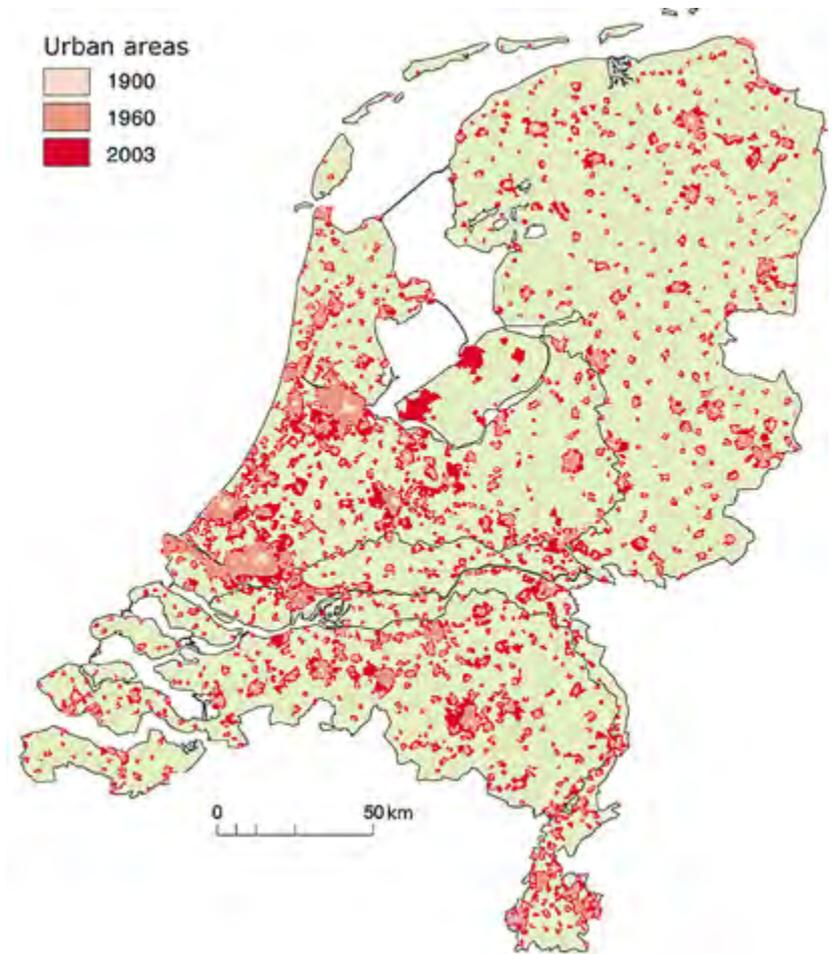
Fig. 5.16 Map of the Netherlands showing urban expansion in the period 1900-2003. Urbanization has been most pronounced in the west and the total urbanized area has grown significantly.

Other factors responsible for the overall trend towards lower groundwater tables are a relative increase in woodland in nature areas,³⁰⁸ and an increase in built environments which replace agricultural land (Fig. 5.16). For example, an increase in woodland and scrub development in nature areas on higher sandy soils has led to more evaporation and less suppletion and therefore lower groundwater tables.³⁰⁹ Precipitation shortages due to climate change also lead to less suppletion of groundwater, a lower groundwater table, and a lower soil moisture content. Groundwater suppletion in urban areas is assumed to be less than in agricultural areas. In urban areas most precipitation flows via drain holes and sewers directly towards surface waters or retention basins, rather than in the soil. Pumping so as to keep the buildings dry is yet another factor in urban areas.³¹⁰ All in all, urban expansion will therefore lead to a lower groundwater table.
