Nederlandse
Archeologische
Rapporten

Fragile monuments of the past

Physical threats and countermeasures

N.W. Willemse

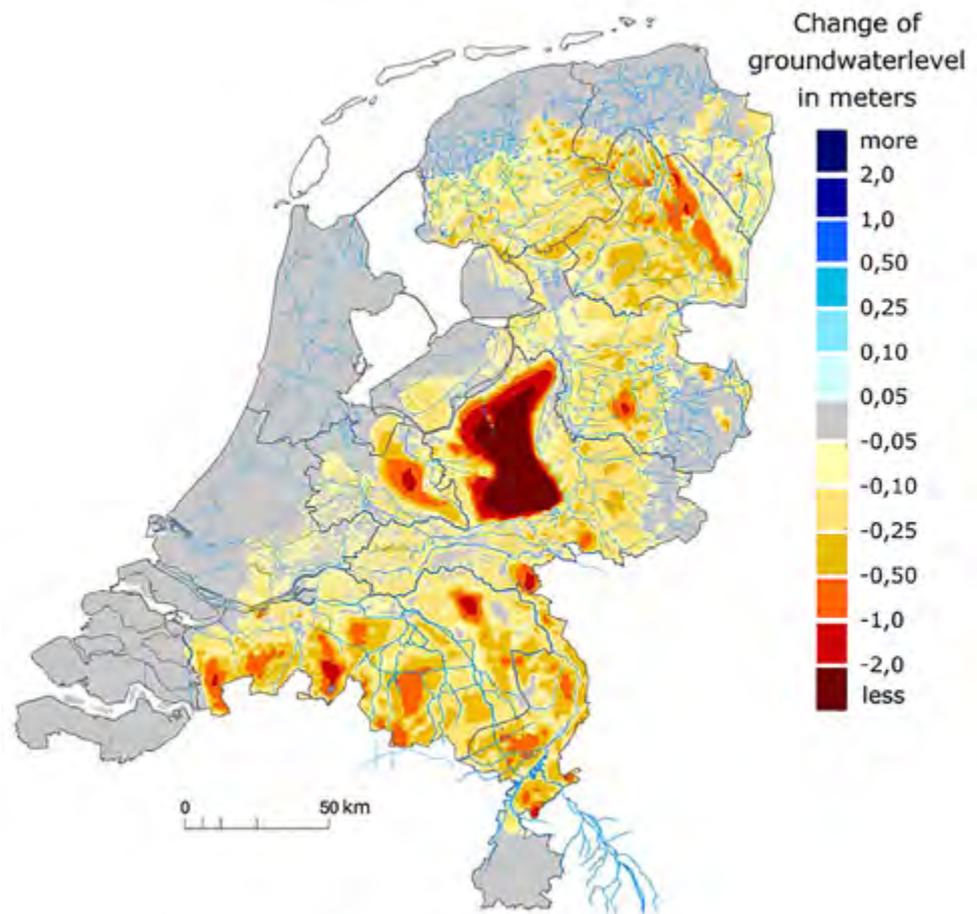
Fig. 5.19 Calculated changes in groundwater level for a scenario involving diffuse water extraction totalling 1,800 million m³ annually (image courtesy of Hoogewoud *et al.* 2016).

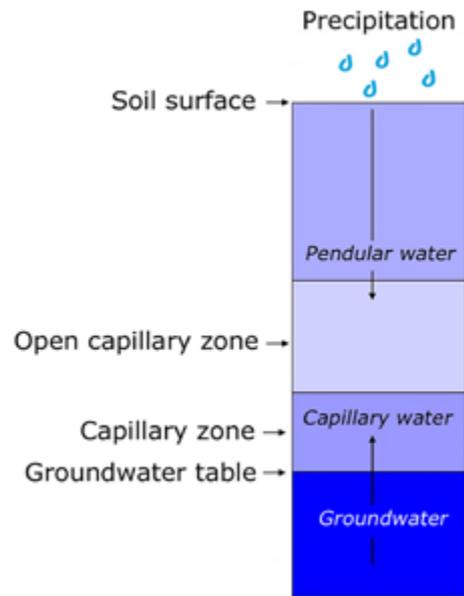
Fig. 5.22 Schematic illustration of the concepts pendular water, groundwater, capillary action, capillary zone, and unsaturated capillary fringe. See the Terms and Definitions for more details.

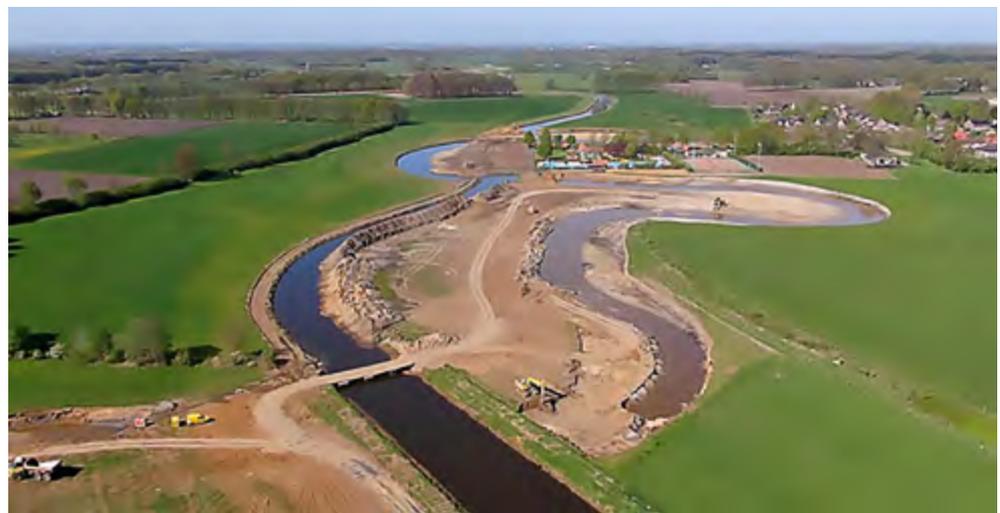
Fig. 5.23 Restoration of the historical channel of the river Berkel near the village of Almen, province of Gelderland (photo: Waterschap Rijn en IJssel, 2014).

In many places 'stream reconstruction' is already a fact (Fig. 5.23); over the next few years another 300km of previously canalized meanders will be reconstructed, a process in which more than 700ha of soil will be turned over.³⁵⁷

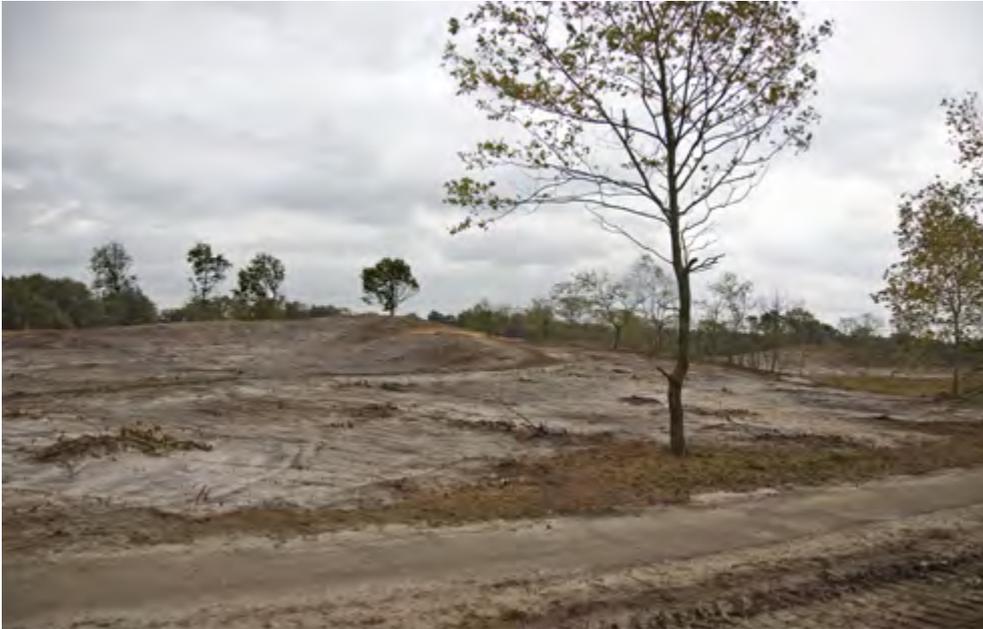
Fig. 5.25 Turf stripping on heathland, Hatertse en Overasseltse Vennen (National Monument 45.864; photo: José Schreurs).

Decreasing the soil phosphate content is another intervention commonly deployed in nature development. On former agricultural land this means removing the cultivation layer (which is saturated with manure), sometimes in combination with ‘soil transplantation’ with soil brought in from elsewhere.³⁵⁸ On Pleistocene sandy soils the result may be a site-wide loss of artefacts and features in the top 10 to 20cm of soil.³⁵⁹ These are the very areas where archaeological remains lie close to the surface (Section 3.5), which renders topsoil removal and ‘soil transplantation’ particularly harmful. More ‘archaeology-friendly’ alternatives which do not involve the removal and/or relocation of soil material, as for example removing phosphate by sowing grass or clover, or applying a potassium fertilizer, are not yet very common.³⁶⁰ Other, smaller nature development projects are the pools with environmentally-friendly edges that are being dug by private landowners, a form of soil removal which is occasionally carried out on a larger scale in the context of nature development projects.³⁶¹

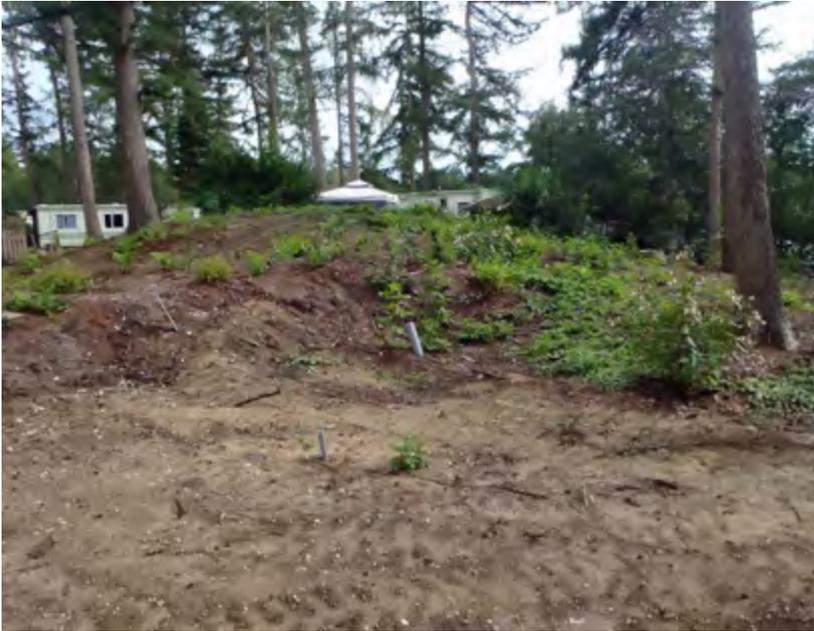
Fig. 5.26 Disturbance by recreational use: an abandoned camper on Herike-Herikerberg, National Monument 45.798 (photo: Datema 2015).

Sometimes overdue maintenance is the cause of erosion and degradation (Fig. 5.26), or thoughtless action by individuals (e.g. hiking and mountainbike trails across burial mounds or earthen banks; Section 5.6.5).

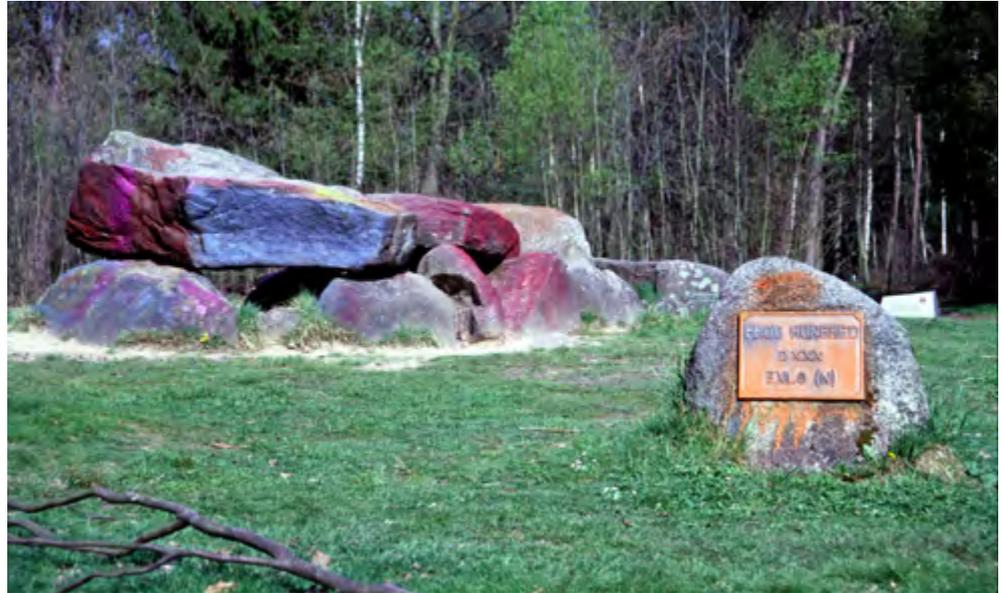
Fig. 5.28 Graffiti on megalith D30, Exloo, National Monument 467.493 (photo: erfgoedfoto.nl/Jos Stöver).

Occasionally an archaeological national monument falls victim to vandalism (Fig. 5.28) or other forms of what at the very least should be considered thoughtless behaviour, such as lighting a fire inside a megalith, mountain biking across banks and burial mounds, equestrians and pedestrians taking a shortcut and leaving an elephant trail, or motor crossing in arable fields.³⁷²

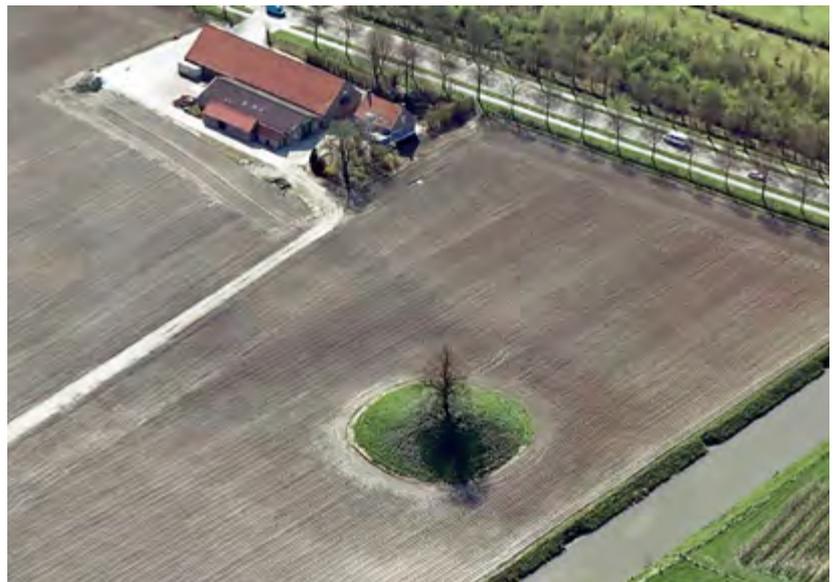
Fig. 6.4 The motte 't Hof Blaemskinderen, 's-Heer Abtskerke (National Monument 45.203), set aside in an arable field. A solitary linden tree marks the motte's summit. Ploughing has caused some slight damage at the foot of the slope (photo: Aerophoto Eelde).

Most archaeology professionals point to grassland or pasture management as the most suitable type of land use from a perspective of archaeological monument conservation (Fig. 6.4).⁴⁰⁰ Advantages that are often mentioned are a reduced risk of soil erosion, the positive effect on soil humidity, and the reduced need for breaking or ploughing the soil. An additional advantage is the fact that the risk of physical damage to subsurface remains and features is also reduced because there is less need to deploy heavy and/or invasive equipment.⁴⁰¹ These last two effects (less intensive tillage, less heavy-vehicle traffic) apply also, albeit to a lesser degree, to production grassland or grass cultivation, both of which involve frequent breaking or ploughing, injecting manure, and year-round repeated mowing, all with heavy equipment.⁴⁰² Even on production grassland, however, the plough soil is thinner than on arable fields, and many forms of tillage involve a shallower depth on grassland than on arable.

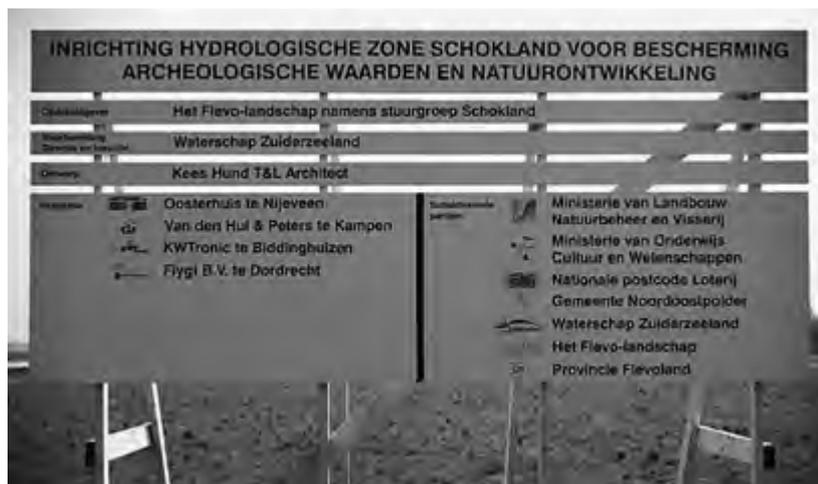
Fig. 6.7 Information panel at Schokland, National Monument 46.033 (photo: Smit *et al.* 2015).

One method to achieve a higher nominal local level is by constructing culverts.⁴¹⁶ An example of a large-scale approach is a series of hydrological interventions at Schokland in 2003 to raise the monument's freatic groundwater level (Fig. 6.7).⁴¹⁷ One of the reasons for the intervention was to improve the preservation of the archaeological sites. Monitoring data collected since 2000 clearly indicate that preservation conditions for organic remains at the site P14 as well as in a large section of the rest of the hydrological zone – especially the north – have indeed improved.⁴¹⁸

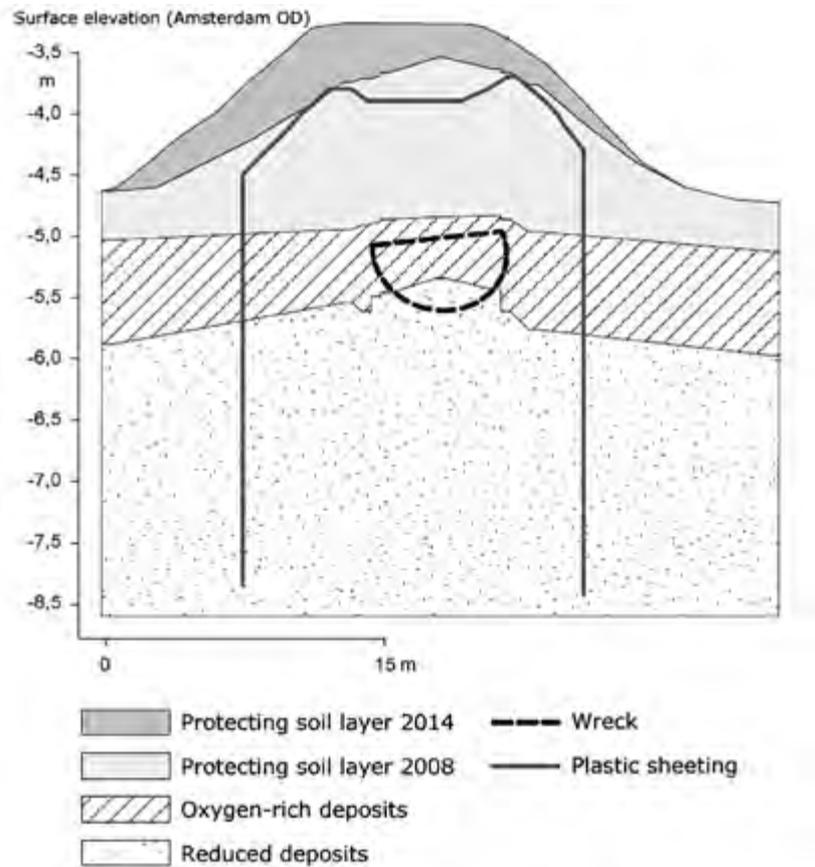
Fig. 6.8 Cross section of a wrapped and clamped wreck, Paradijsvogelweg (after Speleers *et al.* 2016).

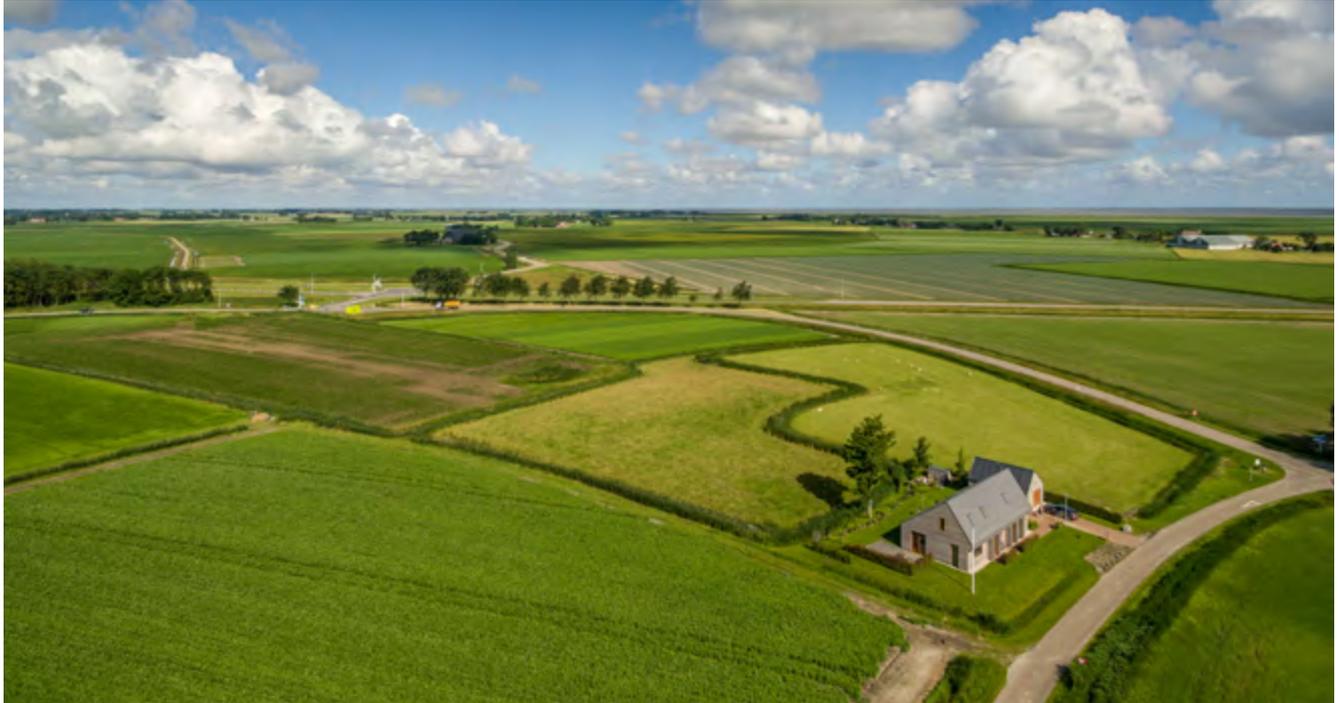
Fig. 6.9 Aerial photo of a new house with garage, Anjum, Noardeast-Fryslân Municipality (photo: Jos Stöver/erfgoedfoto.nl, National Monument 45.901).

Occasionally, shallow foundations are an option (Section 6.7.2). A good example is a new house with garage on top of a raised house platform near Anjum, province of Friesland (National Monument 45.901, Fig. 6.9). A strip foundation was used for the house's timber frame construction; for the garage a slab-on-grade foundation sufficed.⁴²⁴ Sometimes old foundations can be reused. This is not (yet) common practice but it is technically feasible; new buildings on hospital grounds with subsurface remains of the Roman town of Forum Hadriani (see above) in the town of Voorburg were erected on the old foundations of the demolished former nurses' dormitory. For other examples, see e.g. Van Os *et al.* 2016 on the (re)development of the Utrecht Dom Square.⁴²⁵

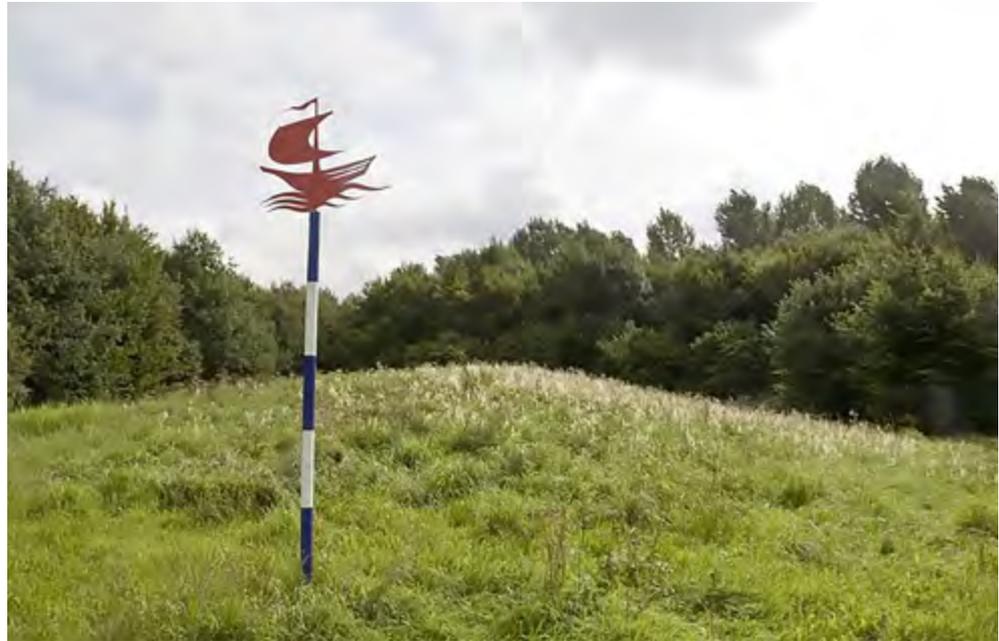
Fig. 6.11 Marker at the site of a wreck, Zeewolde, in this case a caravel from the second half of the 16th century. An extra layer of soil has been applied to the site.

The main argument to cover an archaeological site is that it prevents the deterioration of fragile organic remains (such as wrecks) due to tillage and/or desiccation (Fig. 6.11).⁴²⁸

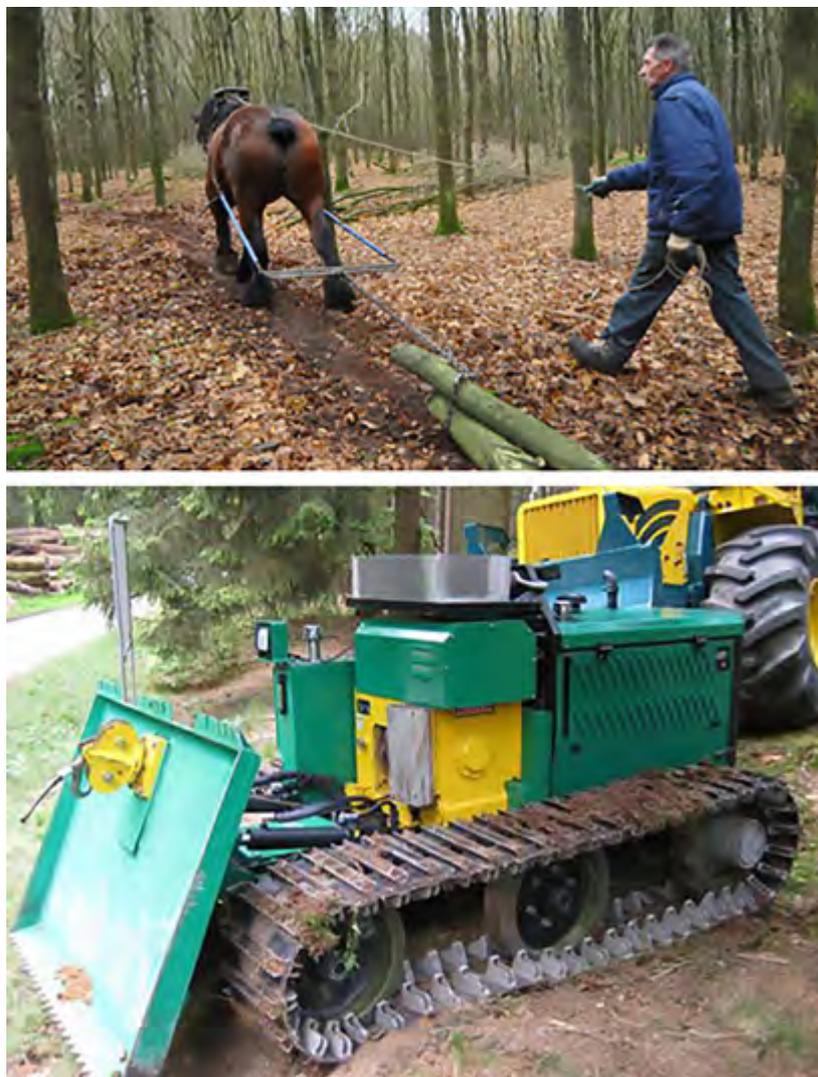
Fig. 6.12 On archaeological scheduled monuments, alternative methods to drag timber (e.g. draught horses or a caterpillar winch) may help to minimize damage or prevent it altogether (photo: Boosten & Penninkhof 2019, 79).

Adjustment or closure of access and outgoing routes is feasible when a realistic alternative exists. If not, for example because there are few access routes, the options are to use lighter vehicles than the standard models or those in which the weight is distributed over a larger surface, for example by means of load-spreading tyres (see below).⁴³⁵ Other possible solutions are using draught horses, caterpillar winches or high winches to drag away felled timber (Fig. 6.12). Draught horses are particularly suited for work in small clearances.⁴³⁶

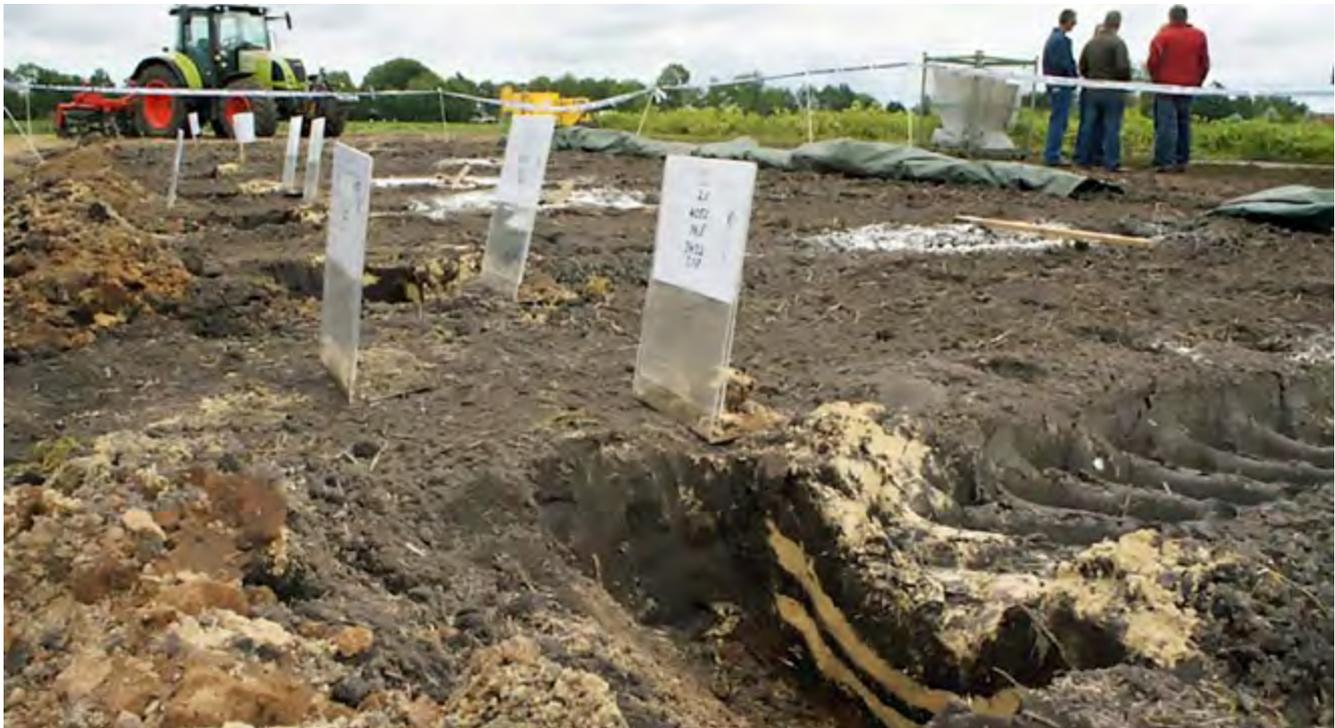
Fig. 6.13 Effect of tyres and tyre pressure on soil composition in a testing area (photo: Jos Swagemakers 2011).

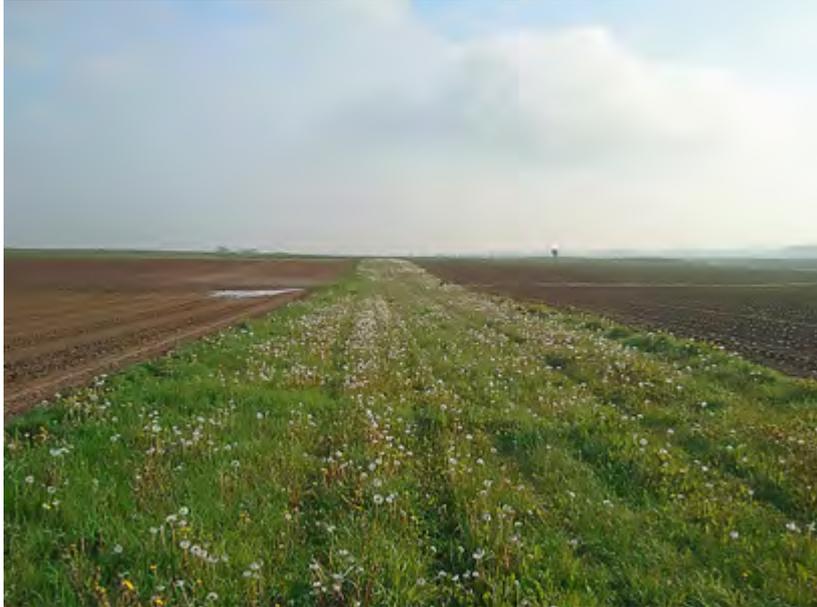
Fig. 6.14 Grass zones, province of Limburg, Belgium
(photo: <http://www.limburg.be/Limburg/waterlopen/ABC/Landbouw-en-natuur/Grasstroken.html>).

Grass buffer zones and grass corridors (Fig. 6.14) break the force of the run-off and intercept some of the eroded sediment as well as providing local protection against soil erosion. Grass buffer zones are laid out perpendicular or obliquely to the direction of the run-off; grass corridors are made to follow the direction of the run-off, usually in depressions where water accumulates naturally and rilling is most likely to

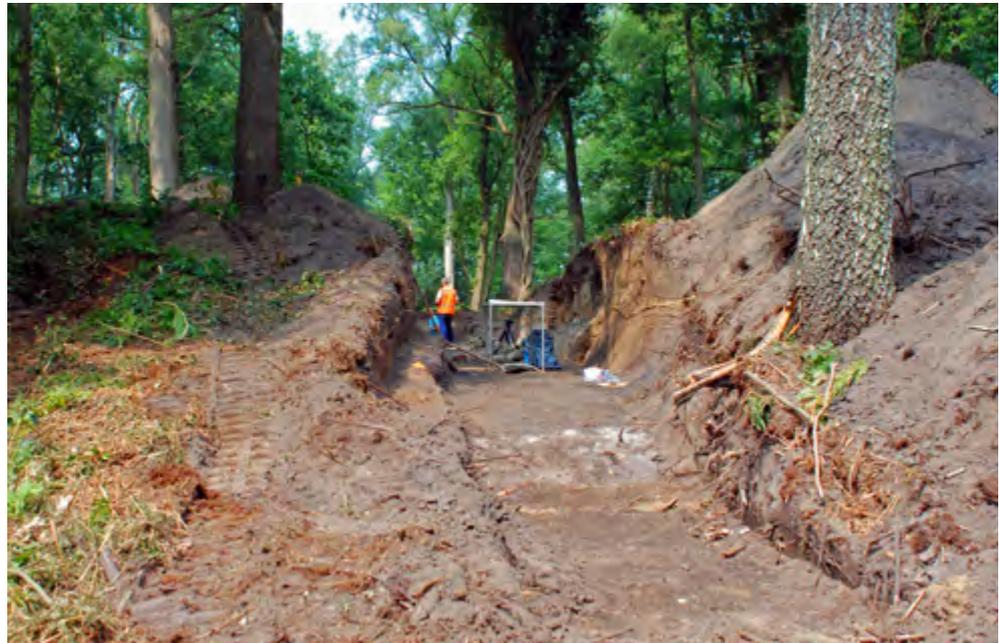
Fig. 6.15 In the past, access to the Hunenborg site (Volthe, province of Overijssel) was difficult, and the monument was barely visible and therefore not very attractive to visitors. The area was overgrown with trees and shrubs, and frequent windfalls had a disastrous impact on the archaeological remains. To remedy the situation, an ongoing project for the past few years has been attempting to make the Hunenborg site more accessible to the general public. Measures to ensure the monument's long-term conservation include the removal of trees and frequent mowing. Archaeological research was carried out prior to the project (National Monument 46.005, cross section through the bank; see also Fig. 4.7. Photo: RAAP).

Sometimes removing the heaviest vegetation is the best option (Fig. 6.15), but not always, as when the vegetation keeps an escarpment from crumbling; this was the case at the motte castle of Eys, province of Zuid-Limburg (National Monument 528.935). After felling, a rotting tree trunk can weaken the stability of a slope; in some recorded instances, the removal of vegetation (including trees) rather than preventing erosion made it worse (e.g. on the terp Oostrum). Prior to a decision about the removal of trees it is important to assess whether the tree roots are strengthening (for instance) a slope and preventing erosion, or whether root action and the chance of windfall constitute a physical threat.

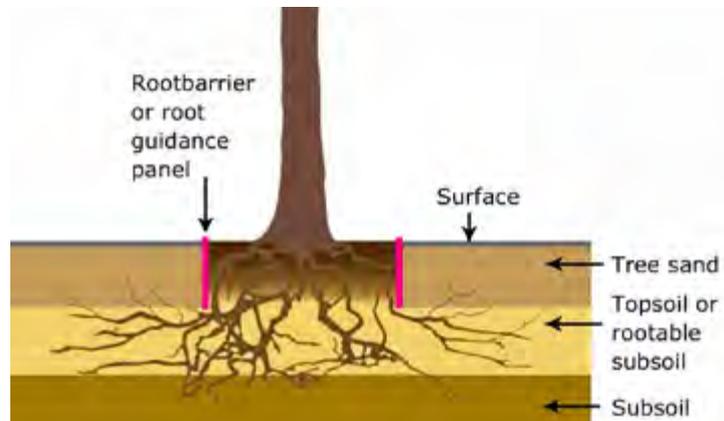
Fig. 6.16 A controlled root system (after Brouwers 2015).

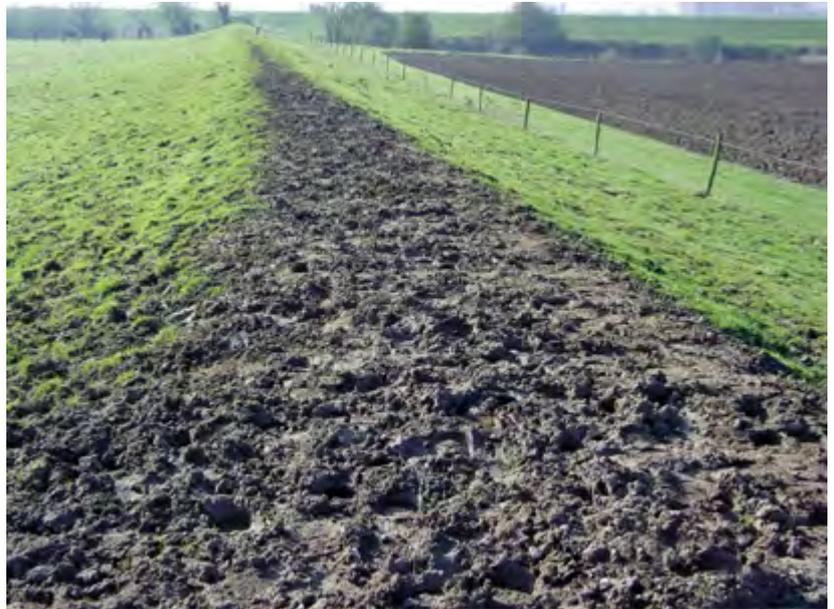
Fig. 6.19 Trampling by livestock on a dike surface (photo: Deltares).

The purpose of lessening the impact of grazing on an archaeological monument is to control the disruptive aspects of grazing on the soil and micro-relief, such as erosion and trampling (Fig. 6.19). This can be achieved by reducing the number of animals per surface unit, or by introducing seasonal restrictions (no grazing during the wet season, for example), depending on local conditions and options. These measures are also applicable to grazing in the context of nature management.⁴⁷⁹

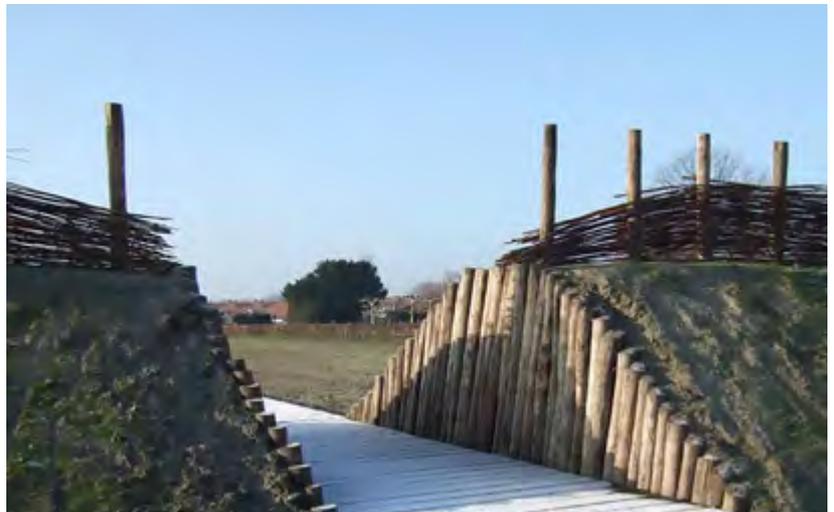
Fig. 6.20 Timber revetments mark an access point through a bank and at the same time keep the surface from crumbling. A timber palisade marks out the bank's course.

- Removing trees and shrubs growing on the bank (however, see above, and also Section 6.12);
- Cutting back branches and crowns of trees growing on and near the bank;
- Maintaining dense foliage cover above the bank so as to prevent wildshoots/seedlings and to encourage a protective moss cover.
- Inserting a revetment into the bank (and the ditch) to conserve the original profile, for instance in places where a path or road cuts through the bank (Fig. 6.20)
