Dutch presence in Cuban waters

A first year of archaeological surveys

**L.F. Derksen, R.W. de Hoop,
M.R. Manders and M. Cacéres Suárez**

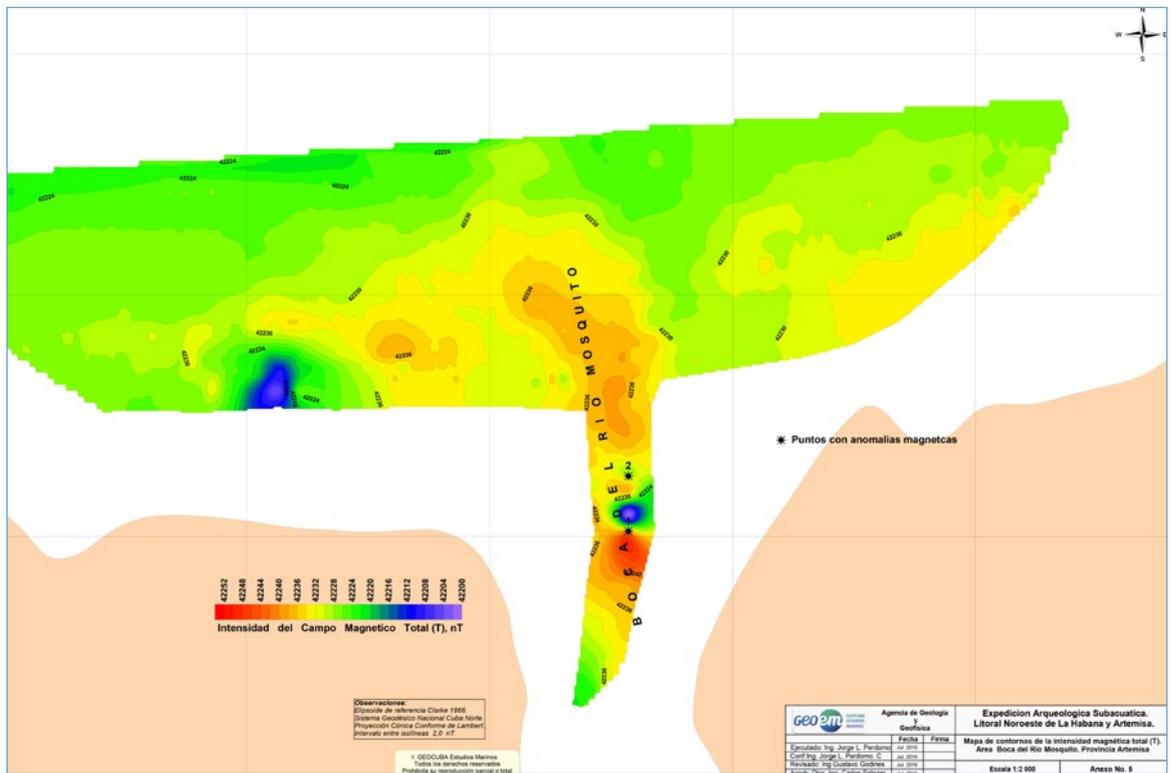
Figure 8 - Magnetometer rendition of the area near Boca de Río Mosquito, showing the intensity of the magnetic field (T). Scale 1:2000 (Courtesy of GEOEM).

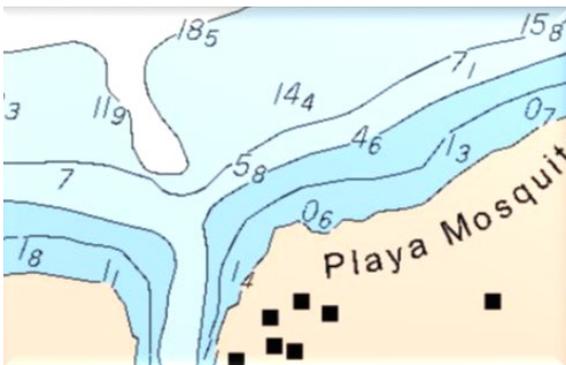
Figure 13 - Bathymetry at Boca de Río Mosquito. Carta náutica, scale 1:150,000, de Cayo Arenas a Bahía de La Habana.

The natural environment is characterized by a channel-shaped declining slope, walled in by high-reaching rocky sides (Figs. 7 & 13). Fine sandy sediment covers most of the area, interspersed with occasional rocks and a mix of modern and natural rubble. Tested once, the sediment seemed very deep: to at least an arm’s length. All in all, the area appears to be a natural trap for ships.

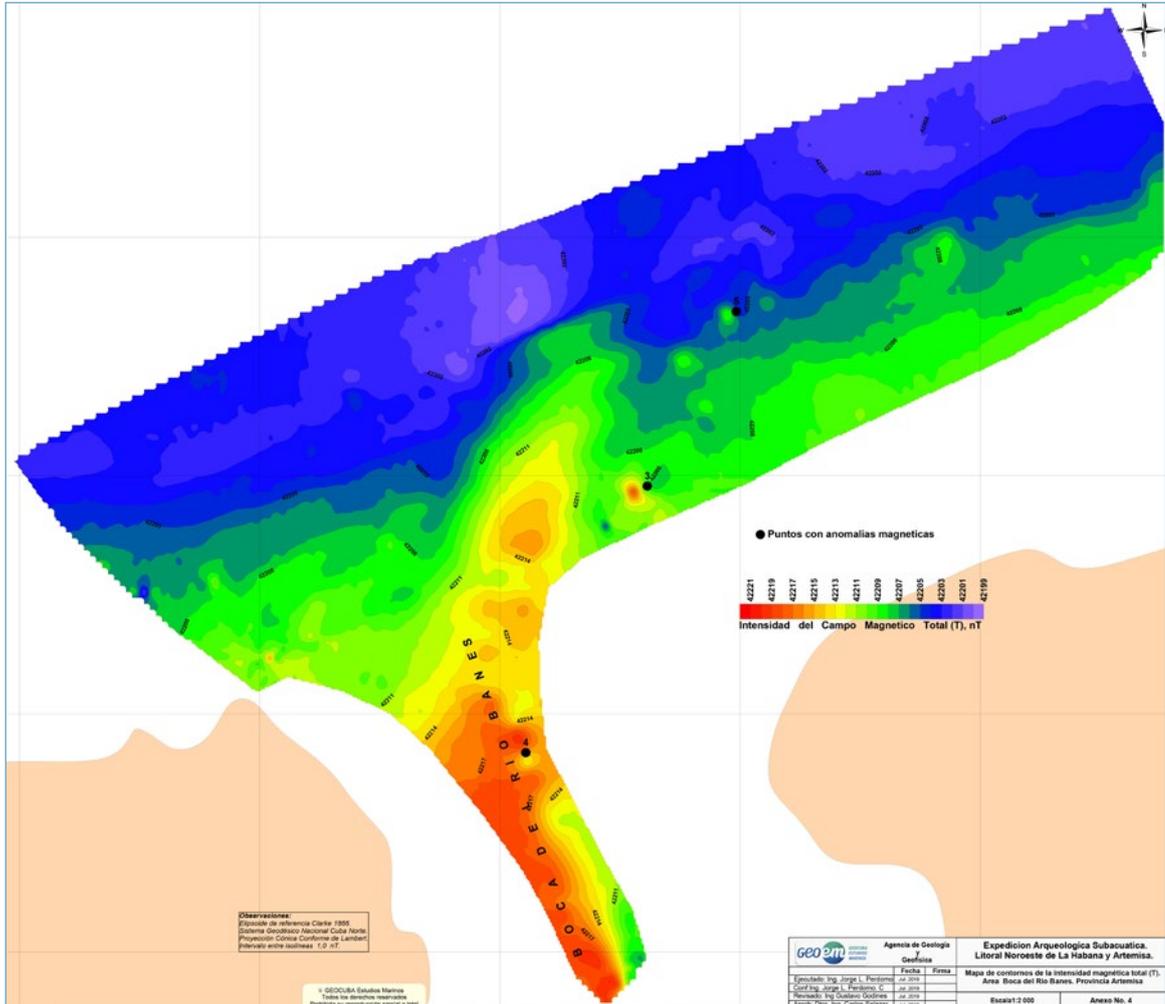
Figure 18 - Magnetometer rendition of the area near Boca del Río Banes, showing the intensity of the magnetic field (T). Scale 1:2000 (Courtesy of GEOEM).

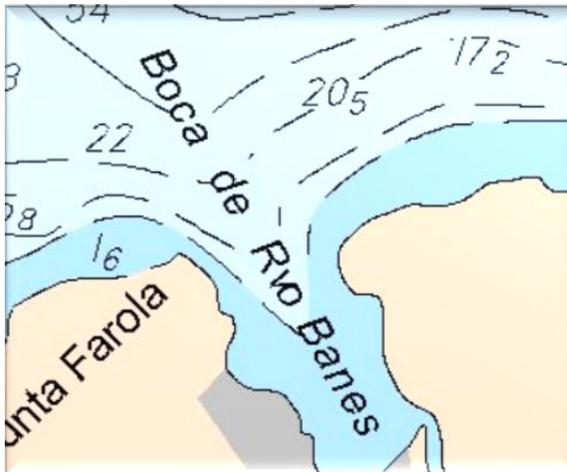
Figure 21 - Bathymetry at Boca de Rio Banes. Carta náutica, scale 1:150,000, de Cayo Arenas a Bahía de La Habana.

The local topography (Fig. 21), characterized by rocky features jutting out of the seabed, proved a menace for anchoring, as testified by the numerous anchors found. The presence of two relatively modern shipwrecks among the tall rocks suggests that other ships also ran the risk of wrecking here. A deep layer of fine, sandy sediment that characterizes the area further suggests that shipwreck material could be buried underneath. While the magnetometer survey gave no further indications of the presence of buried ferrous anthropogenic objects, this cannot be ruled out completely, due to the coarse intensity of the magnetometer deployed. During the survey, the team did not encounter any shipwreck material that could be related to a 17th-century Dutch

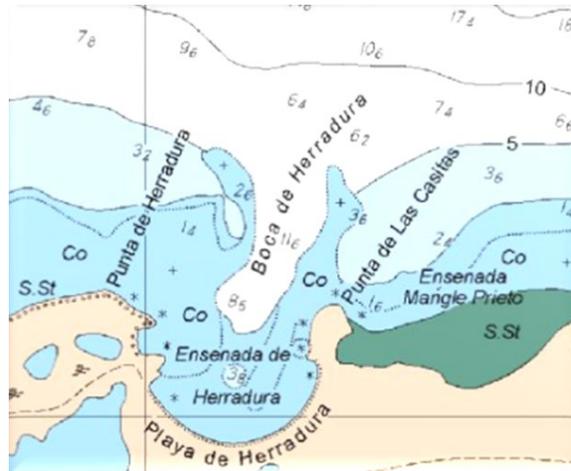
Figure 22 - Bathymetry of the marine area near Boca y Ensenada de Playa Herradura. Carta náutica, scale 1:150,000, de Cayo Arenas a Bahía de La Habana.

Knowing that the *Keizerin* was stranded here on the shore, the survey vessel had to get as close to the coast as possible. However, this proved difficult, as, after surveying only three lines, the local topography already became very shallow, with large rocks situated only 3-5 metres below surface level (Fig. 22). This meant that the boat could not get closer to the shore to continue the SSS and magnetometer tracks.

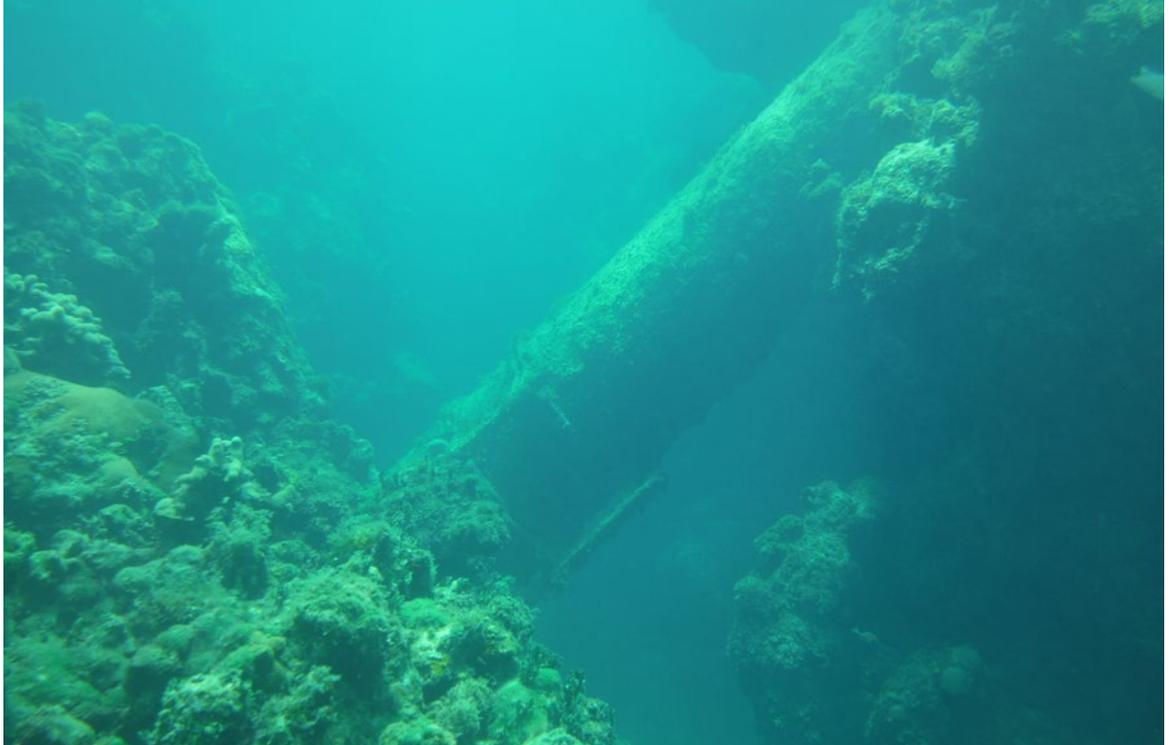
Since the SSS and magnetometer surveys could not be completed to satisfaction, it was decided to visually inspect the shallower area using divers. The entry point was set above the anomaly located in the magnetometer survey, situated on the northeast side of the natural channel. This anomaly turned out to be a large pipeline (Fig. 25) trapped between the rocks. No other significant finds were discovered.

Figure 25 - Pipeline
