# Joint Verification of the location and condition of Hr.Ms. De Ruyter, Java and Kortenaer

6 to 9th of February 2017, Jakarta Indonesia

Version 09/02/2017

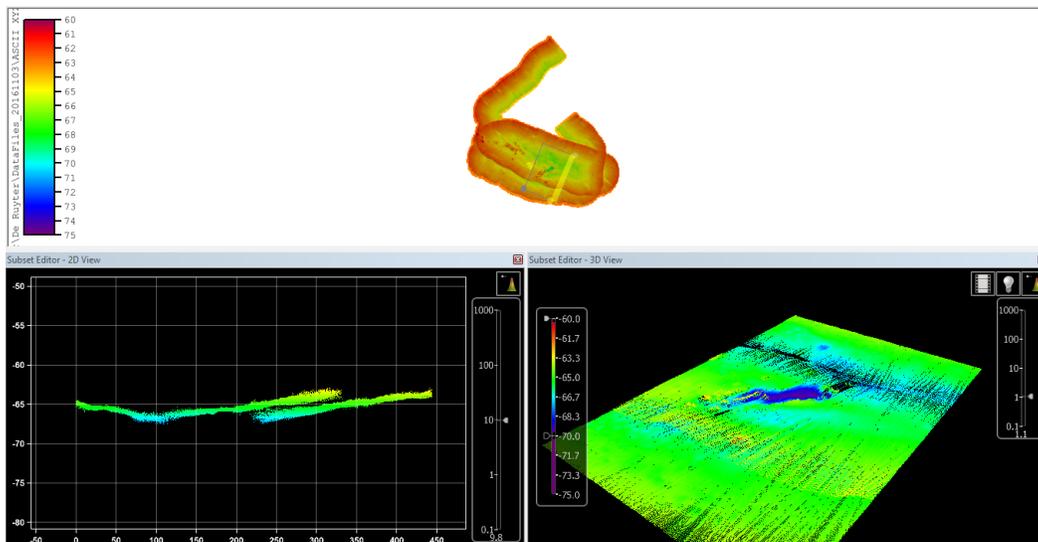
Figure 3: Examining MBES Data Surface Grid 1m bin, 3D and 2D Point Cloud.

The position of the trench on the Multibeam snapshot (figure 6) is in consistence with the position as stated as the find position (located 2002). The trench is around 170 metres long.

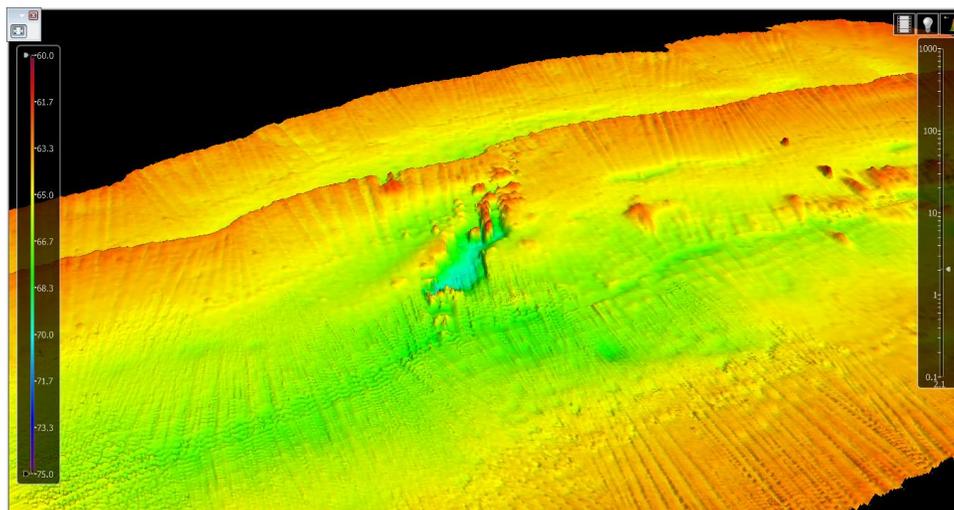
Figure 4: Surface grid 1m bin in 3D View.

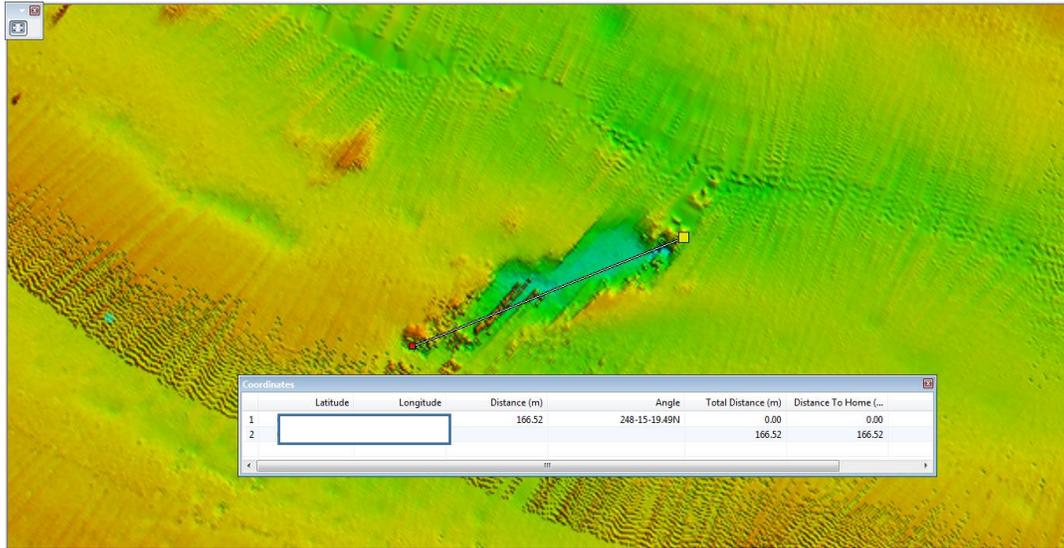
Trench wreck Site A Length 166.52 meter [248-15-19.49N].

Figure 5: Trench Length Measurement.

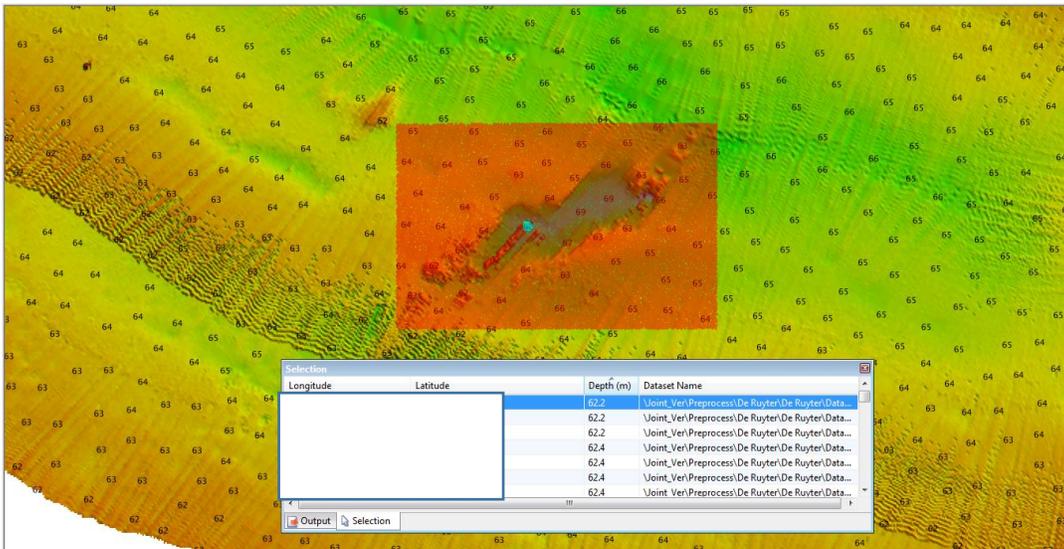
Figure 6: Trench position.

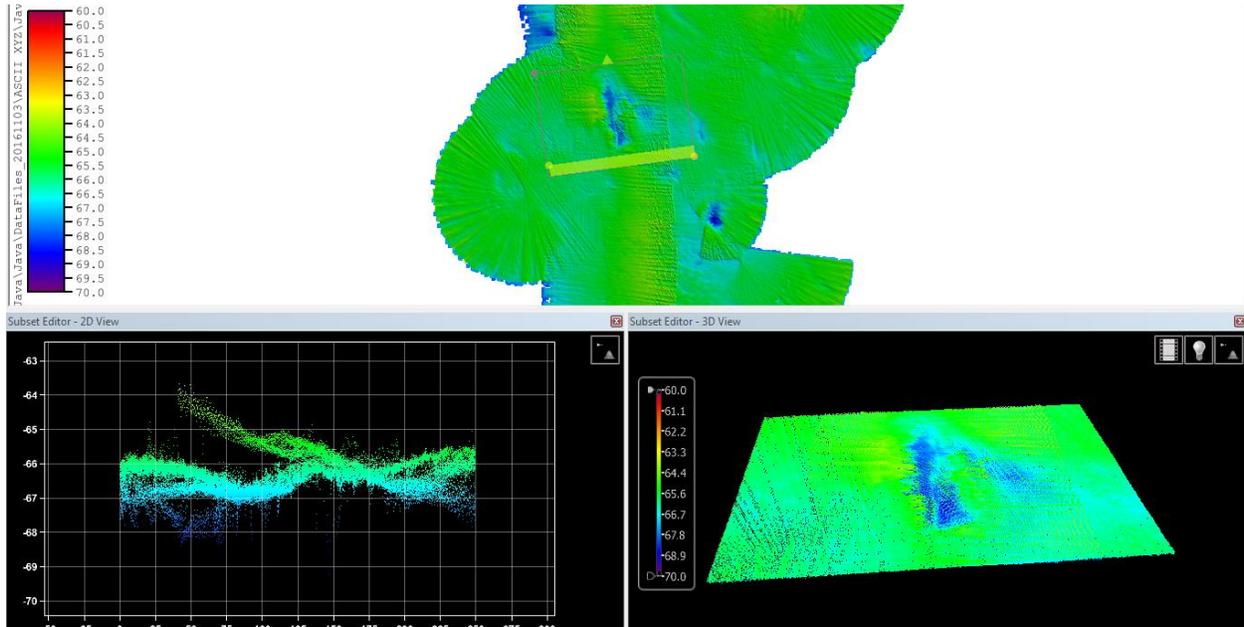
Figure 7: Examining MBES Data Surface Grid 1m bin, 3D and 2D Point Cloud.

The position of the trench on the Multibeam snapshots (figure 10) is in consistency with the position as stated as the find position (located 2002). The trench is round 130 metres long.

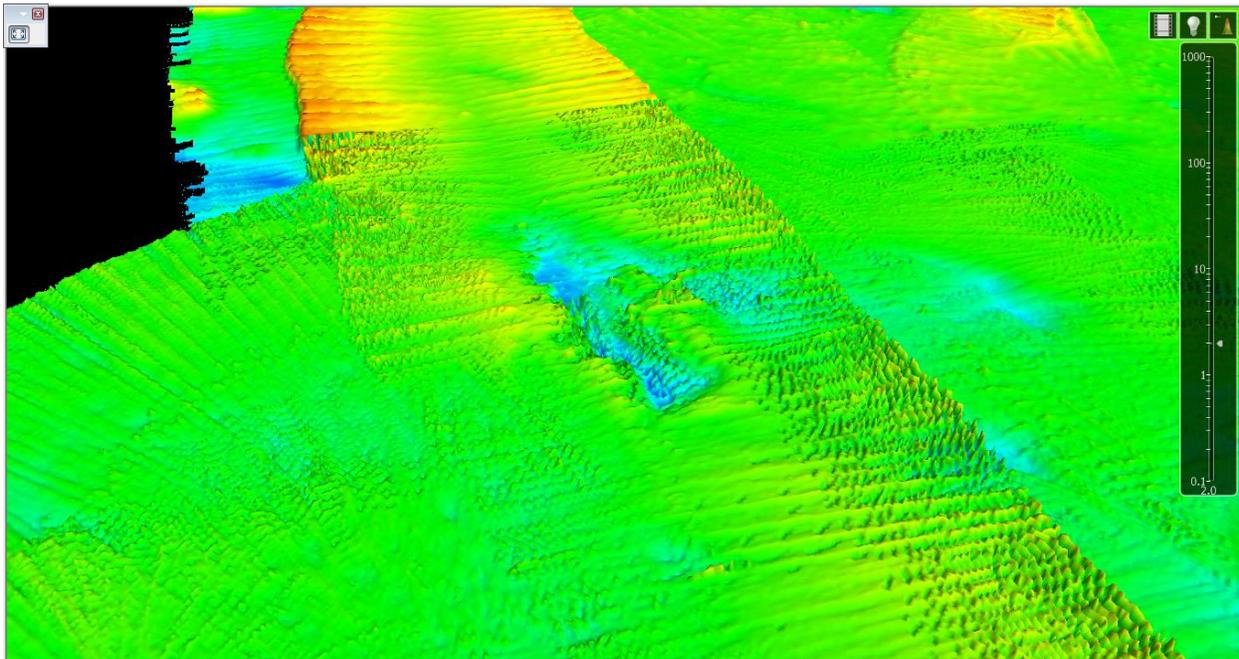
Figure 8: Surface grid 1m bin in 3D View.

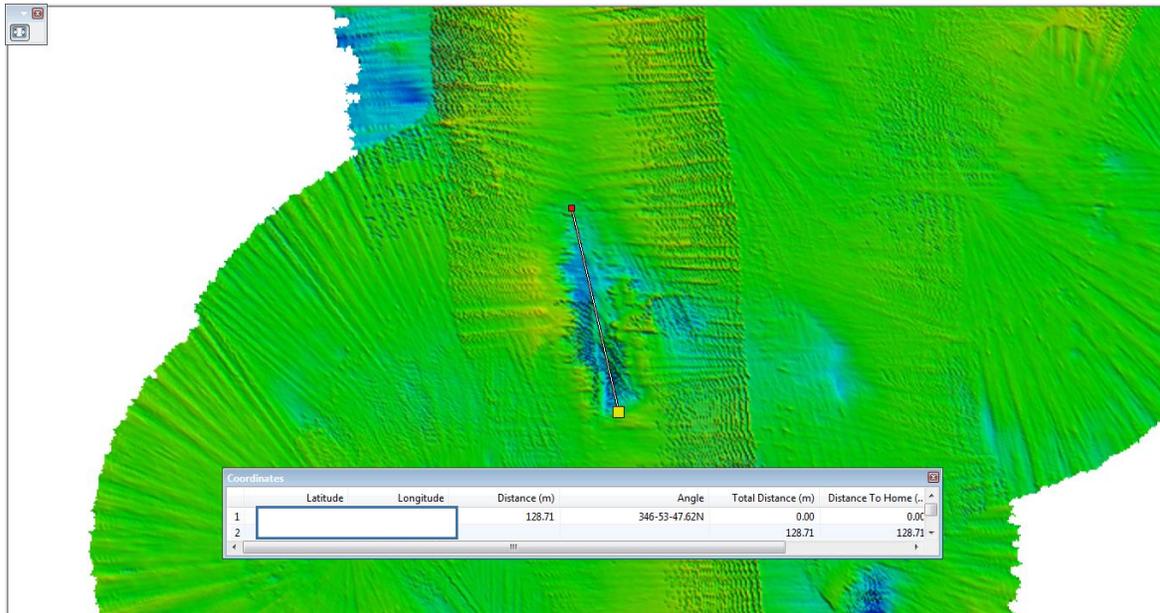
Trench wreck Site B length 128.71 meter [346-53-47.62N].

Figure 9: Trench Length Measurement.

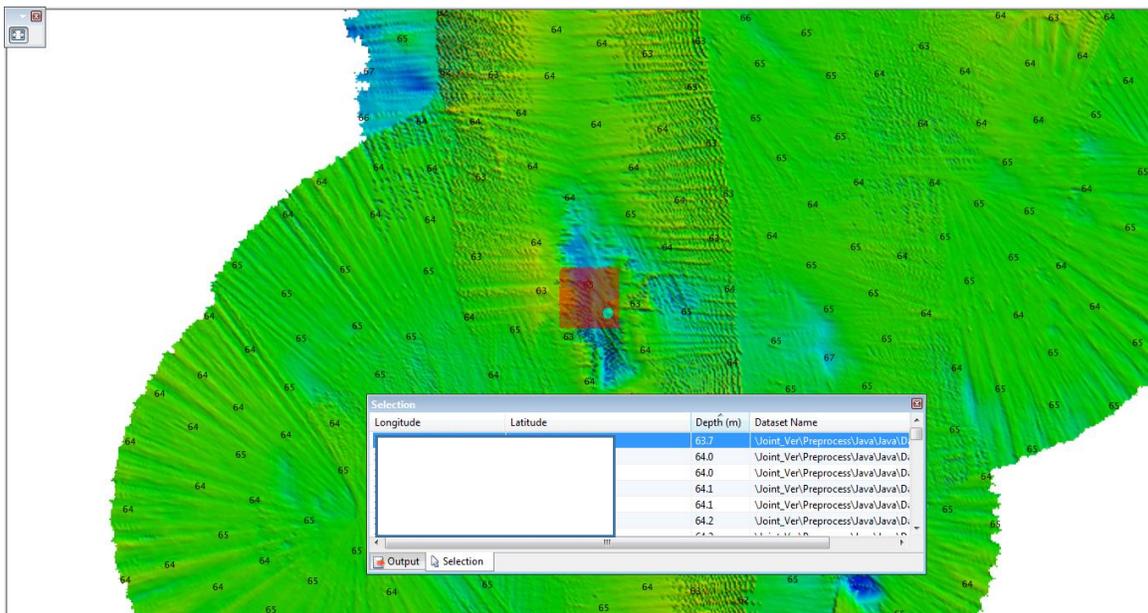
Figure 10: Trench Position.

On Site B more or less a same kind of trench in the seabed of approximately 130 m long can be observed. The position of the trench on the Multibeam snapshot (figure 10) is in consistence with the position as stated as the find position (located 2002).

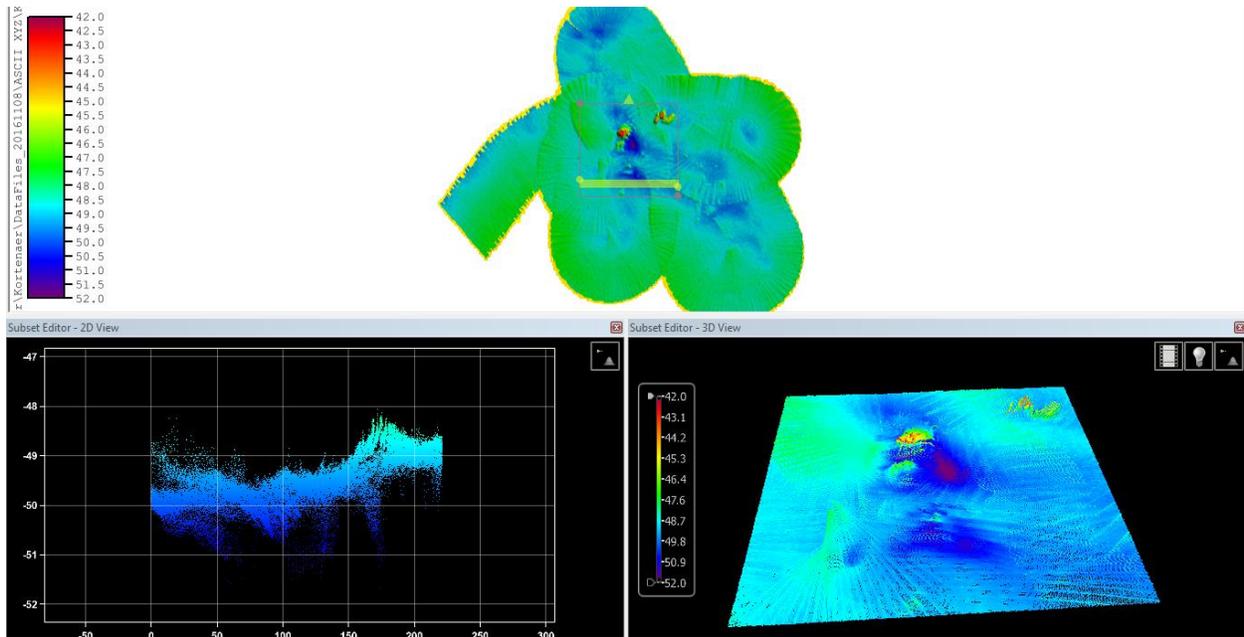
Figure 11: Examining MBES Data Surface Grid 1m bin, 3D and 2D Point Cloud.

The position of the trench and some wreckages on the Multibeam snapshots (figure 14) is in consistence with the position as stated as the find position (located 2004). The trench is around 165 metres long.

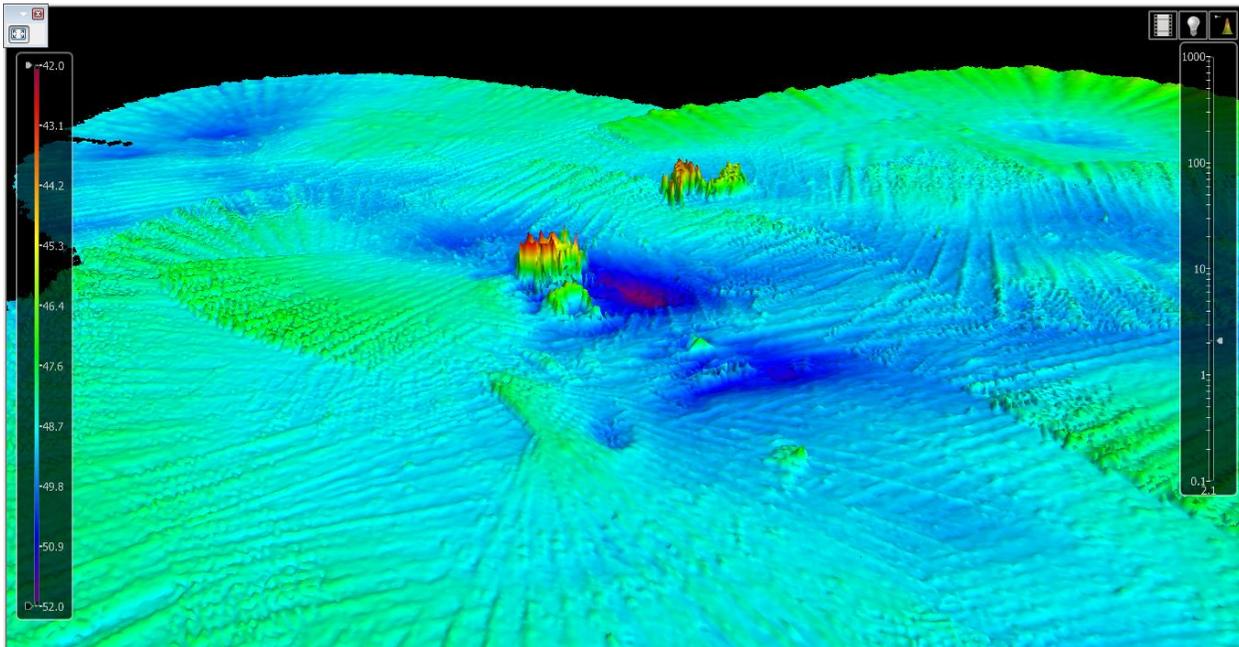
Figure 12: Surface grid 1m bin in 3D View.

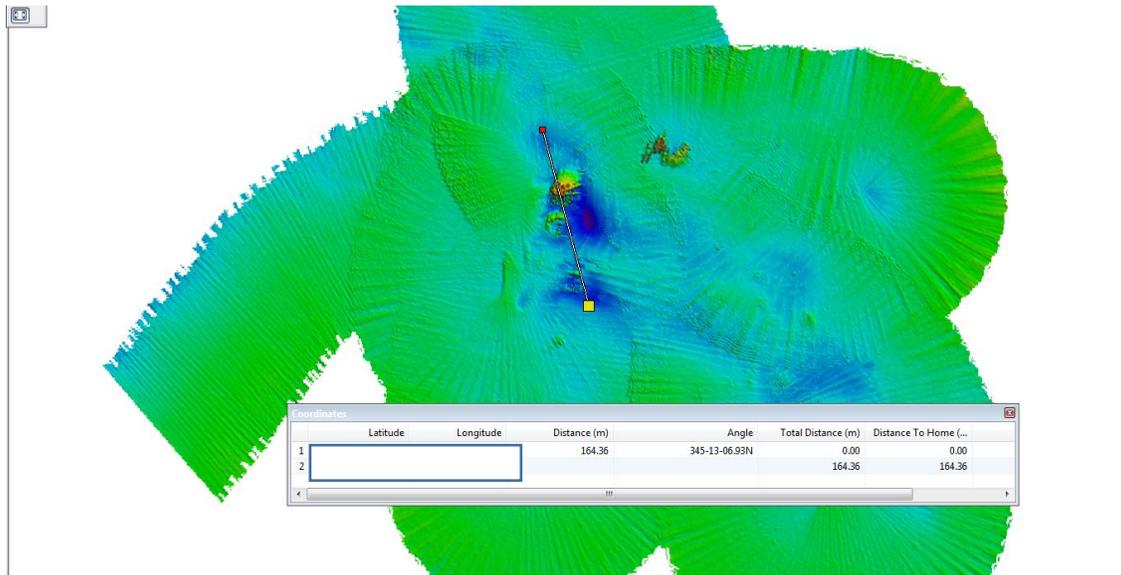
Trench wreck Site C Length 164.36 meter [345-13-06.93N].

Figure 13: Trench Length Measurement.

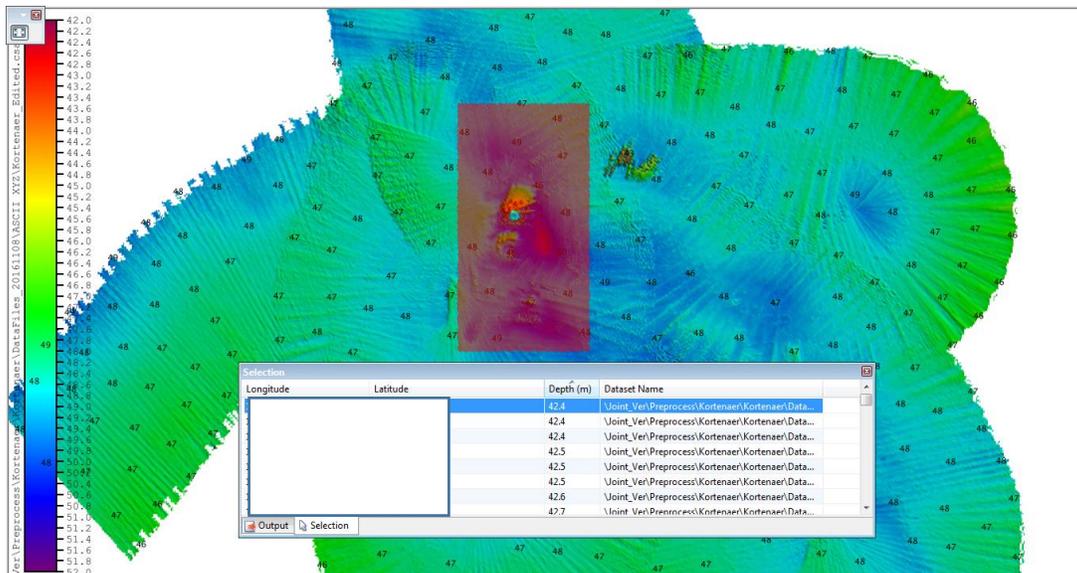
Figure 14: Trench Position.

On site C a shallow trench and some wreckages can be observed on the seabed. The position of the wreckage on the Multibeam snapshots (figure 14) is in consistence with the position as stated as the find position (located 2004).

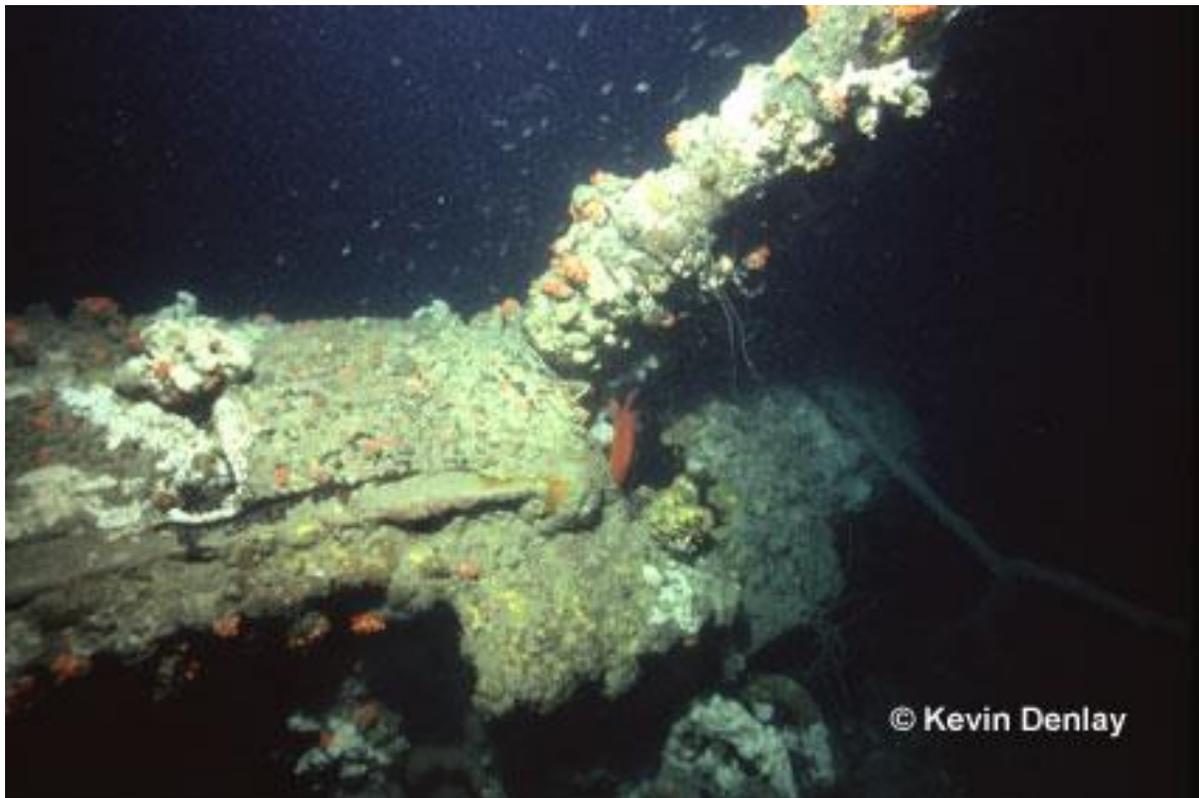
Figure 16: Looking from a lower angle at the face shields on *De Ruyter's* Bofors guns. This one is taken looking at the face from below and to the left. The twin barrels point out to upper right.

No historical photo shows the protective shields in place on *De Ruyter* and when underwater photos of these shields (see figure 16) were first seen they apparently caused somewhat of a controversy as many people were completely unaware that *De Ruyter's* Bofors were actually shielded.<sup>9</sup> Originally these shields had not been installed on the ship, but historical information revealed that they were added on just right before the battle started. The details described above makes the identification of the wreck of that of the *De Ruyter* admissible.

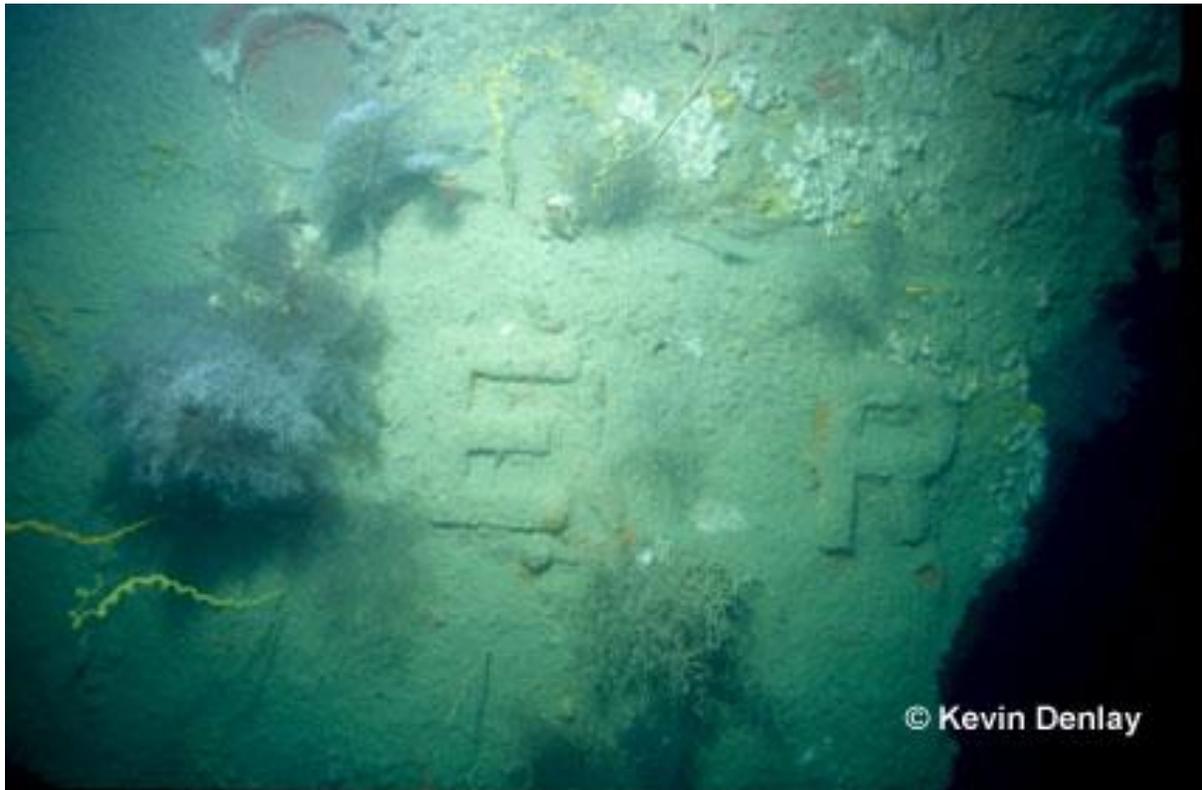
Figure 17: While the letter D is hidden by a small coral bush on left, the letters E and R of *De Ruyter's* name, as seen in historical photos on her stern, are clearly visible. A large gash or split runs down *De Ruyter's* port hull just to the right of the letter R.

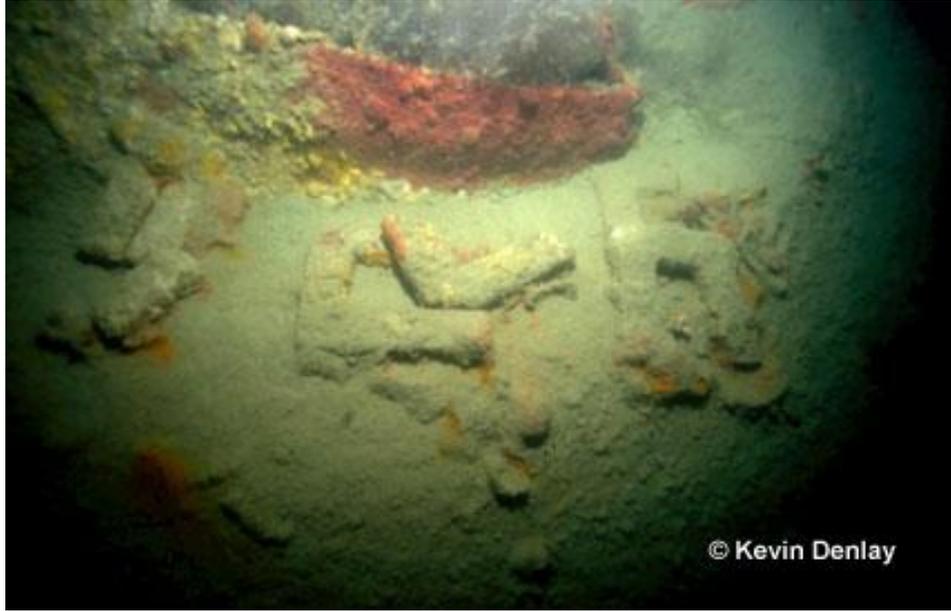
Figure 18: The remaining letters of De Ruyter's name lay jumbled.

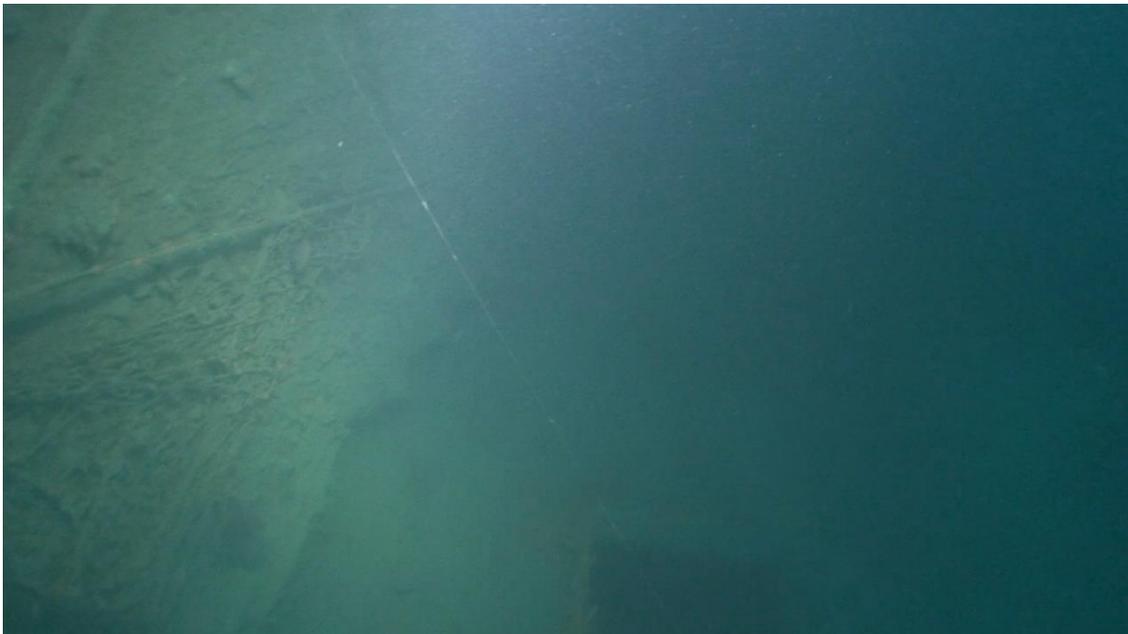
At the time of the 2008 video survey Hr.Ms. *De Ruyter* was laying intact and upright, tilted to starboard at approximately 30 degrees. The starboard guardrail was nearly at the level of the seabed. The forward rangefinder atop the bridge tower had lost its port arm. The forward gun turrets were trained to approximately Green 90. Figure 19 shows a small hatch along the side of the no. 1 turret.<sup>10</sup>

Figure 19: A small hatch (bottom middle/right) along the side of the no. 1 turret.

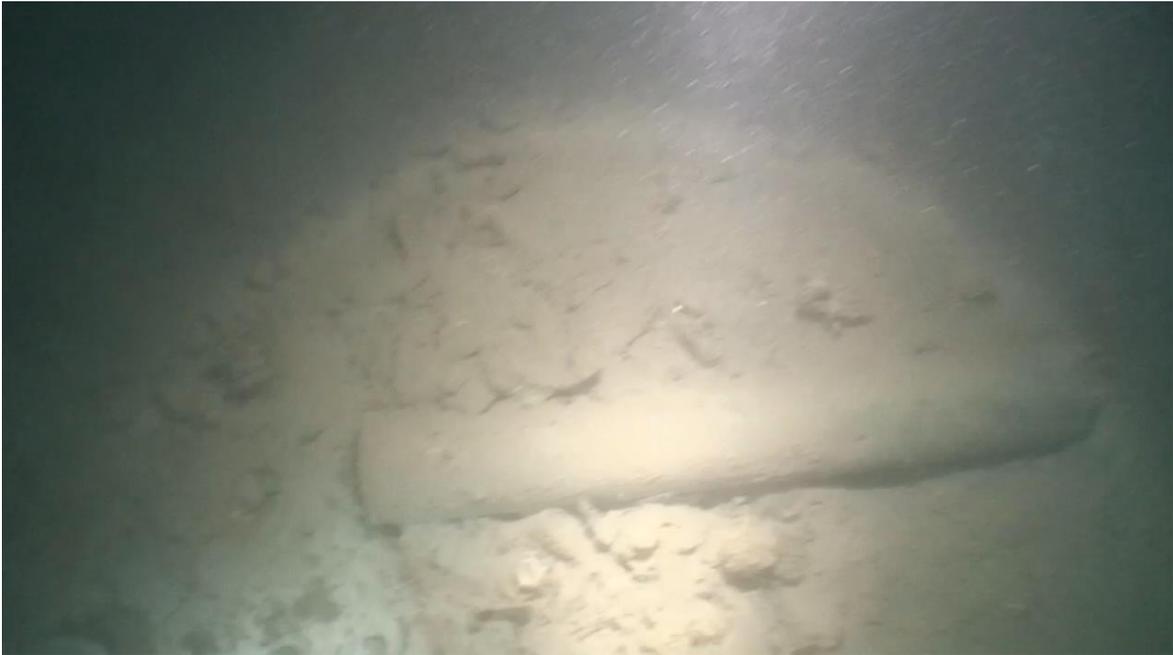
Expended 15 cm cartridge casings were found scattered around the seabed on the starboard side (see figure 20). The *De Ruyter* had seven 15 cm Bofors guns (see Appendix 4).

Figure 20: One of the 15 cm cartridge casings.

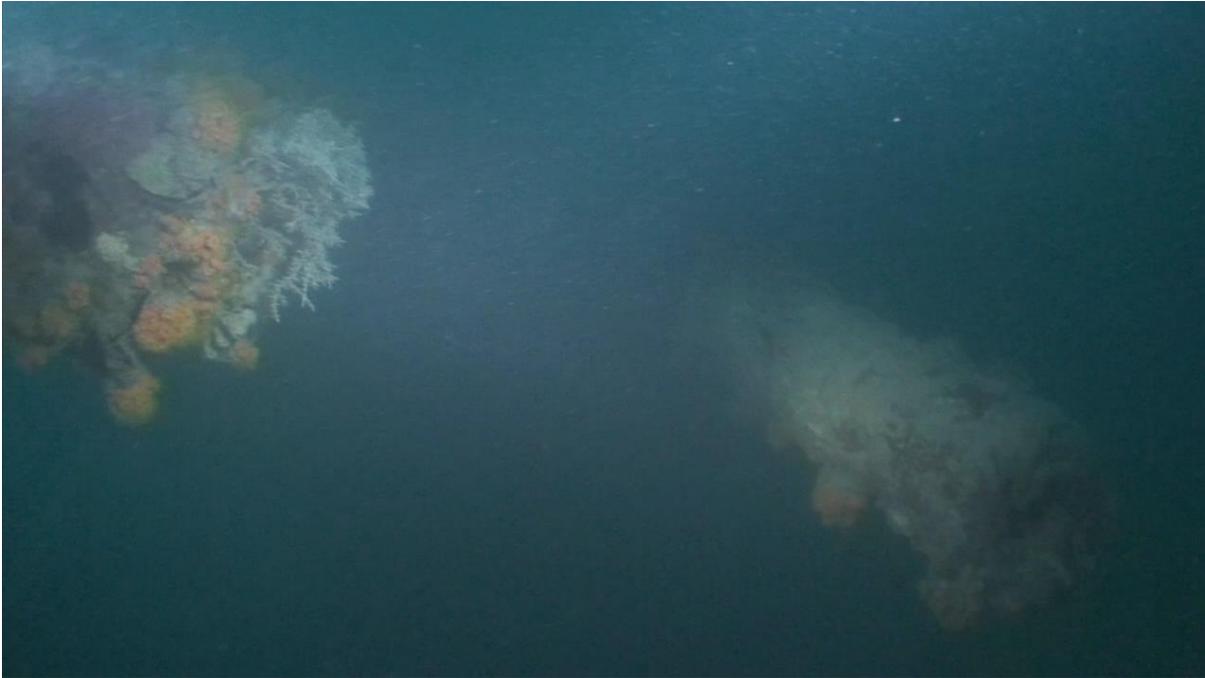
The five 40 mm Bofor guns on the aft deckhouse (above the captain's cabin) were *in situ* and demonstrated the protective shield fitted just prior to her sailing. The aft turrets were still in cruising position pointing towards the stern.

Figure 22: The aft turrets pointing towards the stern.

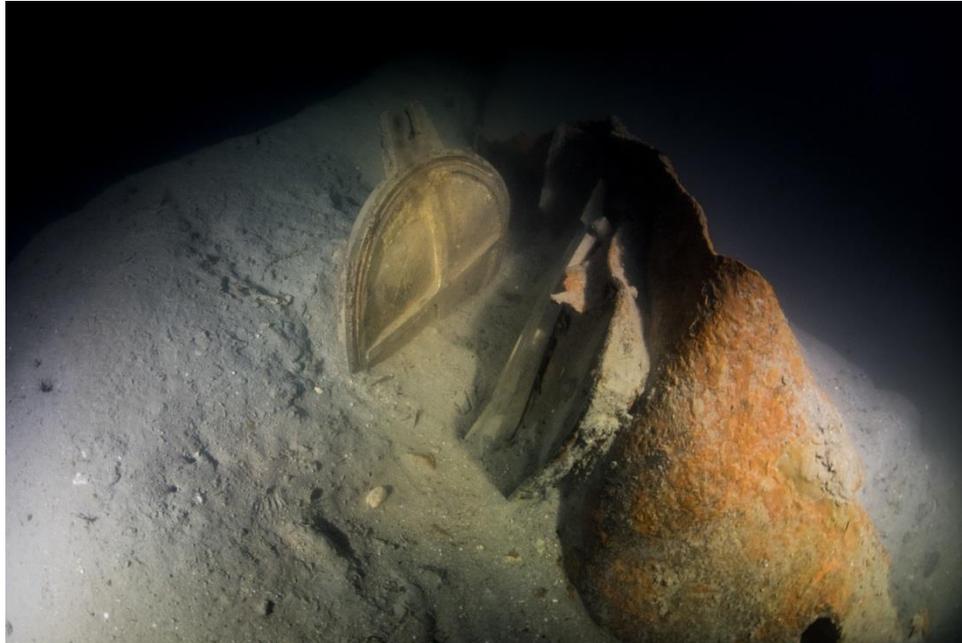
Figure 23: Torn hull plating and scuttle with deadlight at the *De Ruyter* site. The bronze deadlight with the cross on it is typical of those seen in Dutch cruisers and quite unlike the Admiralty pattern ones on HM and HMA ships.

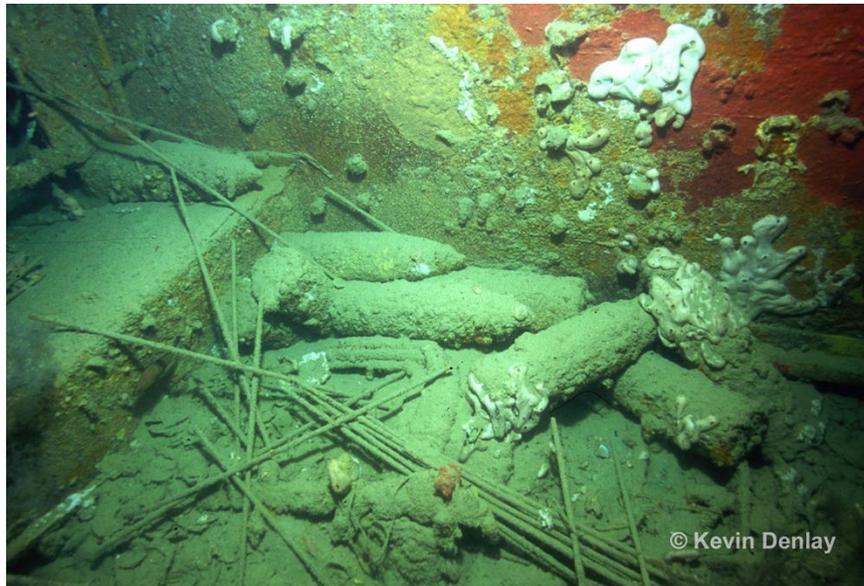
Figure 26: Unused (i.e. 'live' unexploded) 5.9 inch / 150mm projectiles laying against a bulkhead on the Dutch cruiser Hr.Ms. *Java*. The long thin strips (foreground) are cordite from inside the brass shell casings that would have been loaded with the projectiles.

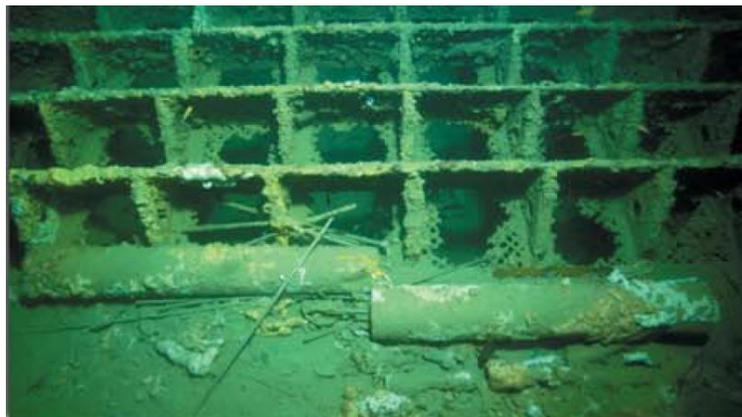
Figure 27: The unique 'baffled' base of the funnel that helped quickly identify *Java*. Sticks of cordite can still be seen protruding from the 15cm (5.9 inch) shells.

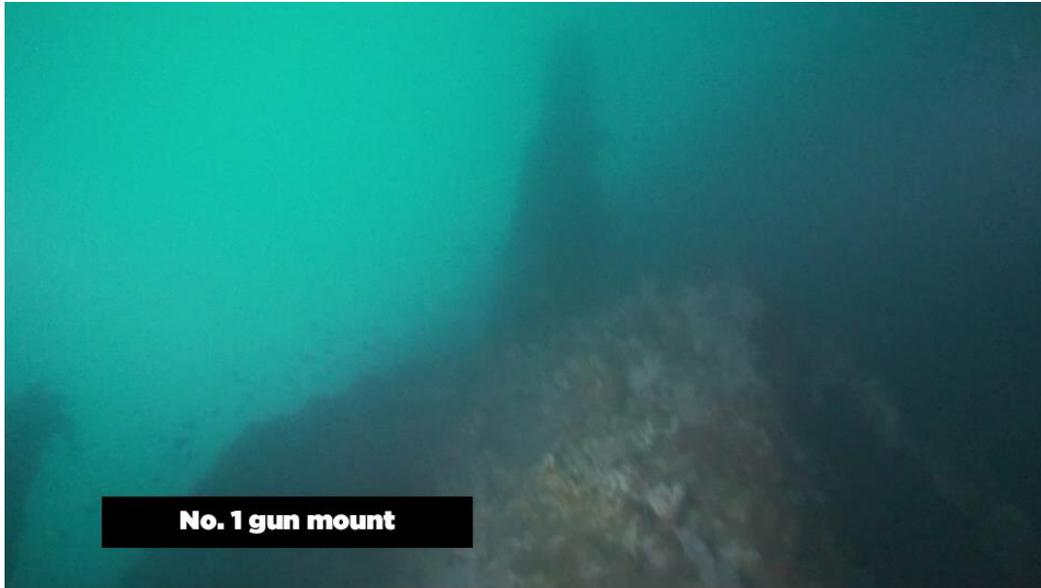
Site B, now identified by the divers as the Hr.Ms. *Java*, was still laying on her starboard side. The forward, remaining after and portside 15 cm gun mounts were trained to approximately Red 90 (figure 28).

Figure 28: No. 1 gun mount trained to approximately Red 90.

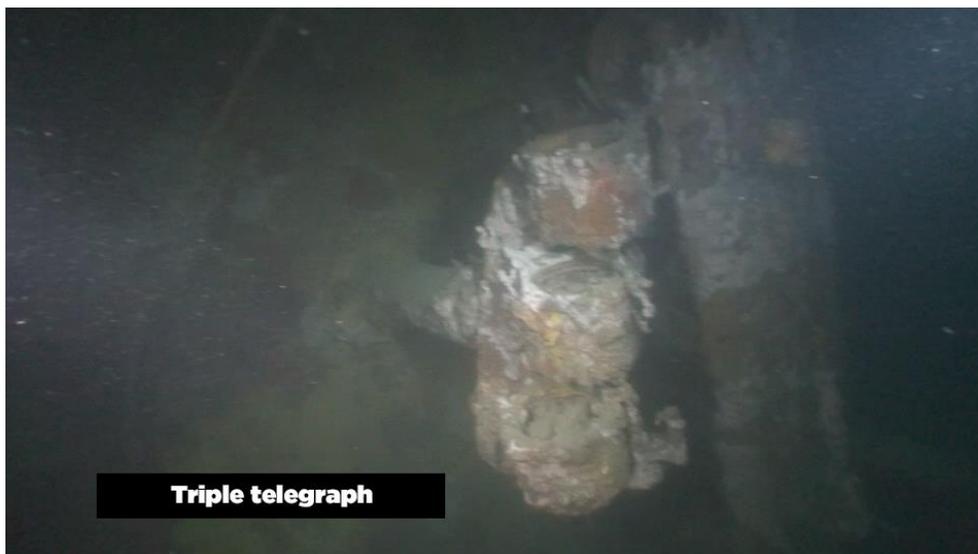
The bridge structure was intact with the frame for the canvas roof still present. Both the helm and telegraphs were present on the bridge (figure 29).

Figure 29: Triple telegraph still present on the bridge.

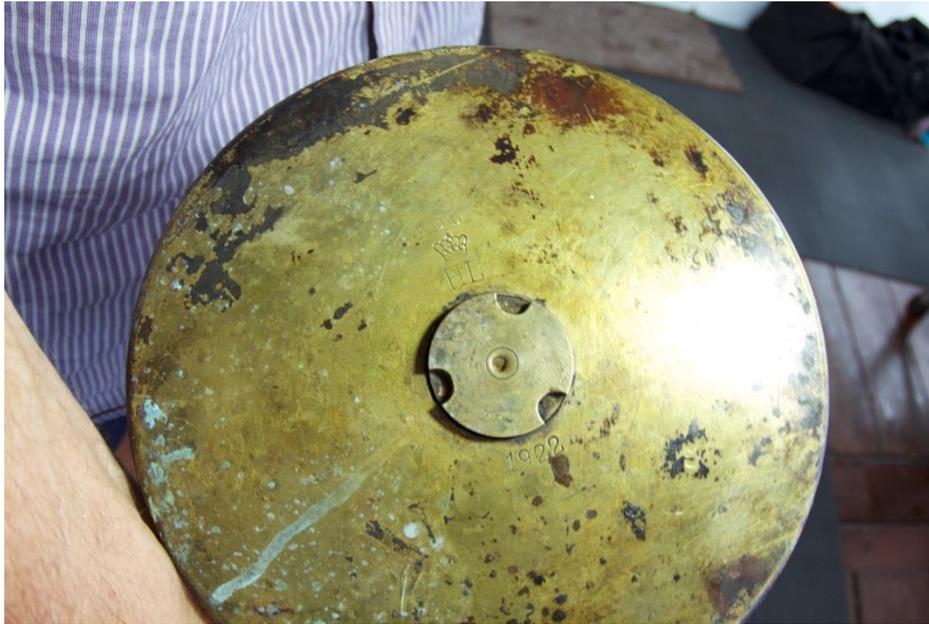
The diving operation in 2016 revealed a similar topography to the *De Ruyter* site (a large trench of 130 m) with subsurface mud/clay in the trench. Several scattered thick torn hull plates and minor fittings were found around the site. A 15cm copper-alloy cartridge case was recovered to help identification of the site. Base markings showed it to be indeed of Dutch manufacture and of the type used by Hr.Ms. cruisers.<sup>13</sup>

Figure 30: Base markings 15cm cartridge case from the *Java* site. Note the Dutch crown and manufacture date 1922.

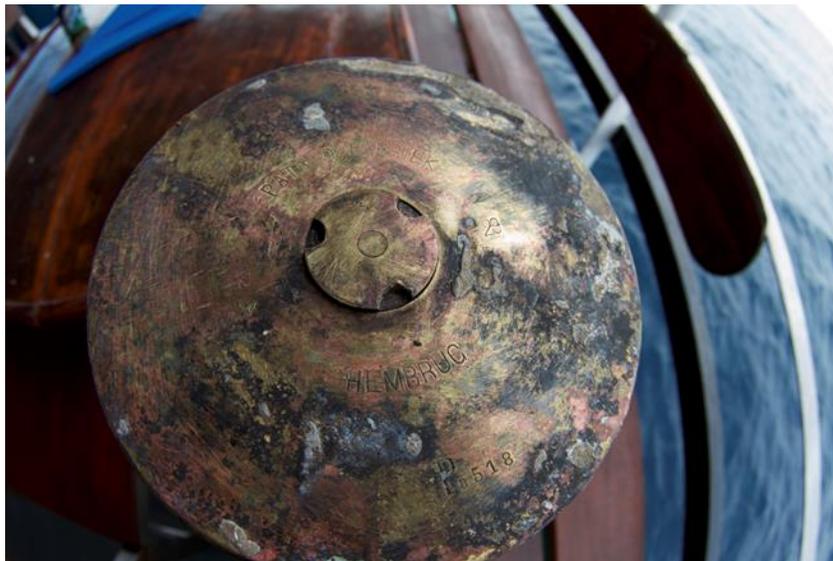
The identity of the ship was confirmed by the retrieval of a 12 cm cartridge case. Base markings showed it to be of Dutch origin, manufactured at the *Hembrug Armoury* north of Amsterdam in 1929.<sup>16</sup>

Figure 31: 12 cm copper alloy shell case that was recovered from the *Kortenaer* site.

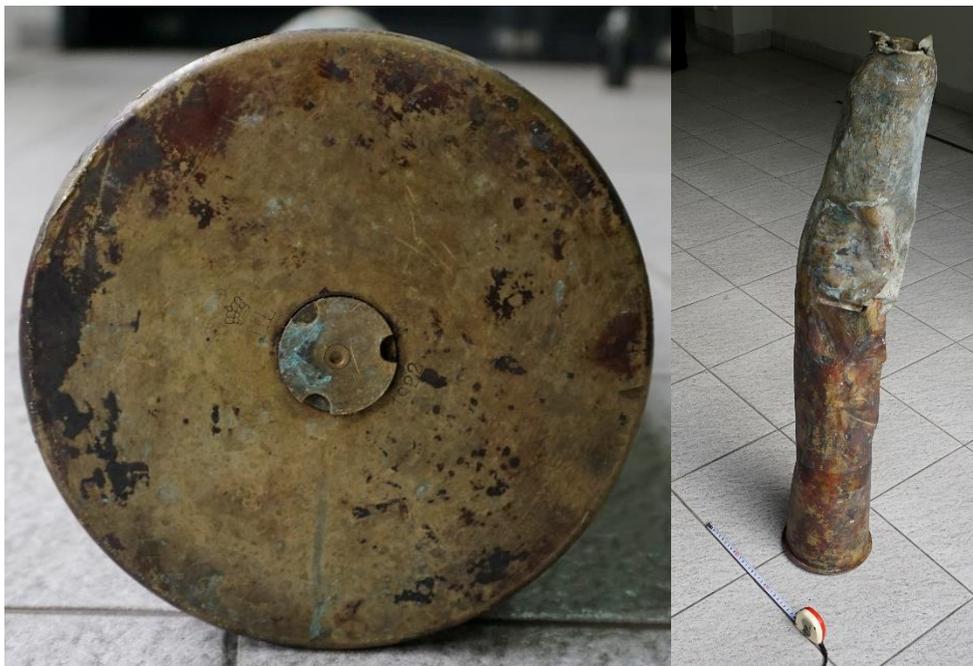
The copper alloy cartridge of the *Java* is 69 cm high and the base has a diameter of 17.5 cm. The numbers and texts on the base correspond with the information mentioned in the dive report of 2016.

Figure 41: The copper alloy cartridge of the *Java*.

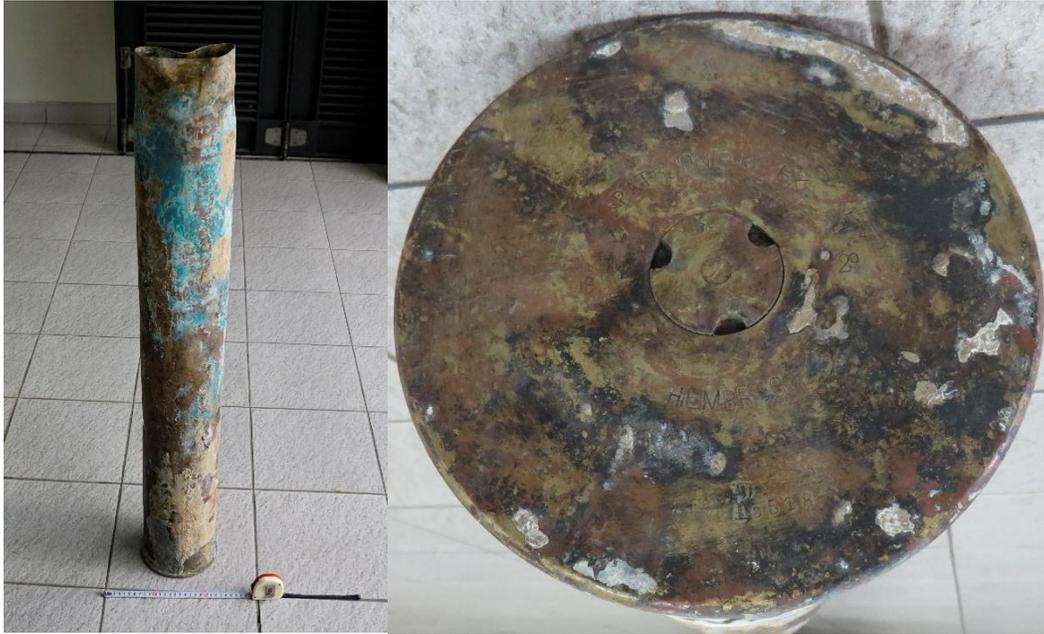
The copper alloy cartridge of the *Kortenaer* is 103 cm high and the base diameter is 16 cm. The numbers and texts on the base correspond with the information mentioned in the dive report of 2016.

Figure 42: The copper alloy cartridge of the *Kortenaer*.

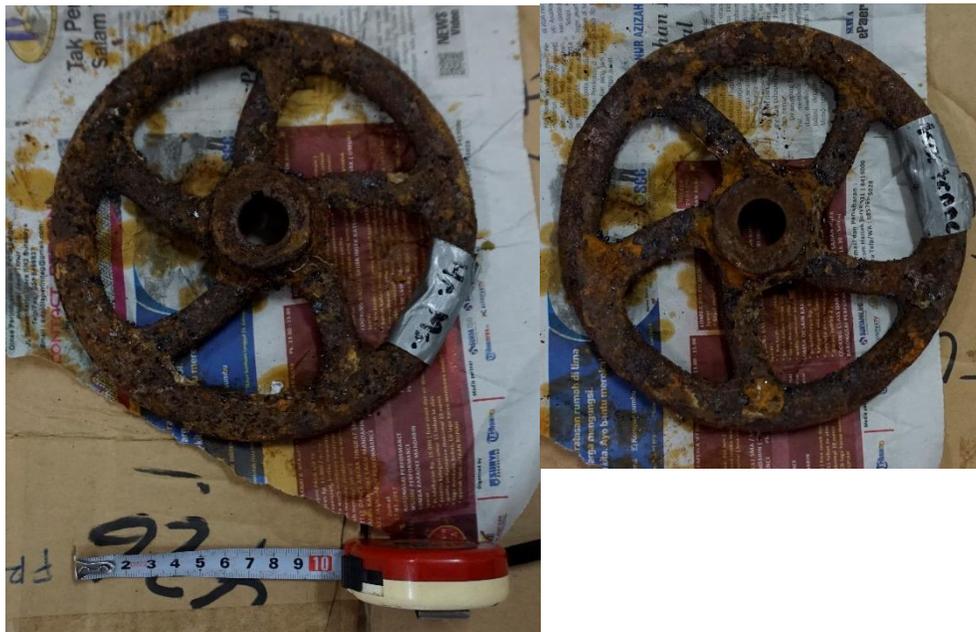
The iron valve hand wheel of the *Kortenaer* is corroded and does not contain any details to identify it as specific for Dutch ships or not.

Figure 43: The iron valve hand wheel of the *Kortenaer* (both sides).

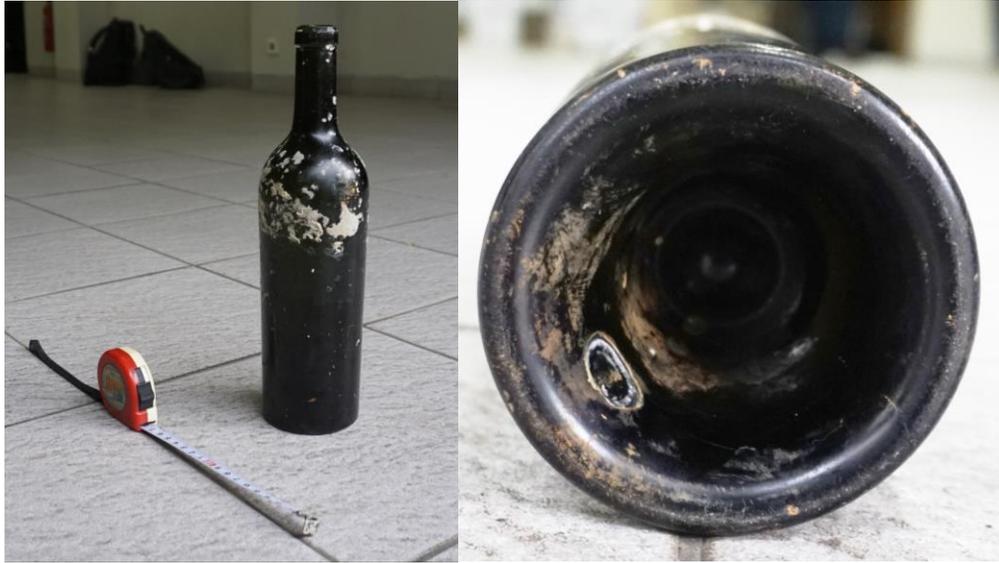
The thick green glass bottle has a deep sole. Although we cannot be certain it was originally from the *Java*, we can say it is quite likely from around that period. It is a typical wine bottle moulded with many irregularities in the glass.

Figure 44: Thick green glass bottle from the *Java*.
